# SAFETY ALERT

## Electric shock from a light fitting.

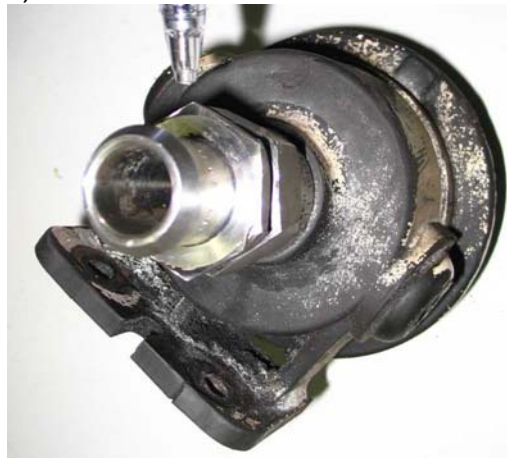
The source of voltage was from a 110 volt power supply located in the master control enclosure on the continuous miner. The Burn Brite light fitting case was plastic; however three brass threaded inserts are embedded in the boss assembly to enable cable glands to be fitted. These metal inserts are not connected to earth, and any metal gland screwed in may not be earthed (see photograph below)

The presence of water in the light fitting caused a fault current to flow to the earth screen of its supply cable. This imposed a touch voltage onto the unearthed external cable gland. The fault current was below the magnitude necessary to cause the electrical protection to operate. The circuit protection is a 10-ampere fuse and a toroidal earth-leakage relay set to trip at 500 milliamps, within 250 milliseconds. The light fitting continued to operate with the water present.

All mines should review the inspection, testing and maintenance of all electrical equipment to include the checking of the integrity of earthing of exposed metal parts and earth continuity testing.

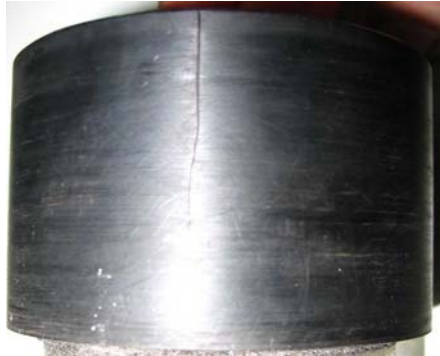
The light fitting was mounted vertically which allowed water to enter and accumulate as a result of a missing "O" ring between the boss and nut assembly of the light fitting. The missing "O" ring constitutes a failure of the Ingress

Protection (IP). (Note: The “O” ring may become dislodged during re-assembly of the light fitting after maintenance). The outer case collar (flamepath) was cracked (see photograph below) and the poly-carbonate case was also cracked.

- Prevent mistaken assembly,
- Identify cracks in the flameproof assembly.
- Ensure adequate earthing
