SAFETY BULLETIN

DATE: JULY 2019

Objects entering cabins of underground mobile plant

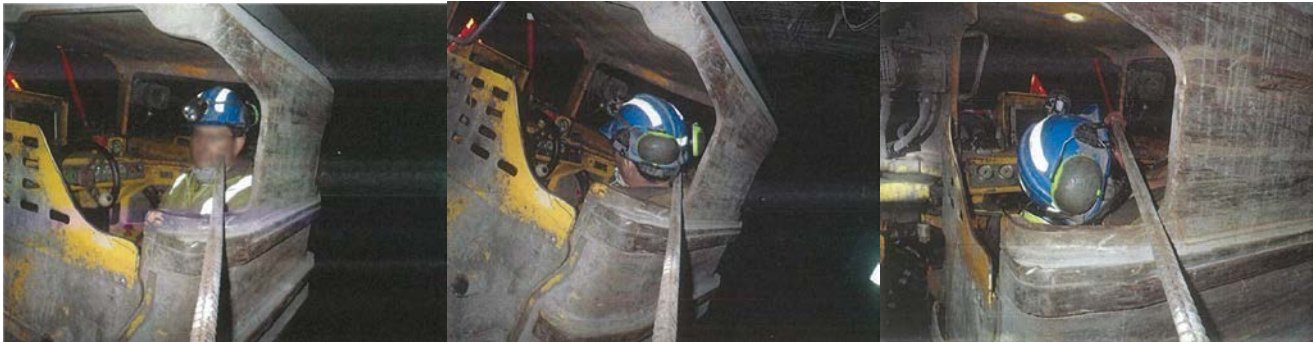
An underground coal mine load haul dump (LHD) operator suffered a fractured cheek bone, as well as severe head and neck lacerations resulting from a protruding roof bolt that was stowed in the rib side mesh. The operator's arm and shoulder were also injured when his body was forced onto the LHD door by the roof bolt.

The operator said he did not see the protruding roof bolt and that he didn't touch the rib with the vehicle but the roof bolt entered into the operator's cabin at head height and hit him.

Figure 1 Simulation of the roof bolt entering the operator's cabin and hitting the operator on the cheek bone (left photo). As the LHD moved forward, the bolt went behind the operator's head (middle photo). As the LHD moved further forward, it pivoted on the LHD canopy and forced the operator onto the LHD door (right photo) (IncNot0034693)

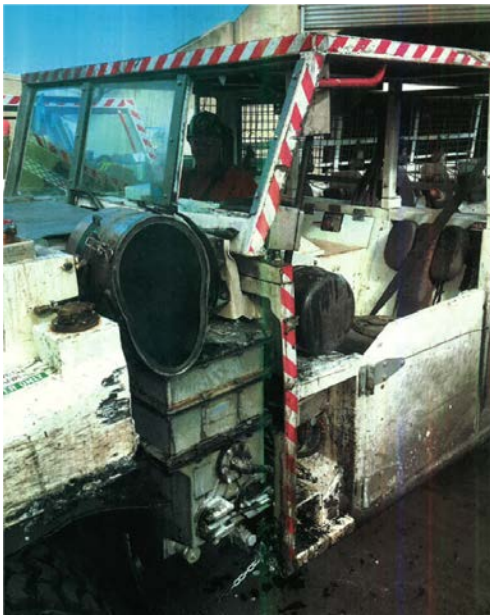
The driver of an underground coal mine personnel transporter hit the rib side.

Figures 2 Damage to side of personnel transporter

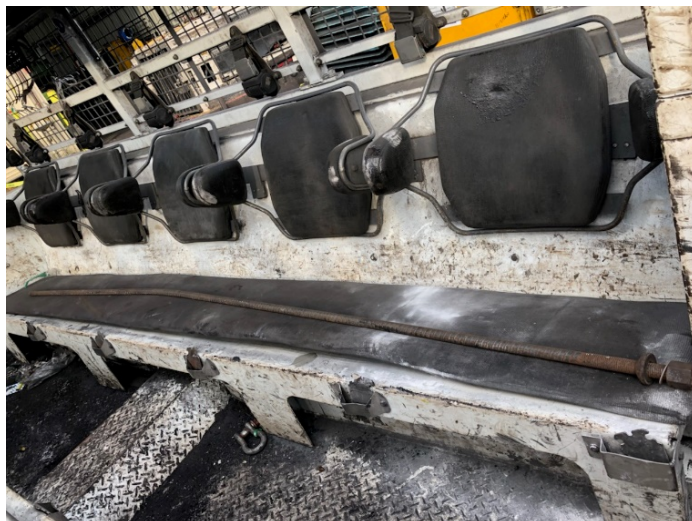
The driver said that a single 2.4 metre roof bolt entered through the passenger windscreen and went through the cabin divider mesh and landed on the rear seat of the transport vehicle. The bolt entering the cabin caused the driver to hit the rib side.

The driver was not injured. However, if a person had been seated in the front passenger seat or in a rear seat, the impact from the roof bolt could have been fatal.

Figure 3 Post-incident simulation of the final location of the roof bolt on the personnel transporter rear passenger seats (IncNot 0034483)

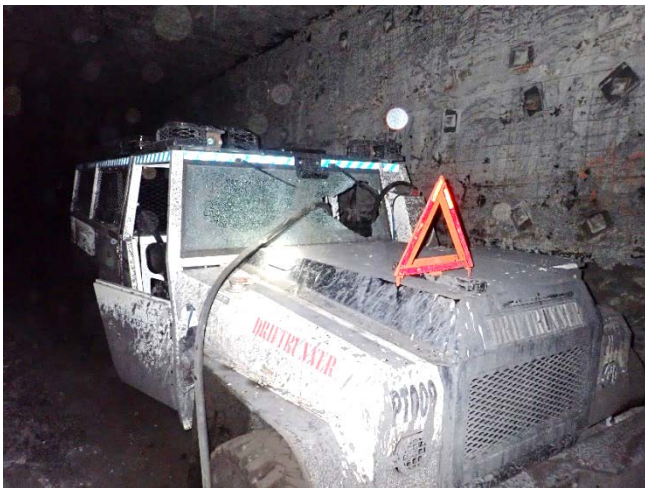
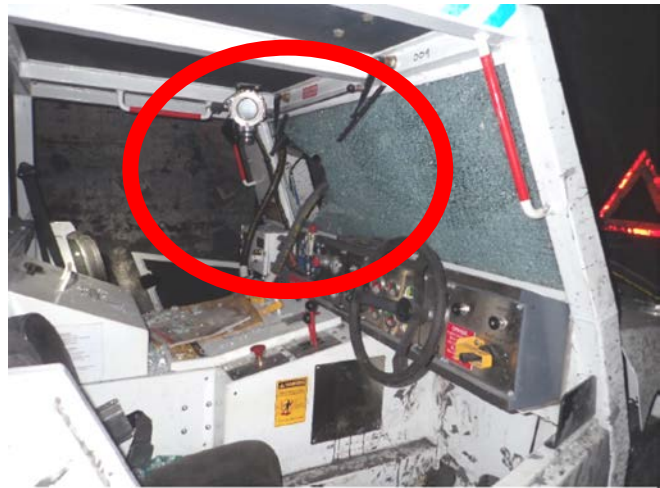
The driver saw the hose clear the roof racks and continued to reverse. The driver heard a loud bang and noticed that the air hose connector fitting had shattered the front windscreen and entered the cabin. The driver had driven underneath the hose the previous day with two different types of mobile plant without incident.

Figures 4 and 5 The damaged windscreen, air hose and fitting that entered the personnel transporter cabin (IncNot0034486)

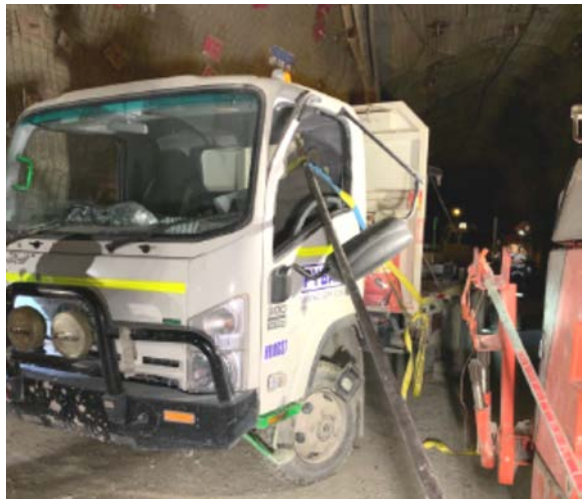
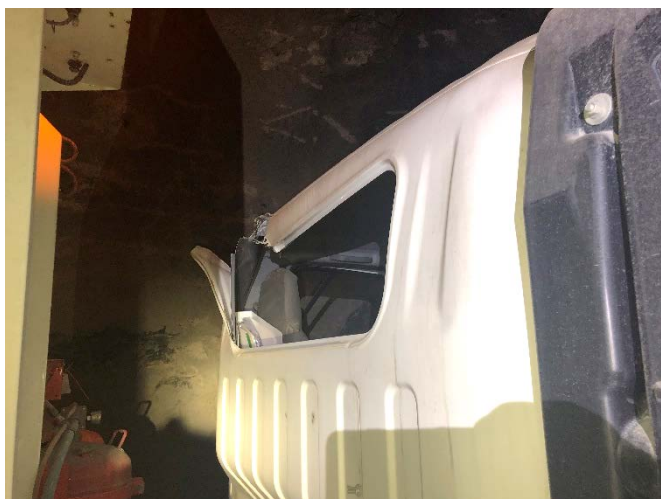
The drill steel continued through the passenger side window, over the head of the passenger and pierced the metal cabin shell above the back window. The back window was pushed out.

The tip of the drill steel lodged against the headframe of the truck tray. The drill steel was compressed against the truck bulkhead and the stored energy was released when the bottom plate of the Jumbo steel holder frame bent. This caused the drill steel to be ejected from the truck, landing about 14 metres away.

Figure 6 and 7 (left) Post-incident simulation of the drill steel entering the truck cabin from the Jumbo. (right) Damage to the back of the cabin body above the passenger seat caused by the drill steel entering the cabin (IncNot 0034365)
