SAFETY BULLETIN

DATE: NOVEMBER 2019

Drive shaft failures causing fires

This safety bulletin provides safety advice for the NSW mining industry.

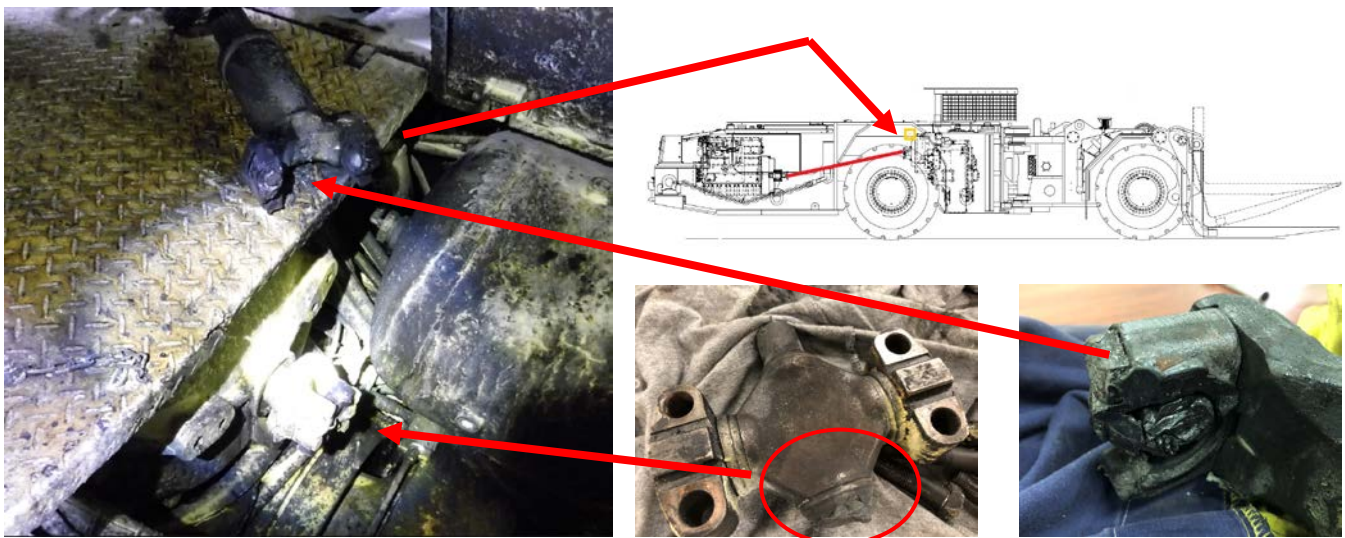
Incident 1:

Figure 1 Failed universal joint on underground coal, heavy haulage load haul dump (LHD) machine

A shield hauler was driving in an underground coal mine, when a bearing failed on the universal joint connecting the drive shaft from the engine to the torque converter, at the torque converter end. The drive shaft was not restrained by safety loops. Before the engine could be shut down, the drive shaft spinning at engine speed contacted components, hydraulic and pneumatic lines, which resulted in a spray of hydraulic fluid and compressed air that ignited. The operator manually activated the fire suppression system that extinguished the main fire. The operator also had to use a hand-held fire extinguisher to snuff a fire in the sound suppression material, which was on the underside of a transmission area access cover knocked open by the drive shaft.

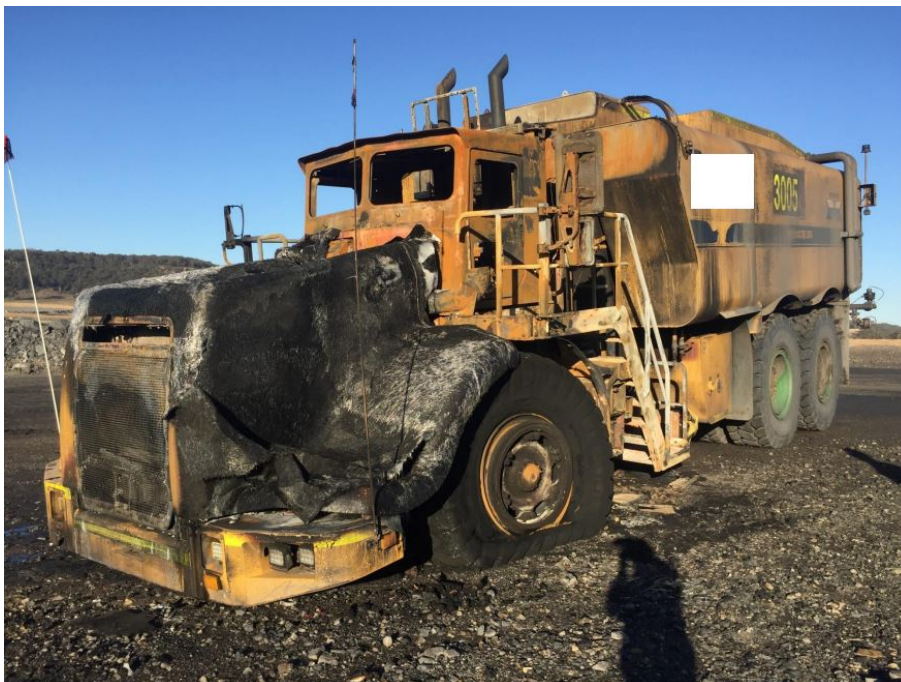
Incident 2:

Figure 2 Watercart extensively damaged following drive shaft failure

An articulated water cart was travelling down a haul road at an open cut coal mine when the front main drive shaft universal joint failed. As it failed, the loose rotating shaft destroyed a guard and damaged the main hydraulic pump and hoses. This sprayed hydraulic oil onto the engine, which ignited on hot components. The operator stopped the truck and activated the fire suppression system. The operator safely exited the vehicle before the fire reignited, extensively damaging the truck.

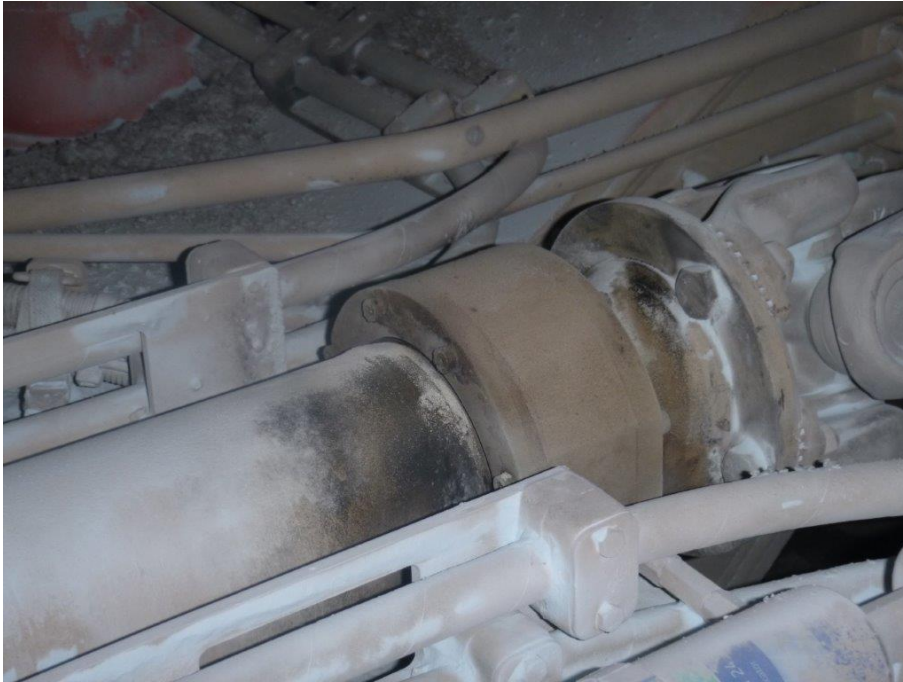
Incident 3:

Figure 3 Heat damage to an underground haul truck

At an underground metalliferous mine, a loader operator saw a glow from under a haul truck. The loader operator radioed a truck operator who stopped and extinguished a small bearing fire on the tail shaft. Following the incident, the original equipment manufacturer (OEM) issued a safety bulletin.
