WEEKLY INCIDENT SUMMARY

Week ending Friday 4 September 2020

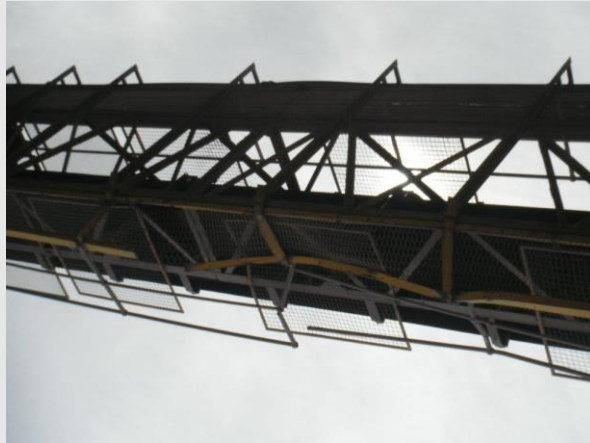
Dangerous incident
IncNot0038155
Open cut construction materials mine

After tipping a load, a haul truck operator drove about 30 metres with the tray of the truck raised. The tray hit the walkway of a conveyor structure.

Mine operators should ensure that tipping trucks are fitted with visual or audible warning devices and/or a device that will automatically stop or inhibit the movement of the truck while the tray is in the raised position.

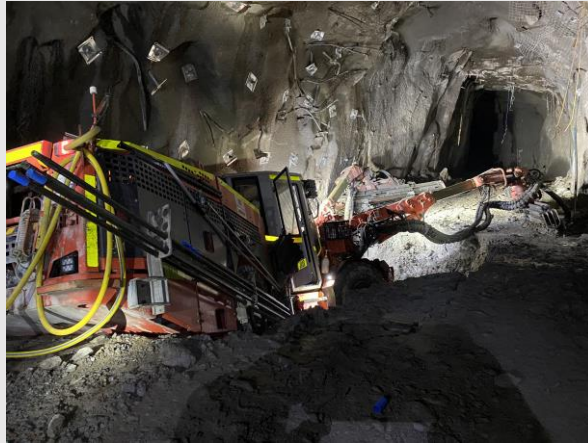
Dangerous incident
IncNot0038162
Underground metals mine

A Jumbo operator and a nipper were working on a stope that had previously been rock filled when they noticed the floor starting to slump.

The floor slumped about three metres.

A preliminary investigation suggested water from the Jumbo seeped through the floor and moved fine material into a larger void, resulting in the slump.

Procedures for backfilling stopes should include adequate controls and verification to ensure that the ground is consolidated no voids remain that could lead to slumping.
