Week ending 1 March 2019

This incident summary provides information on reportable incidents and safety advice for the NSW mining industry. To report an incident to the NSW Resources Regulator: phone 1300 814 609 24 hours a day, 7 days a week.

CM9 reference	DOC19/194085
Mine safety reference	ISR 19-09
Date published	8 March 2019

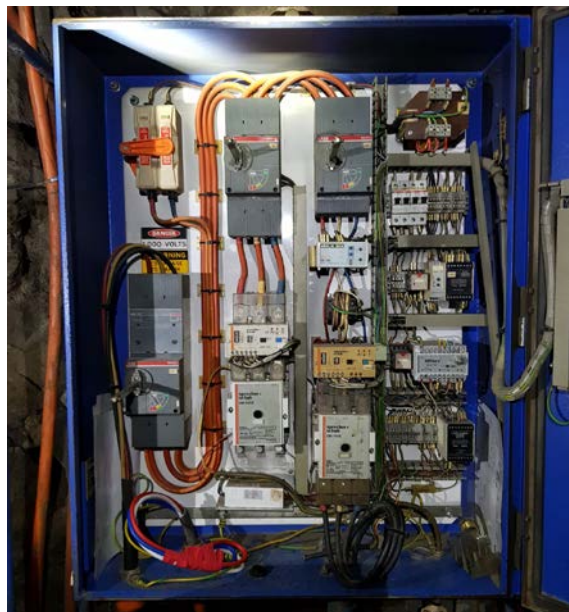
Incident type	Summary	Recommendations to industry
Dangerous incident IncNot0034018	While in the process of reterminating a 1000V outgoing (de-energised) supply cable at a pump starter box, an apprentice electrician has removed the shroud from the live side of the electrical isolator and inserted a T-handle tool to loosen bolts. The apprentice suffered an electric shock. The electrician then pulled the apprentice away and also suffered an electric shock.	<p>Effective supervision of apprentices in the workplace is essential.</p> <p>Isolation points must be determined to sufficiently remove people from energy sources.</p> <p>A S195 prohibition notice and a S191 improvement notice was issued to the mine in relation to this incident.</p>

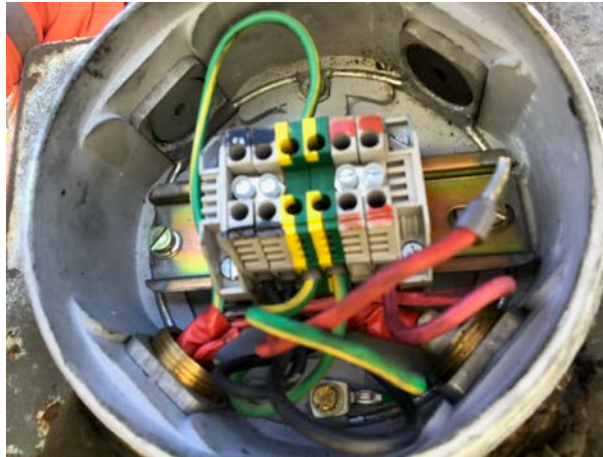
Dangerous incident
IncNot0033965

An electrician suffered an electric shock when working in a junction box. The circuit being worked on was isolated, but another circuit was still energised and the worker contacted the energised conductor.

Before starting work, all potential energy sources must be identified and verified that they have been isolated and tested for dead.
