## Week ending 12 December 2018

This incident summary provides information on reportable incidents and safety advice for the NSW mining industry. To report an incident to the NSW Resources Regulator: phone 1300 814 609 24 hours a day, 7 days a week.

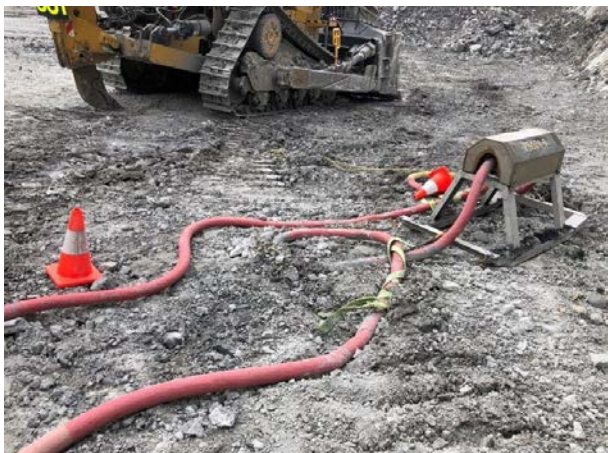
Incident type	Summary	Recommendations to industry
Dangerous incident IncNot0033153	<p>A dozer came into contact with electrical equipment at an open cut coal mine. The dozer backed over a 6.6kV shovel cable and grazed the junction box. Power tripped at the substation. An earth leakage fault was reported against the 6.6kV outlet.</p>

<p>Electrical infrastructure, whether temporary or permanent, should be delineated. The type of delineation used should be appropriate to the level of risk considering the vehicles and equipment operating in the area.</p>

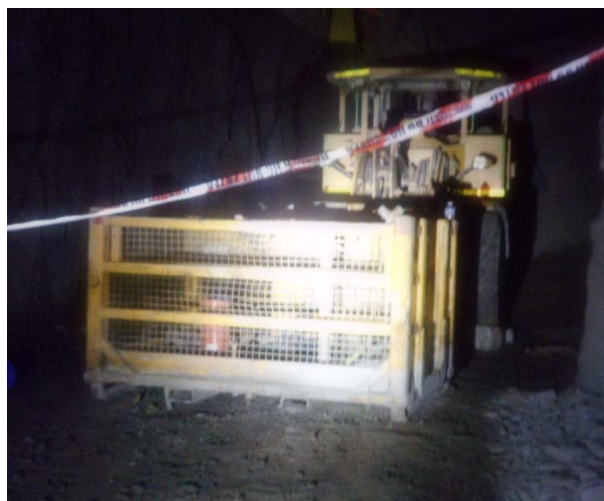
A worker suffered a fractured leg when a basket detached from a loader in an underground metalliferous mine. The basket lock-pin disengaged when the operator pressed the wrong button in the cab while attempting to lift the park brake. The basket fell 2 metres from where it was attached to the loader.

An investigation has commenced. Further information will be released shortly.

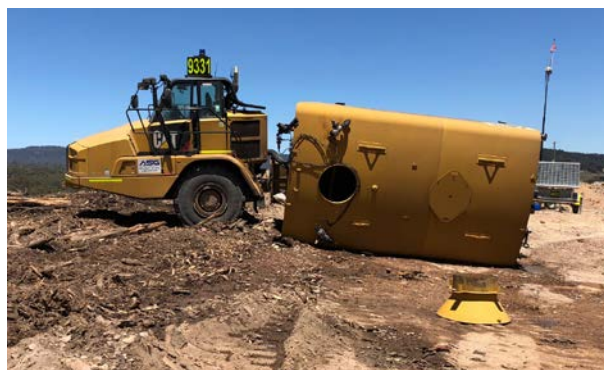
An articulated water cart rolled at an open cut coal mine.

The water cart was reversing at low speed and turned slightly when the rear wheel rode up onto a dozer rill/windrow, causing the tank to roll onto its side.

Mines that are operating articulated vehicles, particularly water carts, should review operating parameters (include slope and cross grades). Work areas should be assessed to determine if articulated vehicles are the correct plant for the task.
