# WEEKLY INCIDENT SUMMARY

Week ending Friday 12 June 2020

This incident summary provides information on reportable incidents and safety advice for the NSW mining industry. To report an incident to the NSW Resources Regulator: phone 1300 814 609 24 hours a day, 7 days a week.

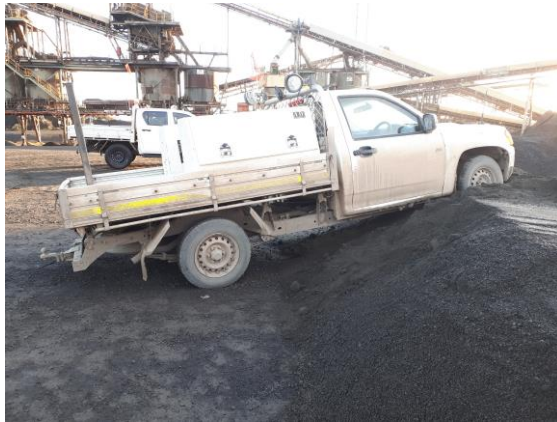
INCIDENT TYPE	SUMMARY	COMMENTS TO INDUSTRY
Dangerous incident IncNot0037536	A light vehicle collided with a bund, resulting in the driver's lip being injured and requiring five stitches.	It is vital that mines have a robust change management process in place that ensures not only the identification of introduced risk, but the implementation of suitable controls to manage the risk. This includes communicating the changes to all workers who may be impacted by that change.
Open cut construction materials mine

Over a weekend, a roadway under a conveyor was blocked with an earth bund.  The bund was put in place on one side of the conveyor and bollards with high visibility tape were erected on the other side. The change management process was not followed and the changes were not communicated to staff.  It was dark when the incident occurred.	
Roads or other vehicle operating areas

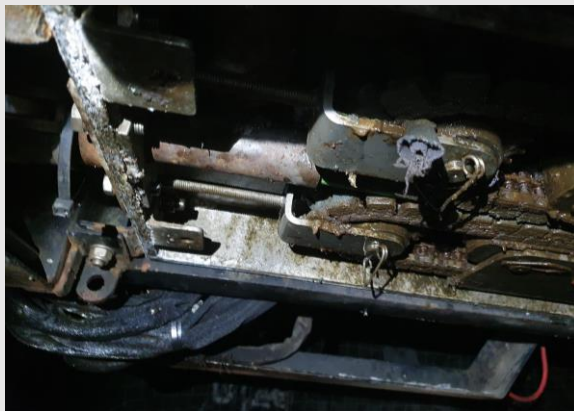
Dangerous  
incident  
IncNot0037555  
Underground  
metals

A contract stope charger has removed a guard and was adjusting the hose pusher mechanism on a production charge-up unit when an operator moved the mechanism in the charge basket. The stope charger's fingers were caught in the chain sprocket, resulting in the partial amputation of his index finger and the loss of the tips of his second and third fingers.

Isolation and control of all energy sources from plant is essential when adjustments are being undertaken.

Engineering controls should be implemented to allow regular tasks to be conducted without the need to remove control measures (guards).

Mechanical engineering control plans must set out the control measures for risks associated with moving components on plant.

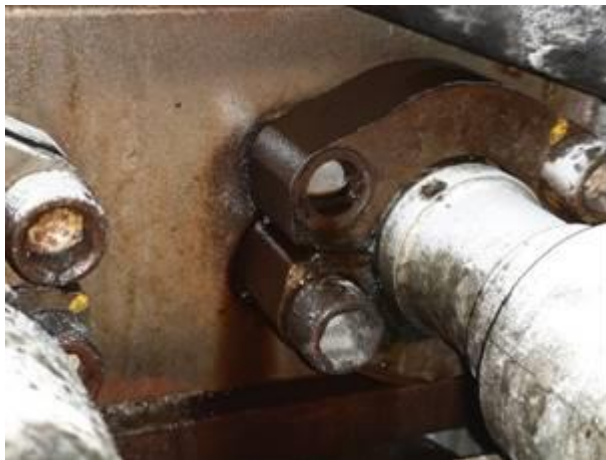
Dangerous incident  
IncNot0037556  
Open cut coal mine

A major hydraulic oil leak occurred on an excavator, resulting in hydraulic oil spraying onto the turbo and catching fire. The apparent cause of the leak was from a broken flange bolt. The automatic fire suppression system activated and the excavator operator used a fire extinguisher to extinguish the remaining flames.

All components within a system including retaining bolts must be identified and appropriate inspection and change out conducted.

When selecting and installing a fire suppression system, the system should cover all likely ignition sources (high temperature areas) so as to extinguish fire in all probable locations.
