# WEEKLY INCIDENT SUMMARY

Week ending Friday 13 March 2020

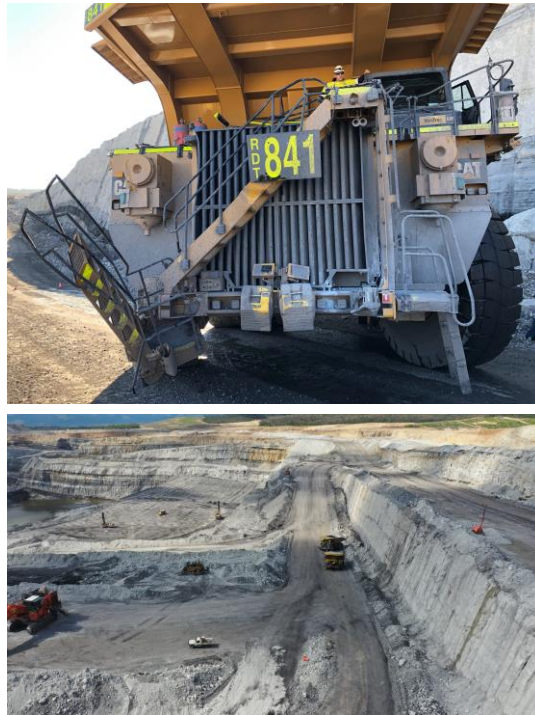
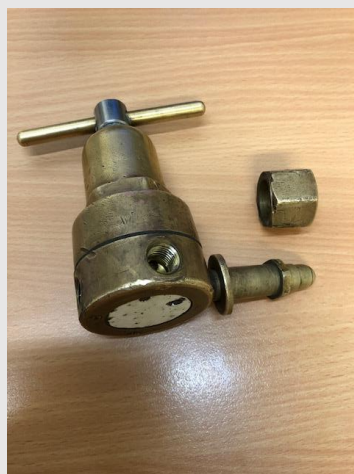
IncNot0036906  
Underground metals mine

A fitter was in the process of re-gassing an accumulator on a drilling jumbo with nitrogen, when the nut connecting the regulator and gauge on the nitrogen bottle failed. This caused the regulator and gauge to be ejected into the air. There were no injuries.

When developing control measures for the unintended release of mechanical energy, mines must consider:

- the identification, assessment, management and rectification of defects that affect the safety of plant
- the risks associated with pressurised fluids
- the inspection and testing of plant, including the testing of safety critical components.
