WEEKLY INCIDENT SUMMARY

Week ending Friday 14 August 2020

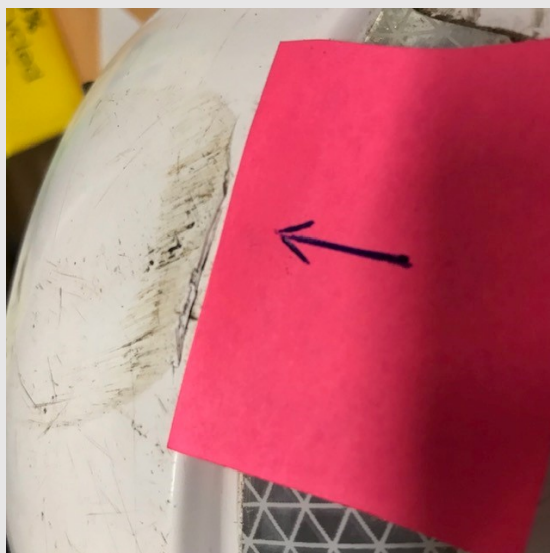
Dangerous incident
IncNot0037966
Open cut coal mine

A worker was hit on the back of the head by the access ladder of a grader that was being repaired. The force cracked his hard hat and knocked him to the ground. He suffered a concussion and whiplash. The ladder was stuck in the raised position due to insufficient oil in the control box. While the worker was waiting to top up the oil, the access ladder cycled down in an anticlockwise direction hitting him on the back of the head. The grader was not running at the time of the incident.

The hazards associated with moving parts of plant and machinery must be identified. Controls such as safe standing zones should be established in consideration of potential system failures.

No go zones must be identified and communicated to workers to ensure they remain out of the line of fire.

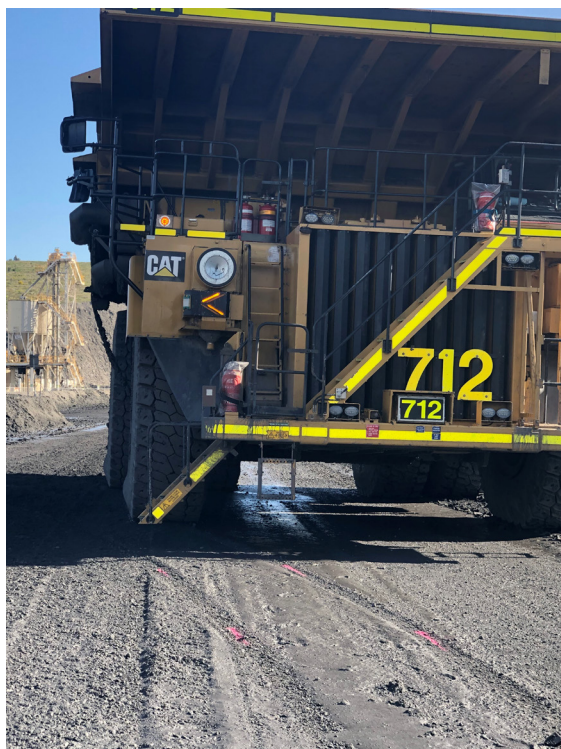
Dangerous incident
IncNot0037957
Open cut coal mine

A light vehicle turned in front of a haul truck at an intersection, narrowly avoiding a collision.

Video footage shows that the vehicle was extremely close to the front of the haul truck and the haul truck position 2 tyre ran over the light vehicle wheel tracks when attempting to stop.

The light vehicle driver said mud on the windows obstructed his view.

Vehicle operators should ensure they have clear visibility at all times by checking that windscreens. Windows and mirrors should be kept clean and free from obstructions.

If a driver is aware of reduced visibility due to mud on windows, the driver should find a safe place to stop and address the issue rather than risk causing an incident by continuing to drive with obstructed vision.
