WEEKLY INCIDENT SUMMARY

Week ending Friday 20 March 2020

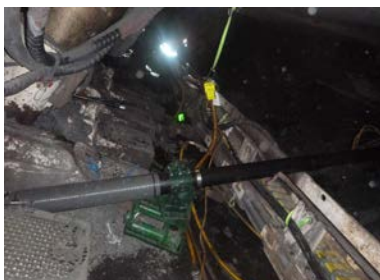
INCIDENT TYPE	SUMMARY	RECOMMENDATIONS TO INDUSTRY
Dangerous incident IncNot0036980 Underground coal mine	<p>An air operated bolting rig dislodged from the spill plate of the AFC mounting and was thrust back into the longwall walkway.</p> <p>The operator of the bolting rig jumped out of the way but was struck on the wrist. It appears the cradle was not properly attached to the pan line spill plate.</p>

<p>Operators must ensure that control measures are in place to manage the risks associated with the dissipation of mechanical energy.</p> <p>Safe work systems must be developed for people dealing with plant - including pre-inspections that identify and check mechanical safeguards used to prevent the dissipation of mechanical energy.</p> <p>Mitigating controls such as No-Go zones should be established in consideration of the energy present.</p>

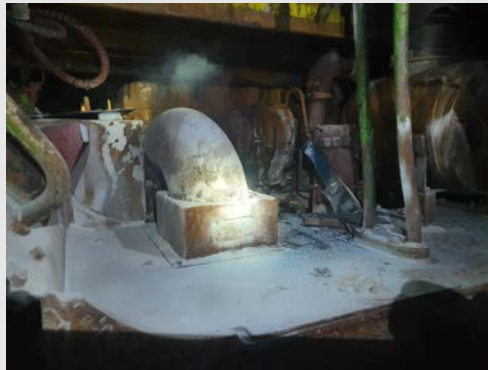
Dangerous
Incident
IncNot0036988
Underground
metals mine

Fire or explosion

An underground loader was in idle mode when the operator saw smoke and flames at the back of the machine. The operator activated the fire suppression system and extinguished the fire. It appears that the fire may have started in the exhaust box.

The cause of this fire has not yet been established.

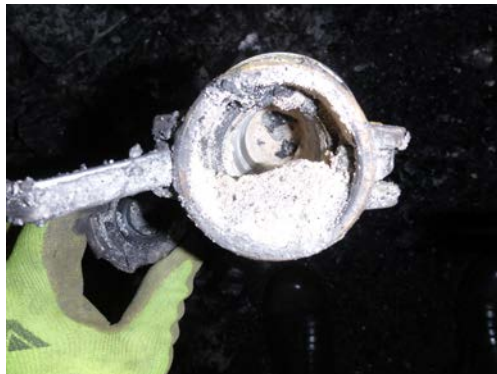
Dangerous
Incident
IncNot0036991
Underground
coal mine

While spraying a ventilation stopping with aquacrete, an operator was sprayed on the forearm. This occurred when he tried to release a hose blockage.

The grout pump had been stopped for a while and upon restarting, the hose appeared to be blocked. The operator turned off the air at the main valve and was undoing a camlock fitting, when the grout released and struck him on the forearm.

Mine operators should review how workers and supervisors are trained in recognising the potential hazards associated with all energy sources. This is especially important when there is the potential for unexpected stored energy, associated with blockages, to be released without warning.
