## Week ending 22 February 2019

This incident summary provides information on reportable incidents and safety advice for the NSW mining industry. To report an incident to the NSW Resources Regulator: phone 1300 814 609 24 hours a day, 7 days a week.

CM9 reference	DOC19/172635
Mine safety reference	ISR 19-08
Date published	4 March 2019

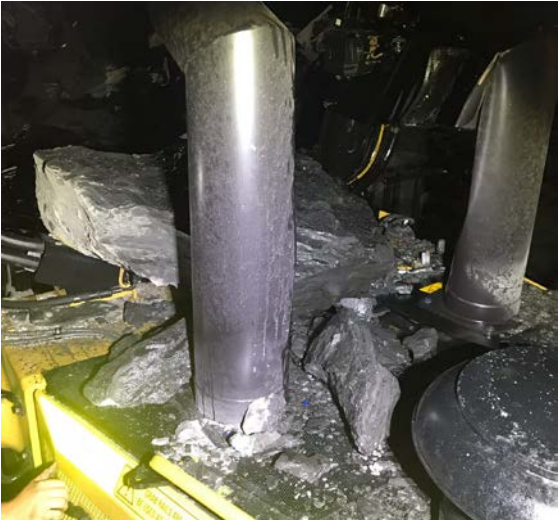
Incident type	Summary	Recommendations to industry
Dangerous incident IncNot0033948	<p>At an open cut coal mine, a dozer was hit with a large rock. In line with the mine procedure, the dozer entered the swing radius of an excavator once the haul truck was driven away. The truck had left without being directed by the excavator operator, who intended to load another bucket into the truck. As the excavator slewed around, it saw the truck had left and stopped. As it stopped, a rock slid off the front of the bucket and landed on the bonnet of the dozer.</p>

<p>Operators must review and should implement the recommendations from safety bulletin <a href="#">SB18-06 Lack of Positive communication</a>.</p>

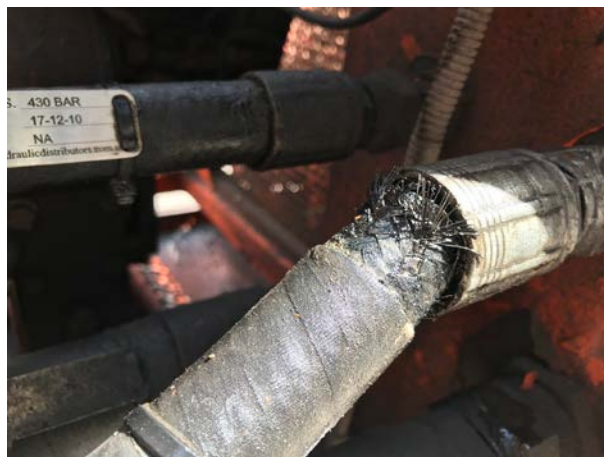
Dangerous incident  
IncNot0033937

A worker was sprayed with oil while fault finding a haul truck recovery power pack. The powerpack was not connected to a truck and when it was started, a hose failed, spraying the operator. No injury was reported. It was identified that the power pack did not have any internal pressure relief and relied on the relief valve fitted to the truck.

All hydraulic systems must be protected for over pressure events. When designing pressure relief systems, consideration must be given to all applications and situations when the equipment is used.

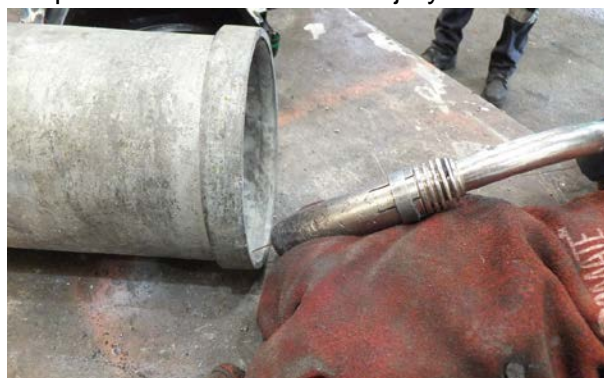
Dangerous incident  
IncNot0033939

A worker suffered an electric shock while welding. The shock occurred when the worker steadied the welder hand piece by placing his hand on the bench. The worker was taken to hospital and was cleared of injury.

There has been a recent increase in welding-related electric shocks. Mine operators should verify that workers completing welding activities have identified appropriate earthing points, personal protection equipment (PPE) is dry and they are appropriately trained.

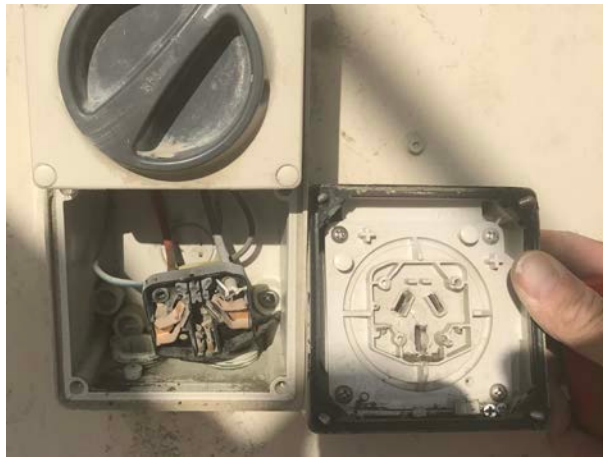
Dangerous incident  
IncNot0033916

A contractor preparing to carry out repairs in a hopper suffered an electric shock. The worker was setting up a portable welder and felt the electric shock as he tested the welder. A mine investigation identified that there was no connection to earth on the earth pin of the 15-amp outlet because the back of the outlet had come loose inside the outlet enclosure.

A NSW Resources Regulator inspector attended the mine and issued several s191 improvement notices. Mine operators should verify that workers completing welding activities have identified appropriate earthing points, personal protection equipment (PPE) is dry and they are appropriately trained.

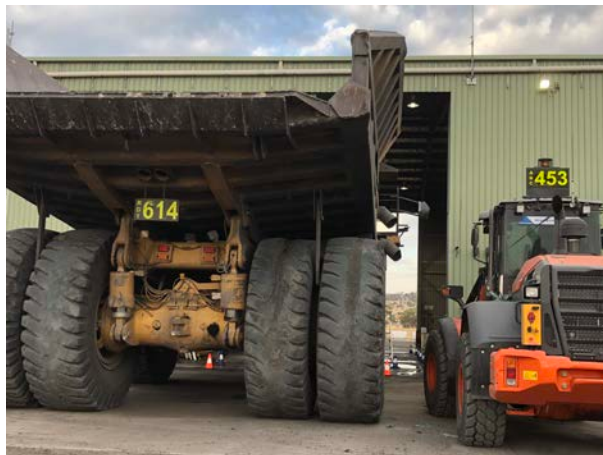
Dangerous incident  
IncNot0033933

A piece of glass hit a worker when a haul truck right-hand inner tyre burst in an open cut coal mine. The worker was operating a tool carrier adjacent to a haul truck on the workshop apron.

The life cycle management of tyres should include the changing out of the tyre before failure. Degradation signals that failure is imminent.

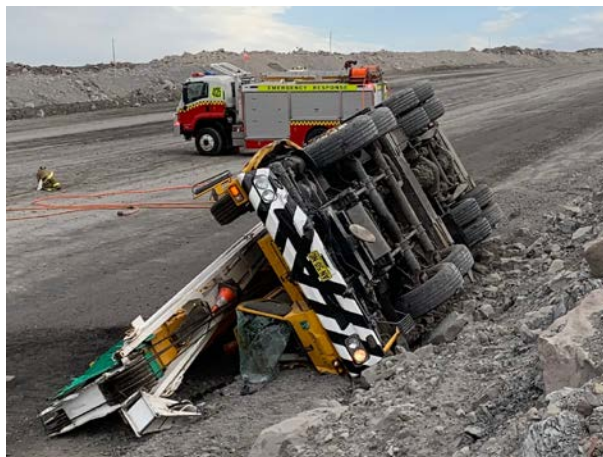
Dangerous incident  
IncNot0033929

A 50-tonne slew crane rolled while travelling down a ramp at an open cut coal mine. The incident occurred on the second successive long ramp of the journey. It was reported that the crane lost brake function. The operator attempted twice to slow the crane by steering it into a windrow. No injuries were reported. Workers exited via the windscreen.

NSW Resources Regulator inspectors attended the mine and issued a s195 prohibition notice preventing the crane from being recovered until appropriate risk controls have been established.

Before heavy vehicles are escorted into the mine,

hazards of the travel route need to be assessed including the route to be taken, operating grades and vehicle interaction.

Appropriate means of slowing vehicles should be used to minimise braking including gear selection, exhaust braking and retardation.

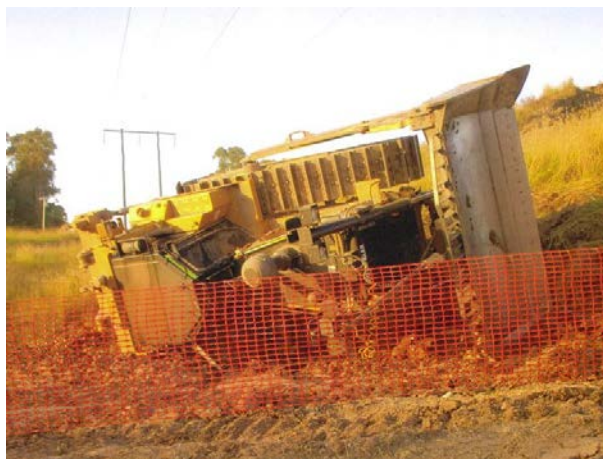
Dangerous incident  
IncNot0033917

A dozer pushing dirt on the slope of an old bund slipped sideways and rolled onto its right hand side. The driver exited the cabin and was uninjured.

Operators need to plan work around grades to minimise the amount of work completed on cross grades.

Work area inspections must be completed before beginning work to determine ground stability.

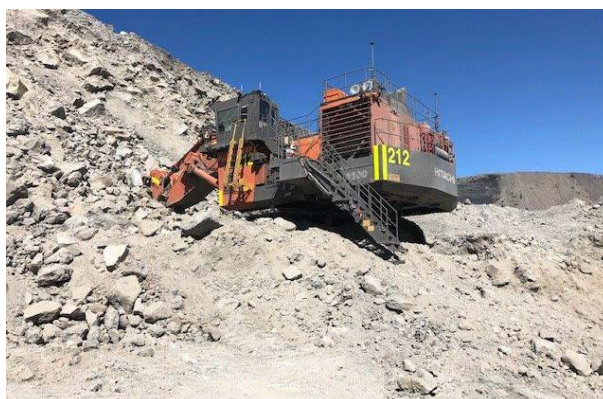
Dangerous incident  
IncNot0033910

An excavator was cleaning overblast that was against a 10-metre highwall. While the bucket was low into the material, further material fell onto the bucket. The machine was caught by the material on the bucket. There were no injuries.

A s195 prohibition notice was issued to the mine preventing recovery of the machine until appropriate risk controls had been established.

Ground and slope stability need to be considered when completing any task. The introduction of new risks needs to be assessed and appropriate action taken to reduce exposure.
