# WEEKLY INCIDENT SUMMARY

Week ending Friday 22 May 2020

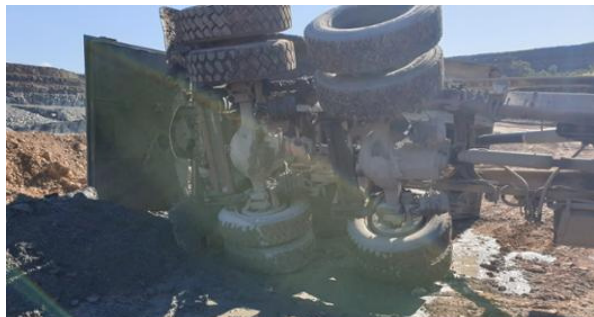
INCIDENT TYPE	SUMMARY	COMMENTS TO INDUSTRY
Dangerous incident IncNot0037381 Open cut construction materials	While unloading a trailer at a site dump, the trailer rolled onto its side when the third stage of the hoist ram was reached. The trailer tipped because of wet material hang-up. The trailer rolled towards the passenger side of the truck. The driver's cabin remained upright.	The stability of articulated vehicles is a known risk. Following a succession of similar incidents, the NSW Resources Regulator published two safety bulletins with recommendations to help prevent truck rollovers.

Refer to safety bulletins: <ul style="list-style-type: none"> <li>■ <a href="#">SB17-01 Industry reports more truck rollovers</a></li> <li>■ <a href="#">SB18-07 Safe systems of work for mobile plant</a></li> </ul>

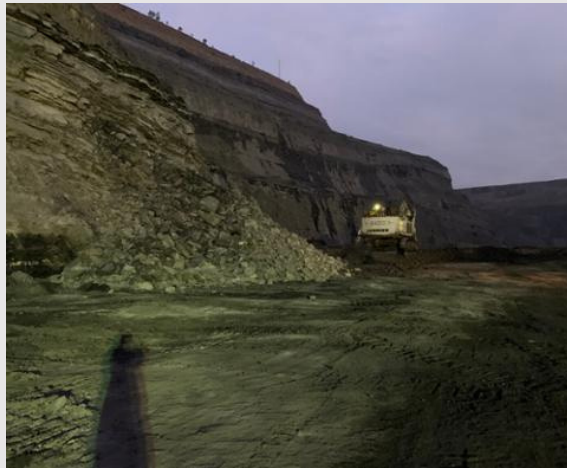
IncNot0037386

A section of a 20-metre highwall failed at an open cut mine.

An excavator crew was about 200 metres from the fall at the time.

Following several incidents in which people and equipment have been exposed to significant health and safety risks as a result of highwalls, low walls and dumps failing, we have published a safety bulletin:

- [SB20-01 Failure of highwalls, low walls and dumps](#)

Operators should take note of the recommendations in this bulletin.

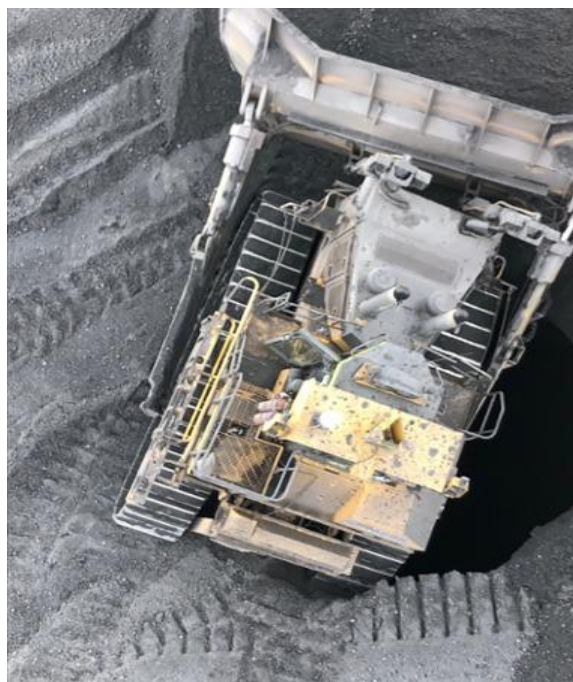
IncNot0037393

A dozer operator was pushing coal on a stockpile and was trying to dig out a bridge that had formed over a valve. The bridge unexpectedly collapsed, causing the coal to slump under the right-hand track of the dozer. The operator was unable to drive the dozer out, but decided to exit the dozer and walk from the stockpile.

Importantly, the decision to exit the dozer placed the operator at heightened risk, because further movement of the stockpiled material could have resulted in him being engulfed.

Operators are reminded of the potential hazards associated with a dozer on a stockpile.

Before starting work, supervisors and equipment operators should inspect and assess the work area to determine hazards, such as the potential for material bridging and subsequent collapse. Planning for the work must include identification of hazards, risk assessment and control.

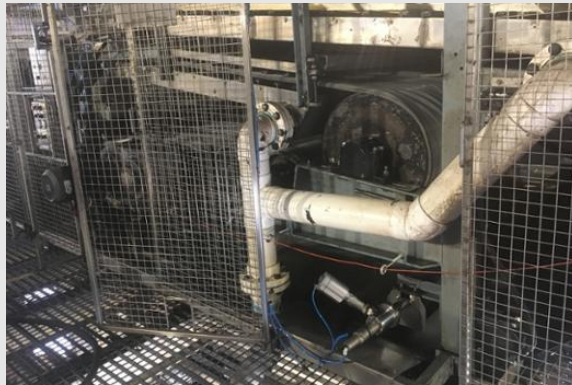
Serious injury  
IncNot0037398  
Coal preparation  
plant

An operator was cleaning a belt press filter when he became entangled between a roller and the filter cloth.

He could not free himself, and remained with his arm trapped by the rotating apparatus until released by a supervisor. The operator suffered arm fractures, a serious laceration to the top of his left forearm and an abrasive-type burn to his left lower forearm.

Under no circumstances should guards be removed, or work carried out on rotating equipment without the equipment being shut down and correctly isolated before work commences.

Where limit switches are identified as a control, mines should ensure that they are installed and operational.

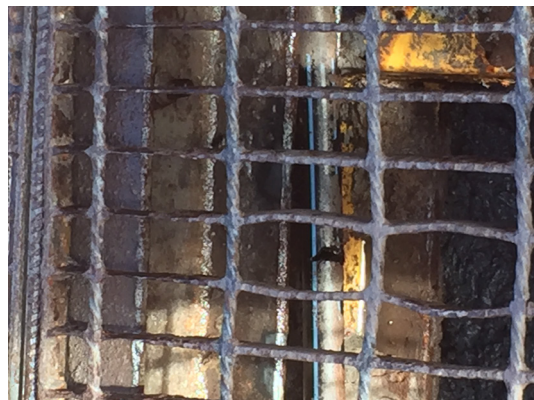
Dangerous  
incident  
IncNot0037412  
Underground  
metals

A contractor was cleaning the floor grate on top of a leach tank area using a high-pressure cleaner. During the cleaning process, a 1.5 centimetre cut was created by the high pressure water jet on a poly line that was sitting underneath the mesh floor.

The line was a cyanide feed line and cyanide fluid sprayed from the cut pipe. The leaking cyanide sprayed for three to five minutes before the line was isolated. The operator had placed the head of the high-pressure washer below the grid mesh to remove some build-up on a beam. No-one was injured.

A job safety analysis (JSA) was completed for this task but did not identify the risk of the lines underneath the mesh floor being compromised. The pressure cleaner operating pressure was reduced for the job from a maximum pressure of 2500bar to 690bar.

The incident highlights the importance of contractors being provided with all relevant information before work begins. Appropriate labelling of the poly pipeline may have alerted the cleaning contractor to the existing hazard.
