# WEEKLY INCIDENT SUMMARY

Week ending Friday 3 April 2020

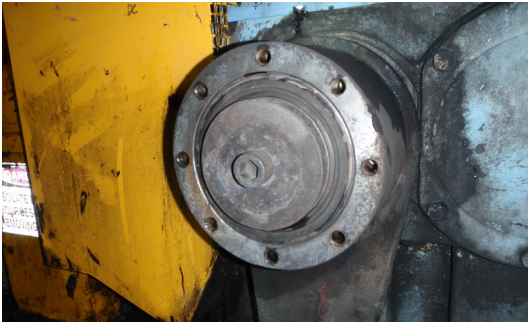
INCIDENT TYPE	SUMMARY	RECOMMENDATIONS TO INDUSTRY
Dangerous Incident IncNot0037079 Underground coal mine

Fire or explosion	While laying out idler rollers for maintenance, workers smelled smoke. They found a conveyor drive gearbox anti-run back had failed and was on fire. The flame was about 300 millimetres high. They turned off the belt and used two fire extinguishers to put out the fire.

Mine operators should review their maintenance strategies for anti-run back devices with particular reference to lubrication.  When developing control measures related to conveyors in underground coal mines, mine operators must take into account Australian Standard AS 4606-2012, Grade S fire resistant and antistatic requirements for conveyor belting and conveyor accessories.

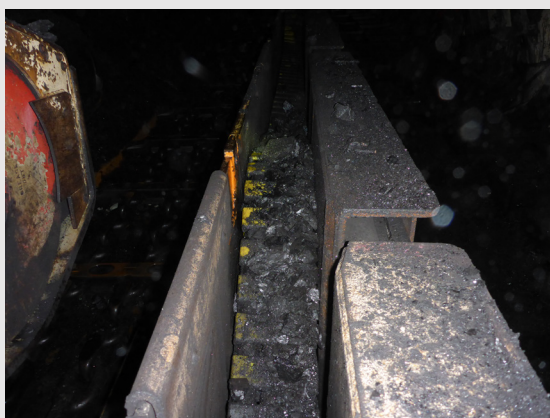
Dangerous  
incident  
IncNot0037069  
Underground coal  
mine

A small coal burst occurred on a longwall face during production. The shearer was cutting into the main gate in full remote mode. The area was identified as a high potential coal burst zone associated with a dyke running through the area. No workers were exposed to the ejected material.

This incident highlights the benefits of implementing robust controls to mitigate the risks of coal burst events. The Resources Regulator has published reports on specific coal burst incidents as well as a report on compliance with legislative requirements in relation to ground and strata failure. The 2019 report recommended that:

- Mine operators should review their trigger action response plans (TARPs) for mapping, inspection and monitoring results to improve the response time to major changes in the mine environment that may affect ground stability.

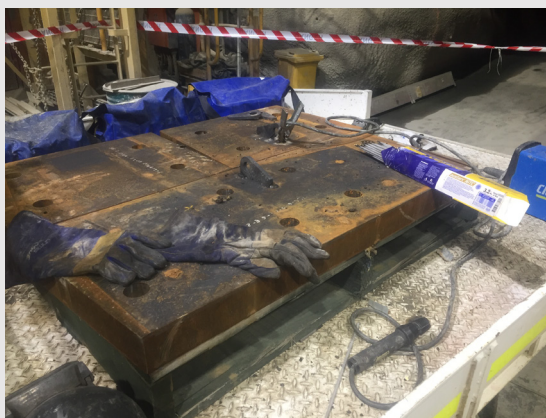
Dangerous  
Incident  
IncNot0037093  
Underground  
metals mine

A boilermaker suffered an electric shock while in contact with welding equipment in an underground workshop.

Mine operators should verify that workers carrying out welding activities have identified appropriate earthing points, their personal protection equipment (PPE) is dry and they are appropriately trained.

Welding machines must be isolated when not in use.
