WEEKLY INCIDENT SUMMARY

Week ending Friday 31 July 2020

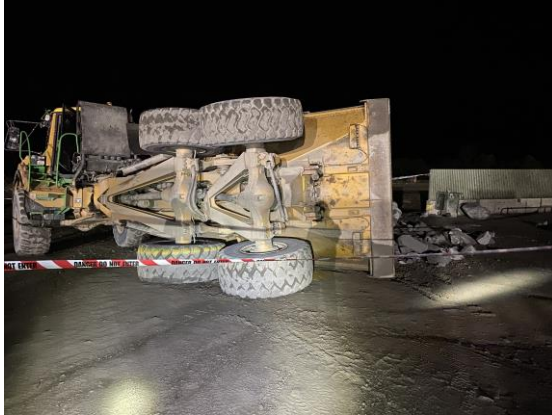
Roads or other vehicle operating areas	<p>A loaded articulated haul truck rolled over while going around a corner. The truck had been parked up in the workshop while the operator was on a crib break. Following the crib break, the driver and a passenger (bogger operator) were returning to work in the truck, when the trailer body rolled over while going around a corner. The cabin remained upright and nobody was injured. Speed is being considered as a contributing factor. The investigation is ongoing.</p>	<p>The stability of articulated vehicles is a known risk that needs to be managed by mines. Consideration should be given to factors such as (but not limited to):</p> <ul style="list-style-type: none"> • speed of operation • operating grades • uneven surfaces (holes, rocks, foreign material) • tipping of loads • hang-up of loads • movement of loads. <p>The risks associated with the rollover of mobile plant was the subject of our compliance priority program in 2018.</p>

Refer to the following outcome report for more information:
[Articulated truck rollovers and falls from mobile plant](#)

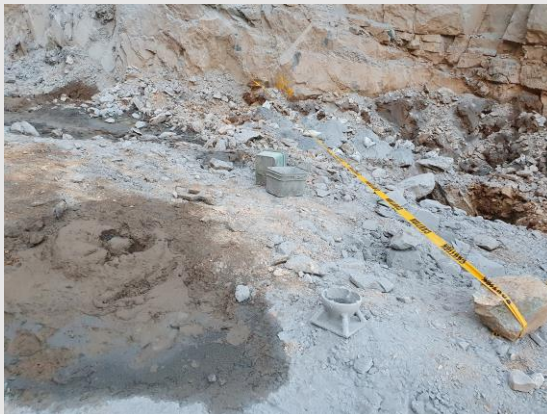
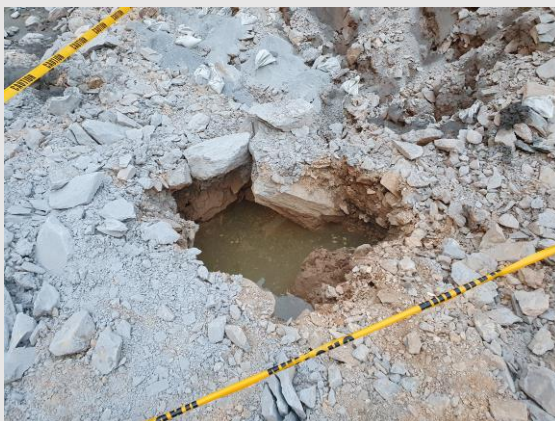
A small void (600 x 800 millimetres) opened up in the cap material that runs along an old previously mined stope. Grade control drilling was being conducted about four metres from the void and it is believed the vibrations from the drilling caused the void to slowly open up. Nobody was in the vicinity of the void at the time and it was monitored from the time it had started to open.

Mines are required to have a Principal Hazard Management Plan for ground or strata failure and to ensure that the plan is implemented as designed.

The stability of back fill material and old workings must be considered during open cut mining around old workings.

A system to update the incoming shift supervisor of TARP risk changes, active TARPs and geotechnical hazards should be in place so that relevant information can be relayed to all workers.

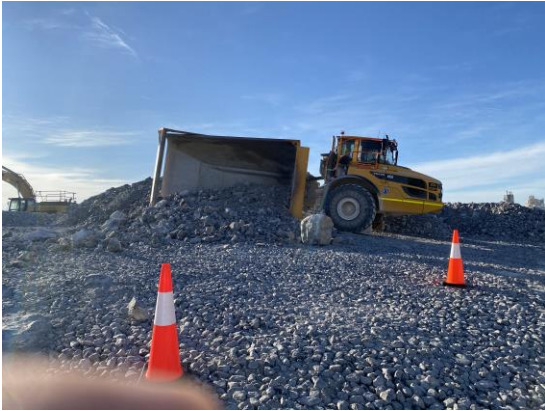
<p>Roads or other vehicle operating areas</p>	<p>A dump truck carting rocks to a run-of-mine (ROM) pad reversed onto a rock pile from a previous tip, causing the tub of the truck to overturn. The cabin remained upright.</p>

<p>See comments for earlier overturned trailer incident in this publication.</p>
<p>Dangerous incident IncNot0037847 Underground coal</p>
