WEEKLY INCIDENT SUMMARY

Week ending Friday 7 August 2020

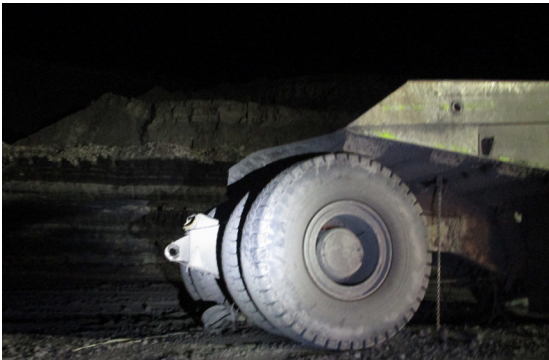
INCIDENT TYPE	SUMMARY	COMMENTS TO INDUSTRY
Dangerous incident IncNot0037912 Open cut coal mine	An empty haul truck was travelling around a corner when the rear axle box wheel assembly detached from the main truck frame. The retaining bolts for the trunnion pin failed, allowing the trunnion pin to dislodge.

This incident is under investigation and further information may be published later. Following maintenance and repairs to mobile plant, the plant should be inspected, tested and verified as fit for purpose. Mobile plant should have suitable maintenance schedules that take into consideration condition and hours of operation. Mine operators are reminded of the importance of following original equipment (OEM) maintenance schedules.

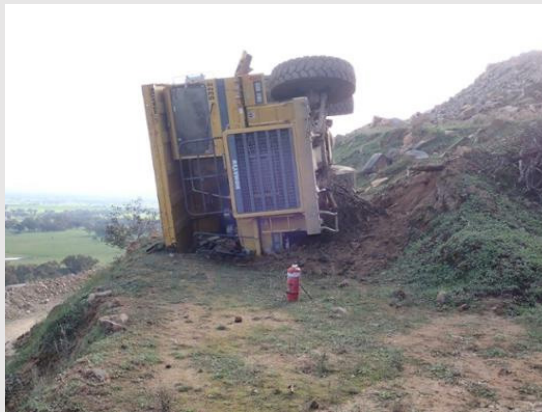
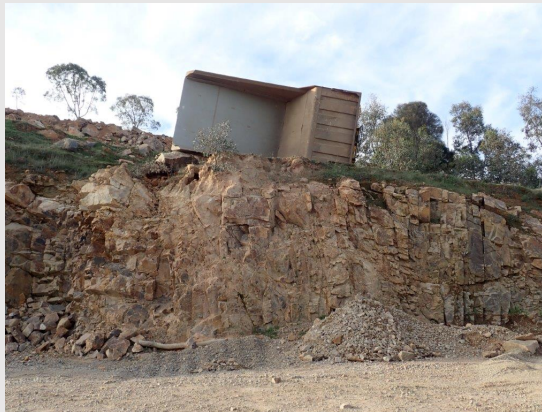
A rigid haul truck rolled over the side of a haul road, coming to rest on the edge of a steep drop.

The operator was wearing a seatbelt and suffered a minor injury.

Initial enquiries suggest that sunlight interfered with the driver's line of sight, causing him to drive into the bunding that was not adequate to hold up the truck. The truck drove over a large rock in the bund wall and tipped over.

Mine operators should ensure that bunds are designed, constructed and maintained to a standard that is suitable to protect workers from harm.

Principal hazard management plans for roads or other vehicle operating areas should consider factors that may affect operator visibility or ability to control a vehicle such as sunlight, fog, or dust obstructions that may affect lines of sight.

This incident also highlights the importance of wearing a seatbelt while operating mobile plant.
