WEEKLY INCIDENT SUMMARY

Week ending Friday 8 January 2021

CM9 reference	DOC20/10370
Mine safety reference	ISR21-01
Date published	15 January 2021
Approved by	Chief Inspector Office of the Chief Inspector

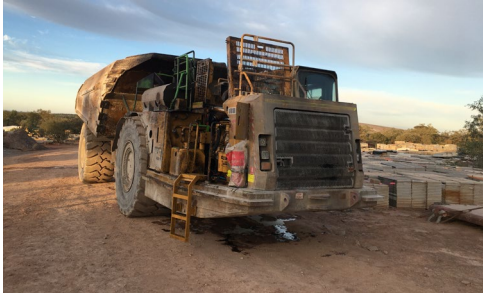
INCIDENT TYPE	SUMMARY	COMMENTS TO INDUSTRY
Dangerous incident IncNot0038855 Underground metal mine

While driving to the surface park up area, approximately 100 metres from the portal, a haul truck's engine caught on fire. The haul truck operator saw the flame coming from the exhaust guard. The fire suppression system initiated, which extinguished the flame.

The mine identified that the 'O' ring failed, resulting in the spray of hydraulic oil onto the hot engine components. The Resources Regulator has identified a concerning increase in reports of fire on mobile plants. Escape of fluids ignited by hot surfaces has been identified as one of the top two causes, along with electrical wiring faults. For further information and the Regulator's position refer to our website .

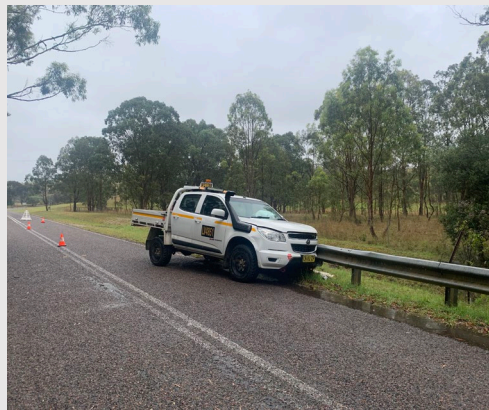
Dangerous
incident
IncNot0038873
Open cut coal
mine

A light vehicle being driven by a contractor collided with a barrier on the edge of a mine access road. The barrier intruded into the front passenger side of the vehicle. Statements indicate that the driver may have been distracted by a kangaroo.

Mine operators should ensure light vehicle operators are aware of the hazards in relation to local wildlife.

In addition, mine operators should also ensure that light vehicles are fitted with safety features that provide protection if a crash occurs. Features include crumple zones, airbags, seat belts and active safety assist technologies.

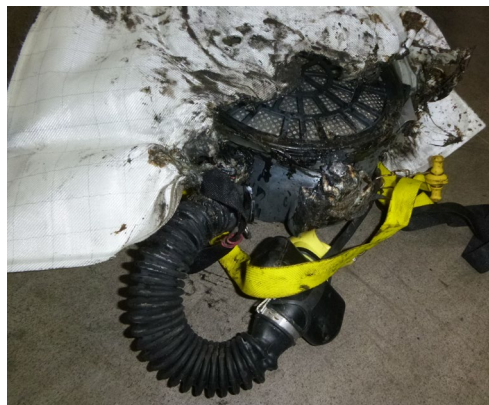
Dangerous
incident
IncNot0038894
Underground
metal mine

An operator activated a self-contained self-rescue unit that was near the end of its life as part of a training exercise. The operator pulled the pin on the SCSR unit to activate the oxygen and the unit ignited. The operator removed the unit from their neck and dropped it to the ground, where it caught on fire. The fire was extinguished, and the operator was not injured.

The cause of this fire has not yet been established. The unit has been sent to the OEM for further testing and analysis.

Mine operators should maintain regular frequent testing of self-rescue units. When excessive failures occur, the entire batch of self-rescuers should be removed from service.

The outcomes of this incident need to be considered when using self-rescuers for training exercises.

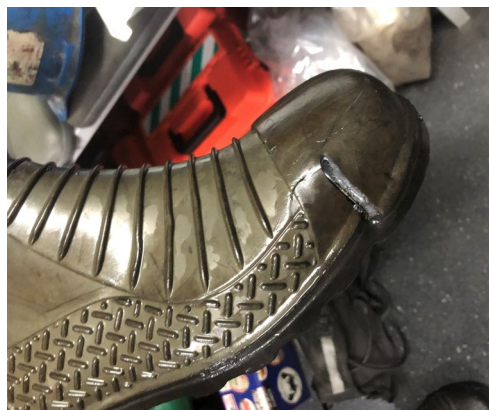
Dangerous incident
IncNot0038925
Underground coal mine

A shuttle car operator was travelling in bye when he hit a pothole. The shuttle car door swung open, then closed on the operator's foot causing a large laceration to his toe. It appears that the door was forced shut by a canch in the roadway next to the rib.

The mine has identified that the shuttle car's anti-slam pin, when raised and the door was shut, did not assist in retaining the door, as it was failing to drop into the designated hole. The mine has notified the OEM. Mine operators should undertake an audit of the door mechanisms of their fleet to ensure they are operating as per specifications. In addition, a road maintenance program should be implemented that includes stopping and fixing deteriorating roads.

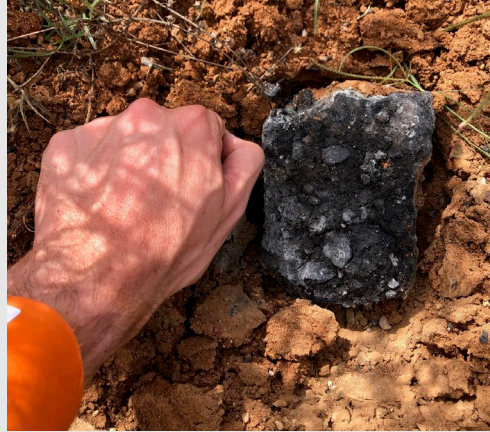
Dangerous incident
IncNot0038944
Open cut coal mine

A blast was fired. One piece of flyrock, with an estimated weight of 2 kilograms, has landed adjacent to sentry two position. The sentry cone was positioned 510.6 metres from the blast and the rock landed

at 511.0 metres and approximately 5 metres from the sentry vehicle.

Mine operators should have systems in place that prevent designated blast holes from being overloaded. Consideration should be given to:

- establish an inspecting and monitoring process to ensure

overloaded holes are being identified and procedures are being followed

- ensure quantity and quality of stemming is applied as per the site blast procedures. This should be reviewed and checked by the blast supervisor on site.

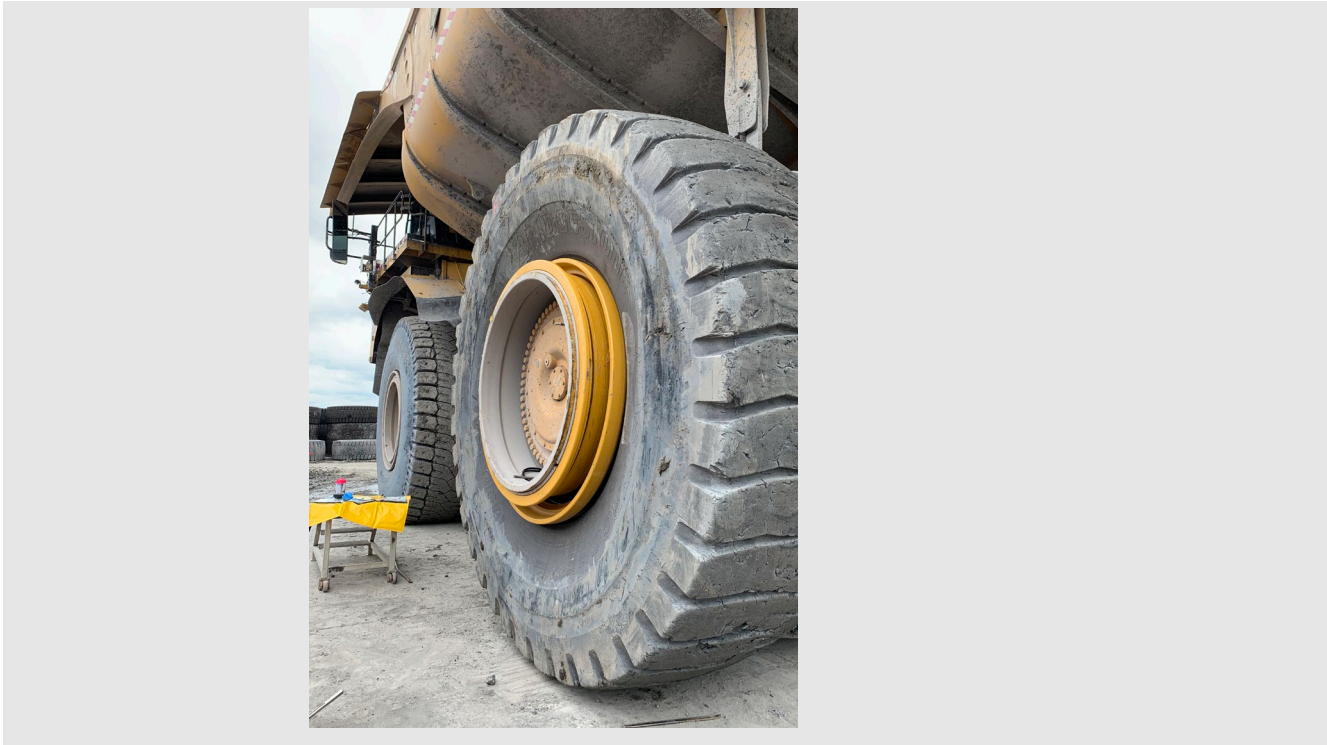
A contract tyre fitter was in the process of installing a tyre when the tyre and rim components shifted horizontally and trapped the tyre fitter's fingers between the lock ring and bead seat band.

Mine operators should review their safety management systems for removing and fitting tyres. Mine operators should ensure that:

- potential pinch points associated with the task are identified
- appropriate controls are implemented to eliminate the potential of injury associated with pinch points when removing and fitting tyres
- correct tooling is provided for the job.
