Week ending 8 March 2019

This incident summary provides information on reportable incidents and safety advice for the NSW mining industry. To report an incident to the NSW Resources Regulator: phone 1300 814 609 24 hours a day, 7 days a week.

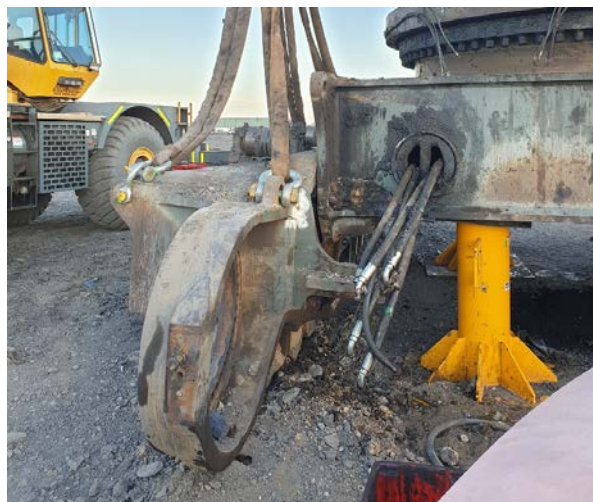
Incident type	Summary	Recommendations to industry
Dangerous incident IncNot0034077	<p>A maintenance worker was hit in the face with pressurised hydraulic fluid. The worker was standing on a ladder to disconnect a hydraulic hose on an excavator track adjuster.</p> <p>The tracks were disconnected from the machine. However, there was residual pressure present in the accumulator which the worker had not identified.</p>	<p>Mine workers must be trained and competent in isolation. Correct isolation includes the identification of all energy sources and the complete dissipation of the energy. Training must include all steps in the isolation process.</p>

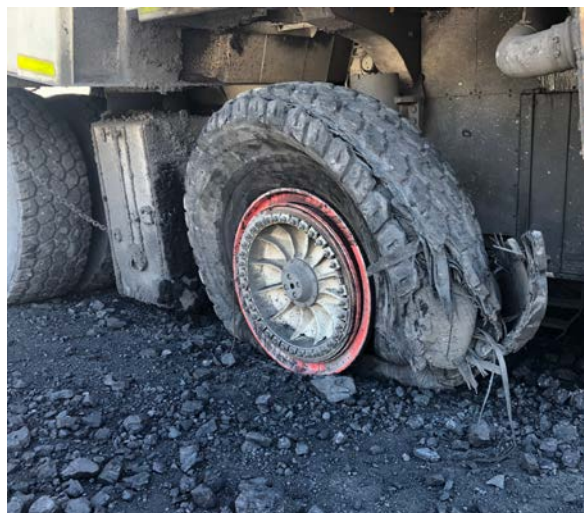
Dangerous incident
IncNot0034039

A large haul truck was travelling at speed into a mine when the operator took a wide turn. To avoid a collision with an oncoming haul truck, the driver over-steered the vehicle, causing the front right-hand tyre to fail and the front of the truck to dig into the ground. The truck was driven another 15 metres at a speed of about 50km/h. Additionally, a rock fell off one haul truck onto the other haul truck, breaking the right-hand side windscreen.

All mines must consider the hazard of speeding while driving.

Engineering controls need to be considered to minimise this risk. The use of speed monitoring and alarms need to be considered and the appropriate action taken when speeding is identified.
