WEEKLY INCIDENT SUMMARY

Week ending Friday 18 September 2020

CM9 reference DOC20/781409

Mine safety reference ISR20-38

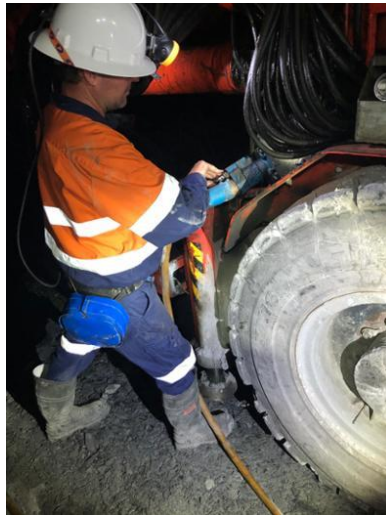
INCIDENT TYPE	SUMMARY	COMMENTS TO INDUSTRY
Dangerous incident IncNot0038233 Underground metals mine	A jumbo offsider sustained a serious crush injury to his foot when it was caught beneath a stabilising jack that was being lowered. The offsider was preparing to plug a pump cable into a cable receptacle on the jumbo while the stabilising jacks were being lowered.	Work procedures and controls must consider the risk of workers being in proximity to equipment. No-go zones and safe standing zones for workers should be implemented and communicated to all workers involved in the operation of plant. The use of proximity detection should be considered when completing risk assessments for working around operating equipment.

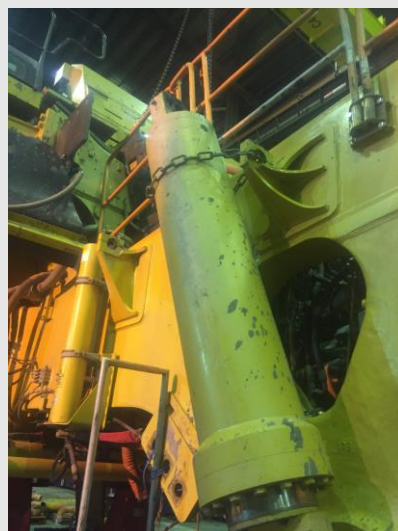
Dangerous incident
IncNot0038244
Open cut coal mine

An electrical tradesman had his head caught between a lift cylinder and the body of a haul truck. The tradesman was disconnecting an earth strap adjacent to POS34. The tray of the truck had been removed and the lift cylinder was chained to a lug. As the tradesman reached to disconnect the earth strap, the lift cylinder pivoted and pinned the tradesman against the truck. He sustained minor head injuries.

While the lift cylinder had been chained to a lug, there was enough slack in the chain to allow the cylinder to move when bumped.

Unintended movement of secured loads is an identifiable risk. Safe work procedures should clearly articulate the risk and outline the controls required to prevent unintended movement.

Mine operators should ensure that their work procedures for this common task include this particular risk and the necessary controls.

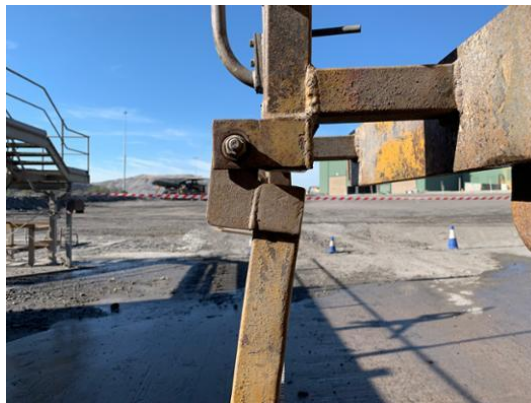
Dangerous
incident
IncNot0038271
Open cut coal
mine

A worker's index finger was severely crushed in the pivot point of a haul truck's emergency egress ladder. The truck was being washed down and the egress ladder was activated to allow access to air filter dust caps. The operator put his hands on the rails of the ladder to climb up, but when he put his weight on the bottom step the ladder closed at the pivot point where he had his hand crushing his finger.

Mine operators should review their procedures to determine if their training includes the hazards associated with potential pinch points and their identification.

Mine operators should consider reviewing the emergency egress handrail design in consultation with the OEM.

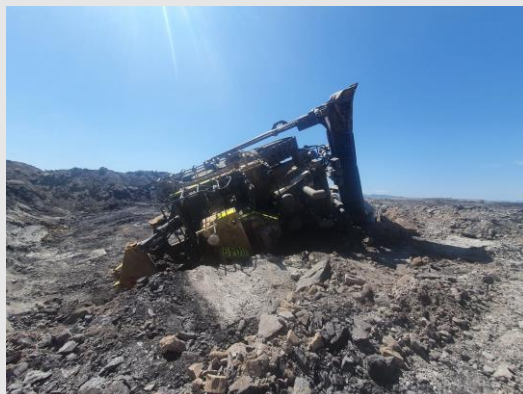
Dangerous
incident
IncNot0038274
Open cut coal
mine

A dozer tipped over when the operator drove the left-side track partially up a pile of side casted material. The dozer became unbalanced and slowly tipped onto its right-side track. The operator was able to exit the dozer and was uninjured.

Equipment operators must maintain situational awareness and remain vigilant to manage the risk of machine rollovers. When planning tasks and travel paths, supervisors must consider rollover hazards.

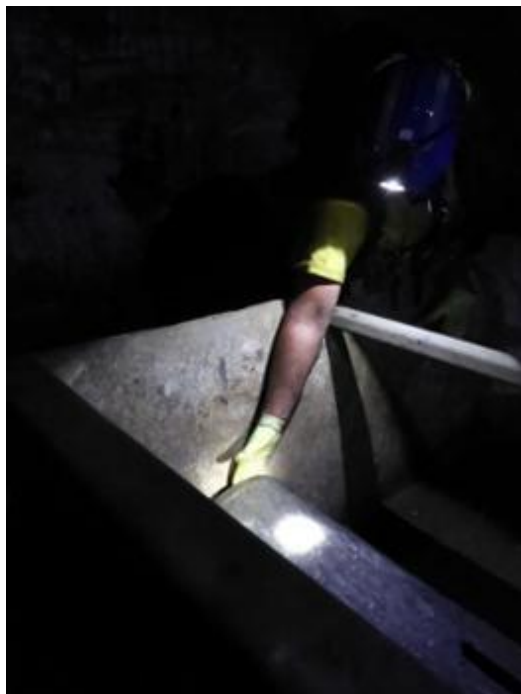
Dangerous incident
IncNot0038285
Underground coal mine

A mine worker severed the tip of one finger and received deep cuts to other fingers of his right hand while sliding an auger sleeve into an empty kibble. He and another worker were attempting to get the auger sleeve into the kibble, which had a cross brace on the top, making it awkward to manoeuvre. One worker lifted the auger sleeve to attempt to slide it under the cross brace and the other worker had his hand at the back of the auger sleeve to guide it into place. When one worker pushed the auger sleeve it slipped quickly off the top of the kibble crushing the other worker's hand between the auger sleeve and the kibble wall.

Workers must be trained to identify potential hazards when undertaking unplanned tasks and be capable of assessing and controlling risks. Communication between workers jointly undertaking tasks is of paramount importance and the approach to any unplanned task should be discussed and agreed upon.
