## Week ending 15 August 2018

This incident summary provides information on reportable incidents and safety advice for the NSW mining industry. To report an incident to the NSW Resources Regulator: phone 1300 814 609 24 hours a day, 7 days a week.

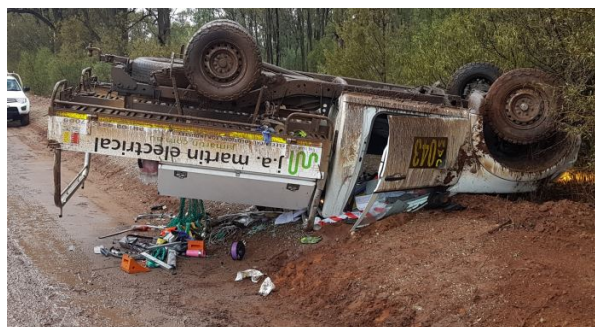
Dangerous incident  
SinNot-2018/01295

A light vehicle rolled onto its roof while travelling on the surface of an underground coal mine. The driver had previously stopped the vehicle to engage the four-wheel drive function.

Roads should be designed and maintained for all weather conditions. Relying on instructing workers to “drive to the conditions” is a lower order control. The [Work Health and Safety Regulation 2011 clause 36](#) hierarchy of control measures requires the use of substitution, isolation or engineering controls before accepting administrative controls.
