Week ending 19 September 2018

This incident summary provides information on reportable incidents and safety advice for the NSW mining industry. To report an incident to the NSW Resources Regulator: phone 1300 814 609 24 hours a day, 7 days a week.

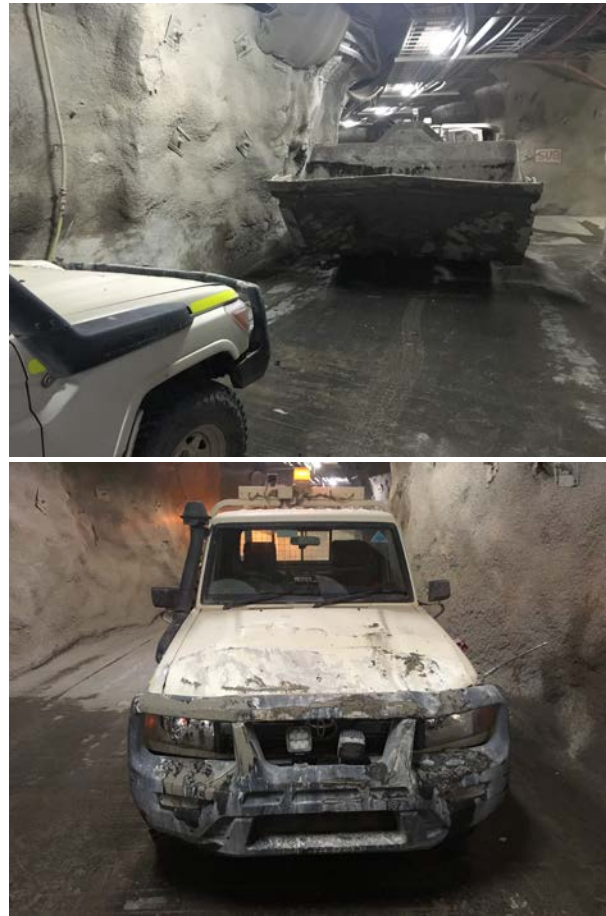
Incident type	Summary	Recommendations to industry
Serious injury SinNot-2018/01518	Two workers were conducting surface environmental monitoring in a remote location when one worker has slipped over and broke his ankle. The worker was evacuated from by helicopter for treatment.	Mine emergency plans and procedures must include response requirements for workers in remote areas. This must include communication methods, immediate response and evacuation of injured workers.
Dangerous incident SinNot-2018/01509	A loader hit a light vehicle in an underground metalliferous mine. The loader was tramping towards a workshop and up an incline when it hit the vehicle, which was parked and being washed down by a worker.	When dealing with the risk of a collision involving mobile plant, the hierarchy of controls should be followed. Systems such as collision detection and avoidance systems, visual aids and segregation should be implemented before relying on procedural controls.

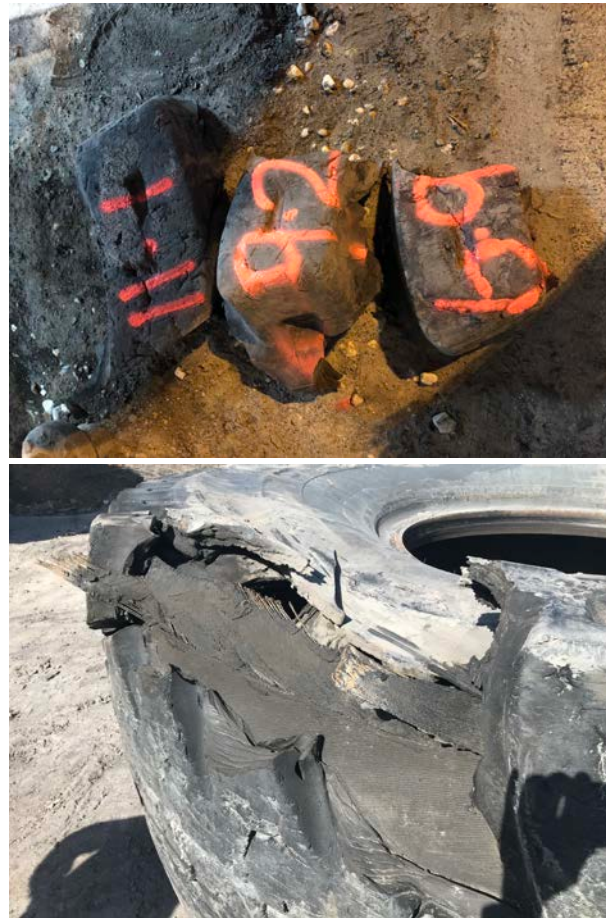
Dangerous incident
SinNot-2018/01507

An inner rear tyre failure occurred ejecting several large pieces of rubber (up to 11 kg) up to 200 metres from a truck.

[Work Health and Safety \(Mines and Petroleum Sites\) Regulation 2014 clause 179 Dangerous incidents \(a\) \(iv\)](#) *an uncontrolled escape of a pressurised substance* is applicable to tyre failures and must be reported immediately to the Central Assessment Unit (CAU).
