Week ending 23 May 2018

This incident summary provides information on reportable incidents and safety advice for the NSW mining industry. To report an incident to the NSW Resources Regulator: phone 1300 814 609 24 hours a day, 7 days a week.

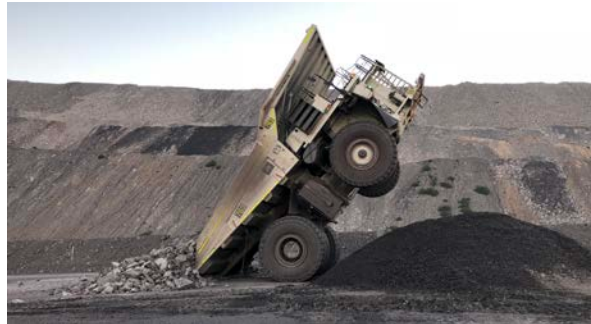
Dangerous incident
SinNot- 2018/00789

A operator was unable to safely exit from the cab of their loaded haul truck for three hours after inadvertently hitting the brake or accelerator pedal, causing the truck to tip up and sit on the rear of its tray. The truck was queued on a ramp and started to roll backwards. The operator initially failed to detect this movement and reacted suddenly. The operator reported they may have had a micro-sleep.

Schedule 2 of the Work Health and Safety (Mines and Petroleum Sites) Regulation 2014 includes the requirement that the health control plan must address fitness for work, which includes fatigue.

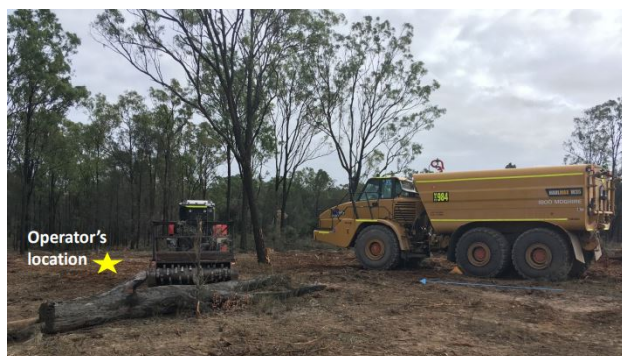
Dangerous incident
SinNot- 2018/00781

An articulated water cart hit a tree. The operator exited the machine, it then rolled forward 10 metres into the tree.

The principal hazard management plan for roads or other vehicle operating areas should include procedures detailing the requirement that mobile equipment is parked fundamentally stable.

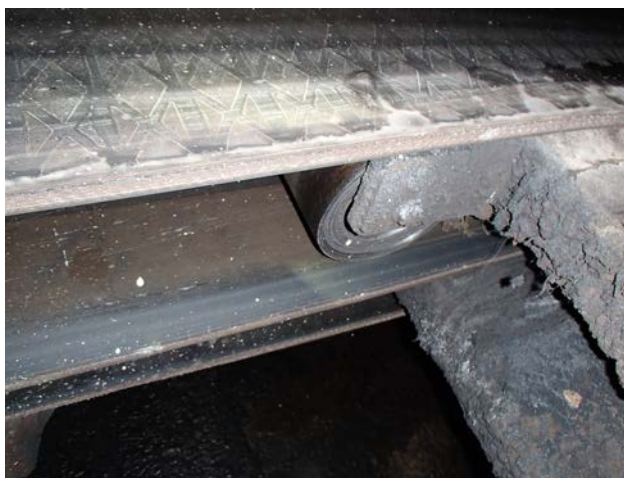
Dangerous incident
SinNot- 2018/00775

A fire occurred in the loop take-up of a trunk conveyor. The cause of the fire was identified as a collapsed return roller.

Failure of conveyor idlers is a known risk. Controls should include:

1. routine belt inspections where the focus is on thoroughly completing the task
2. condition monitoring
3. CO detectors in a designated location.

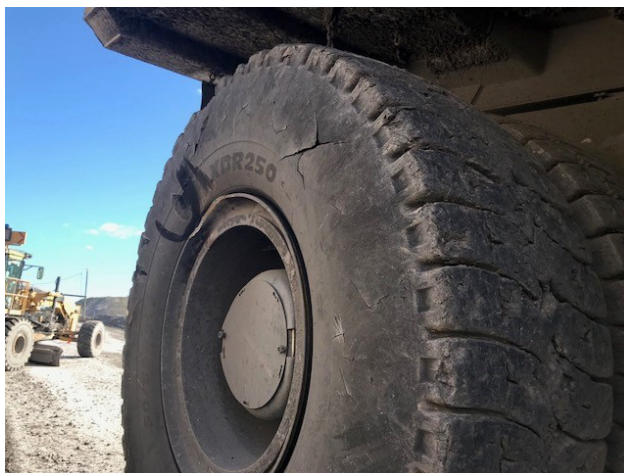
Dangerous incident
SinNot- 2018/00773

A collision occurred between a grader and haul truck. The grader was travelling down a ramp when the operator reported to have had a micro sleep and travelled toward the haul truck travelling up the ramp. The front of the grader made contact with the sidewall of the truck tyres.

Schedule 2 of the Work Health and Safety (Mines and Petroleum Sites) Regulation 2014 includes the requirement that the health control plan must address fitness for work, which includes fatigue.

Segregation between vehicles travelling in opposite directions should be

considered when developing the principal hazard management plan for roads or other vehicle operating areas.
