# Mine Safety High Visibility Campaign 2024

Small mines sector - site presentation

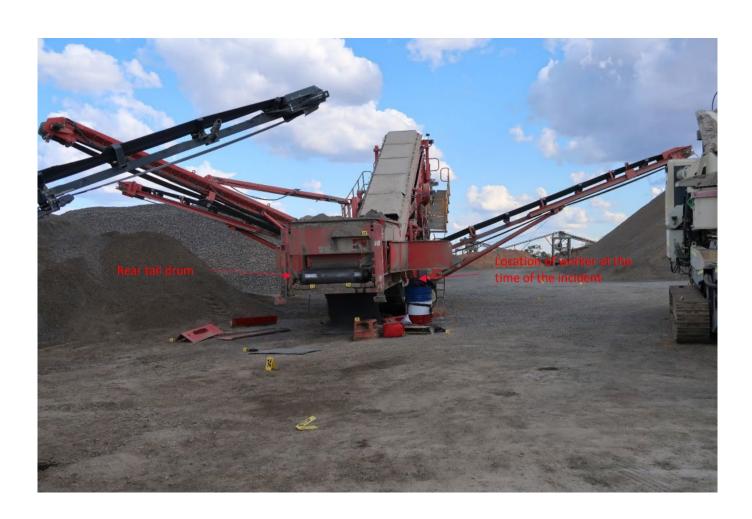
### Quarry sector - Entanglement - amputated arm - August 2023

A worker assisting with tracking the belt on a mobile screen was seriously injured when his arm became entangled in the screen's rotating tail drum.

While undertaking the task, one of workers was in proximity of the right-hand side of the screen toward the rear of the item of plant. The screen was energised with its conveyor operating. The worker's arm became entangled in the rotating tail drum of the screen, pulling the worker into the drum up to his shoulder.

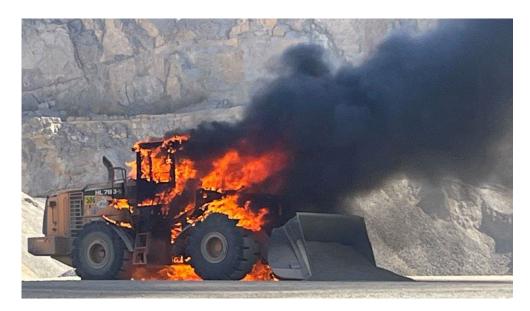
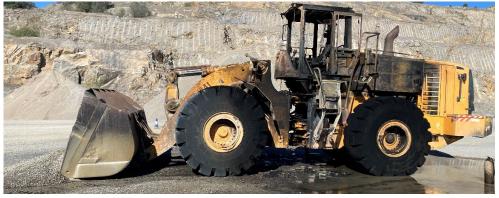
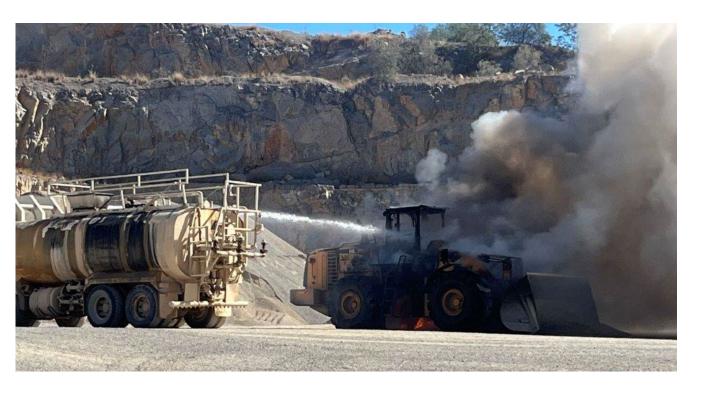
### Quarry sector - Loader fire - September 2023

- Loader continued to be operated after a fault was identified and not actioned
- No injuries

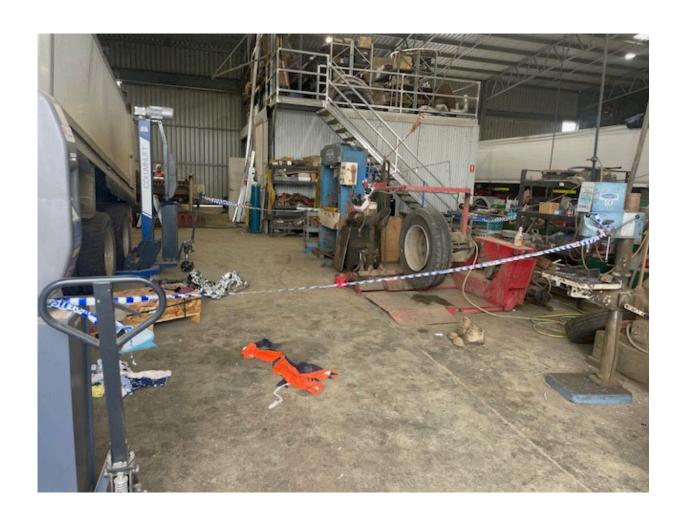
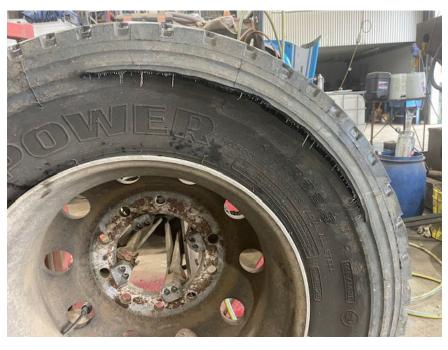
### Quarry sector – Tyre explosion in a workshop - February 2024

- Pressure release from tyre
- No guarding around tyre
- Worker hospitalised

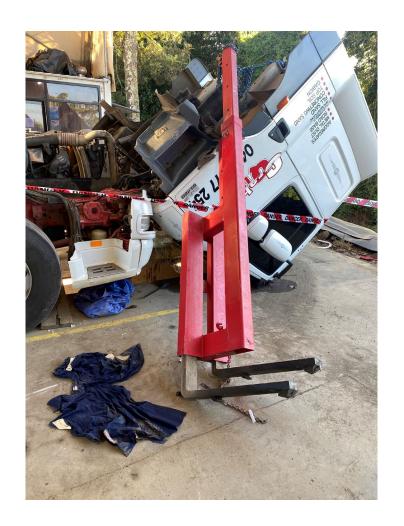
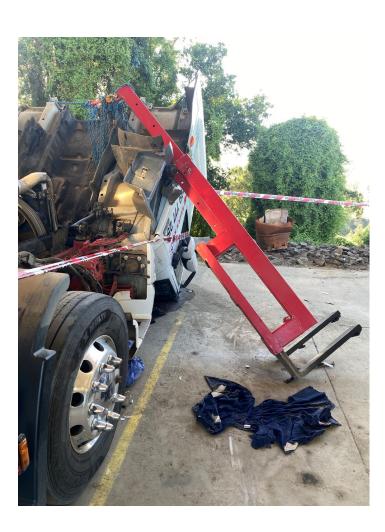
### Quarry sector – Lifting jib fell off a fork-lift – March 2024

- Lifting jib fell off a fork-lift
- Worker hospitalised

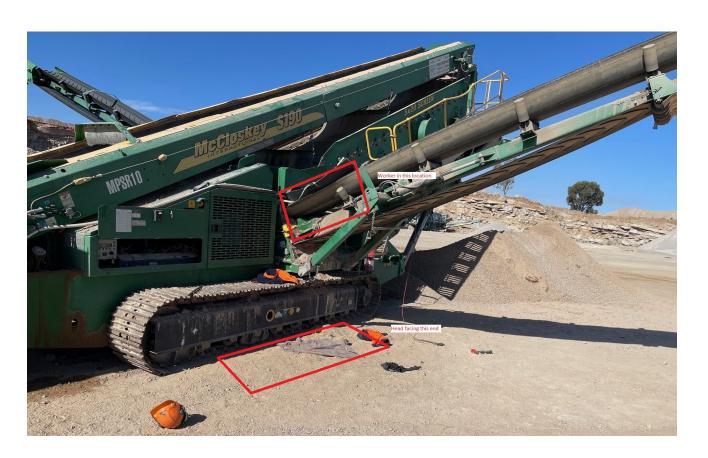
### Quarry sector – Fall from height from a rock crusher – March 2024

- Worker fell from a rock crusher
- Worker hospitalised
- Use the correct access ways to platforms on crushers
- Falls from a low height can result in significant injuries

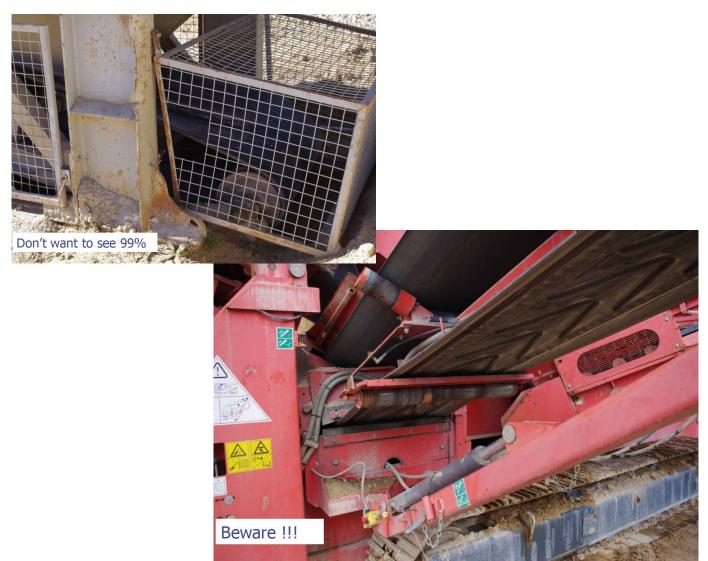
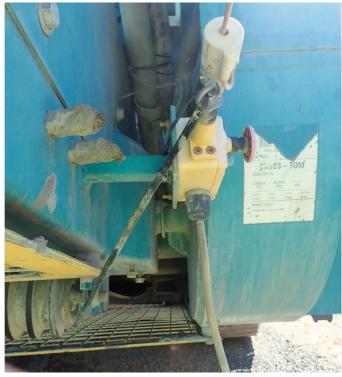
### Quarry sector - Poor examples of conveyor guarding

- Unguarded nip points
- Guarding not to Australian Standards
- Trip hazards on walkways

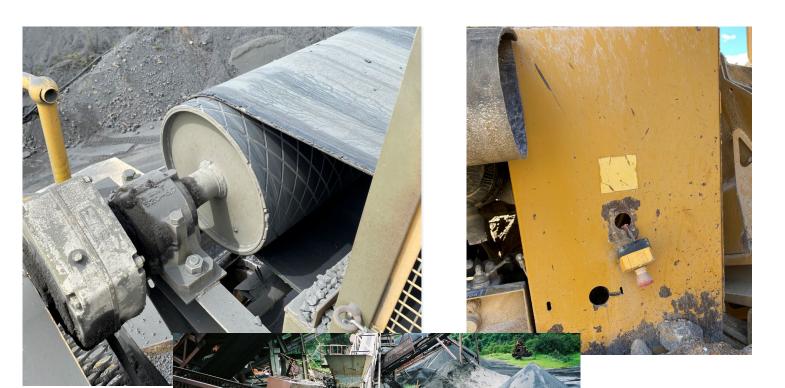
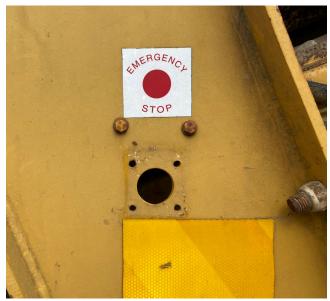
### Quarry sector - Poor examples of conveyor guarding

- Unguarded tail rollers
- Guarding not to Australian Standards
- Ineffective emergency stops
