Compliance Report

Woodsreef Mine Major Rehabilitation Project

EPBC 2012/6437

15 August 2016 to 15 August 2017

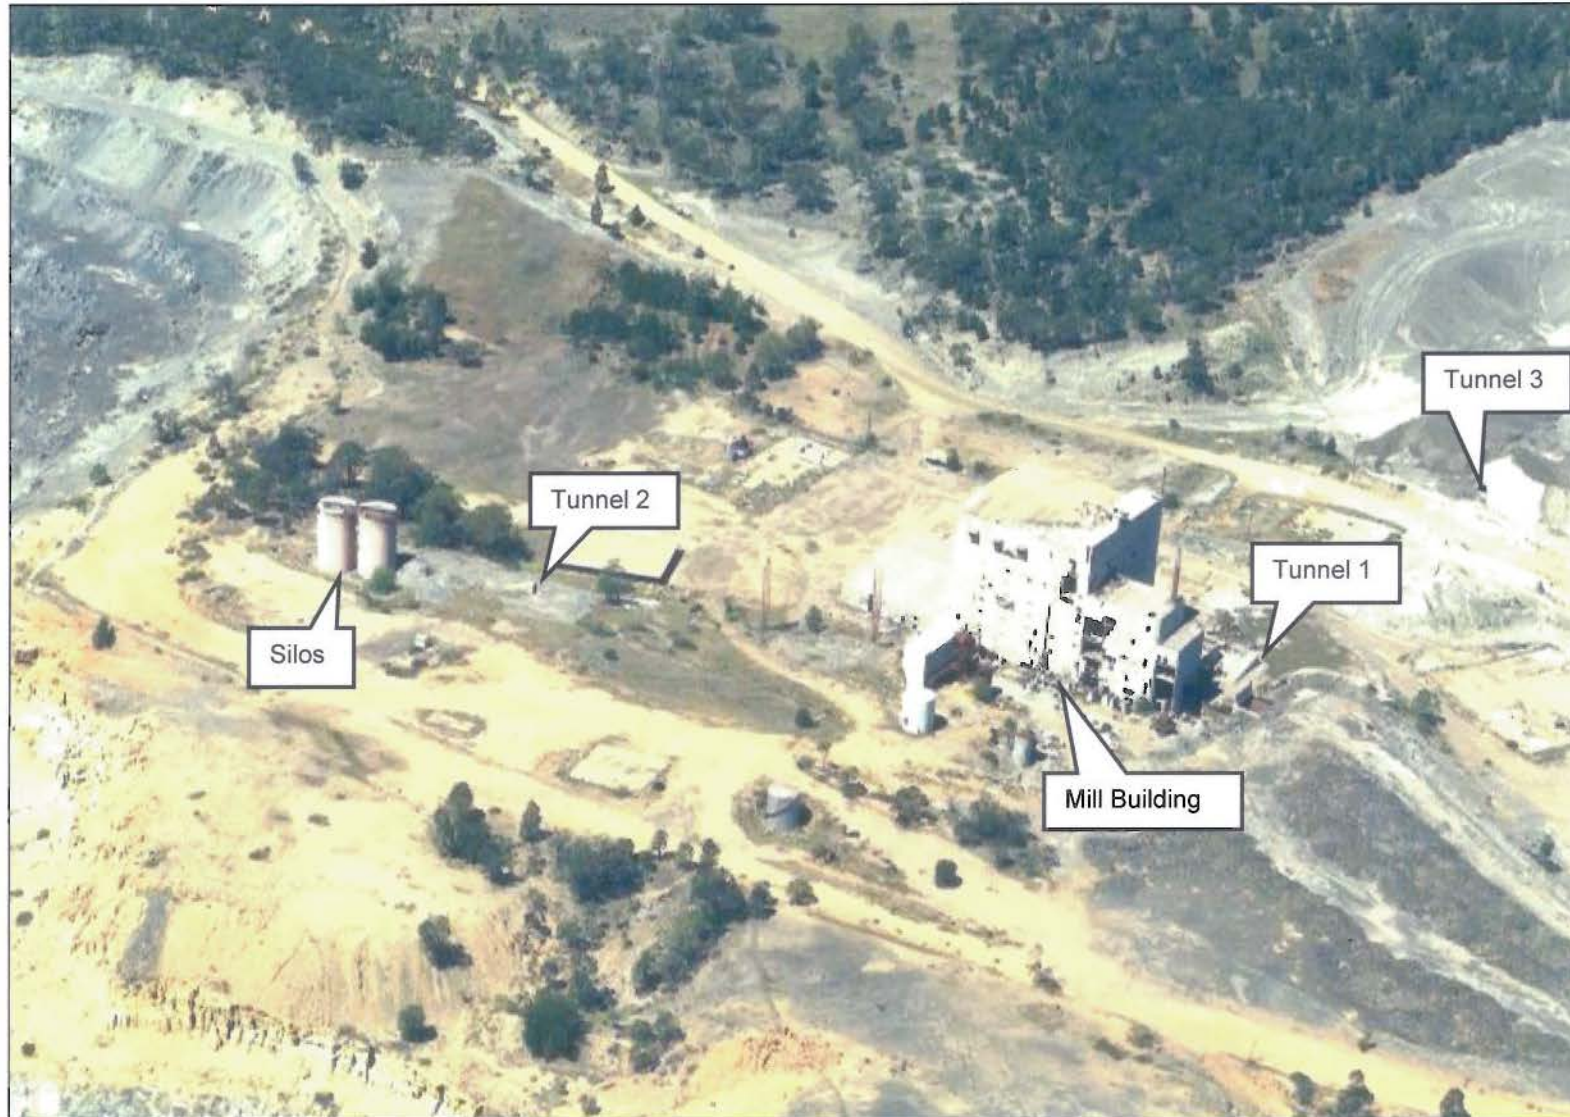
Figure 1-4: Woodsreef Mine Infrastructure Aerial View

Tunnels 1, 2 and 3 – means the existing tunnels on site which have been identified as existing or potential LEBP habitat and identified in Figure 1-4 of the **Public Environment Report**.

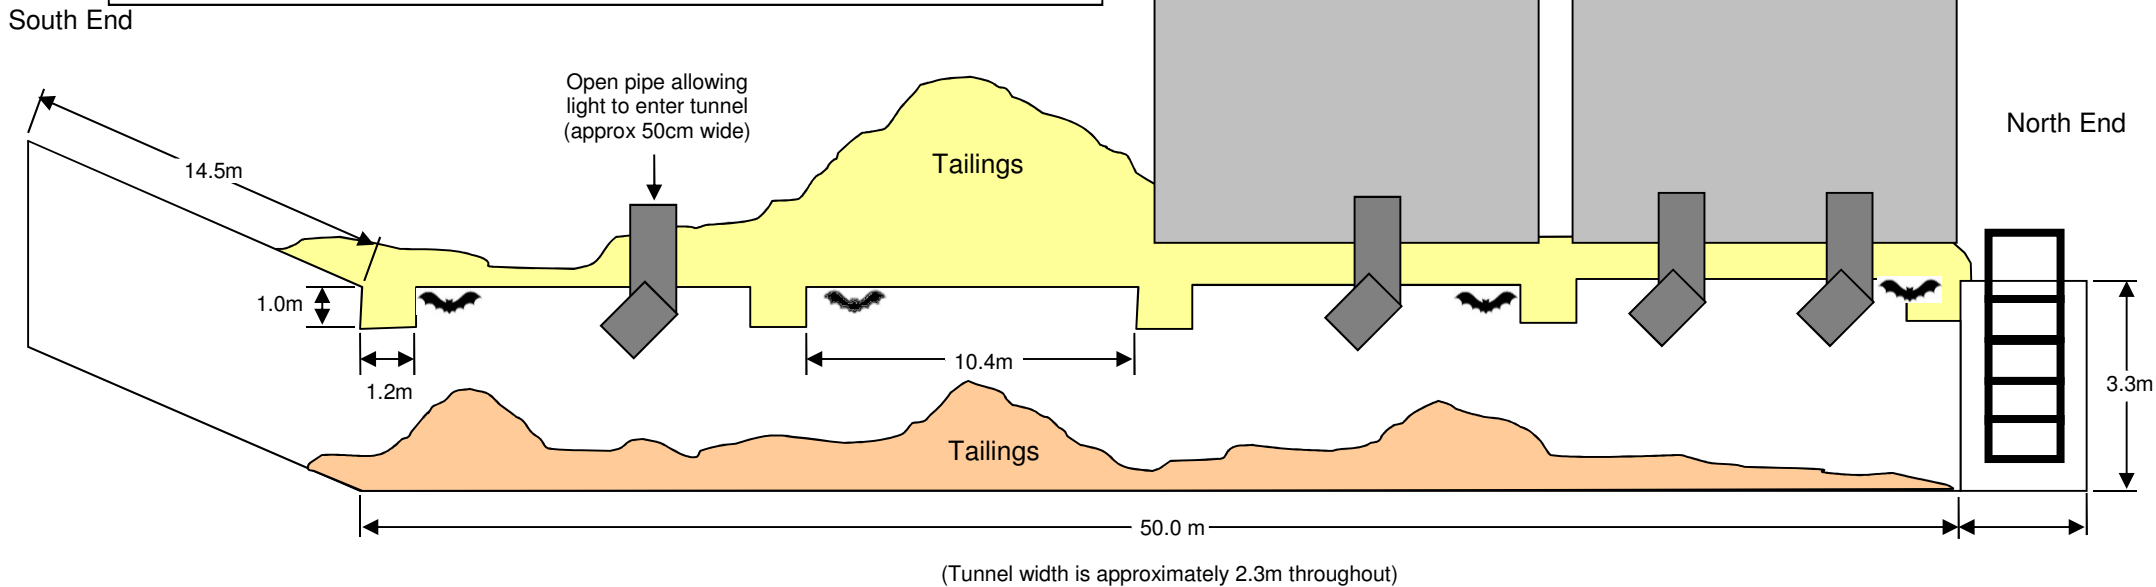
- Scattered metal debris throughout tunnel from asbestos elevators
- Bats roosting on rough part of roof (e.g. rough concrete and wood that has been fixed to concrete wall and roof)
- Standing water in parts of tunnel from recent heavy rain
- Entire tunnel is of concrete construction

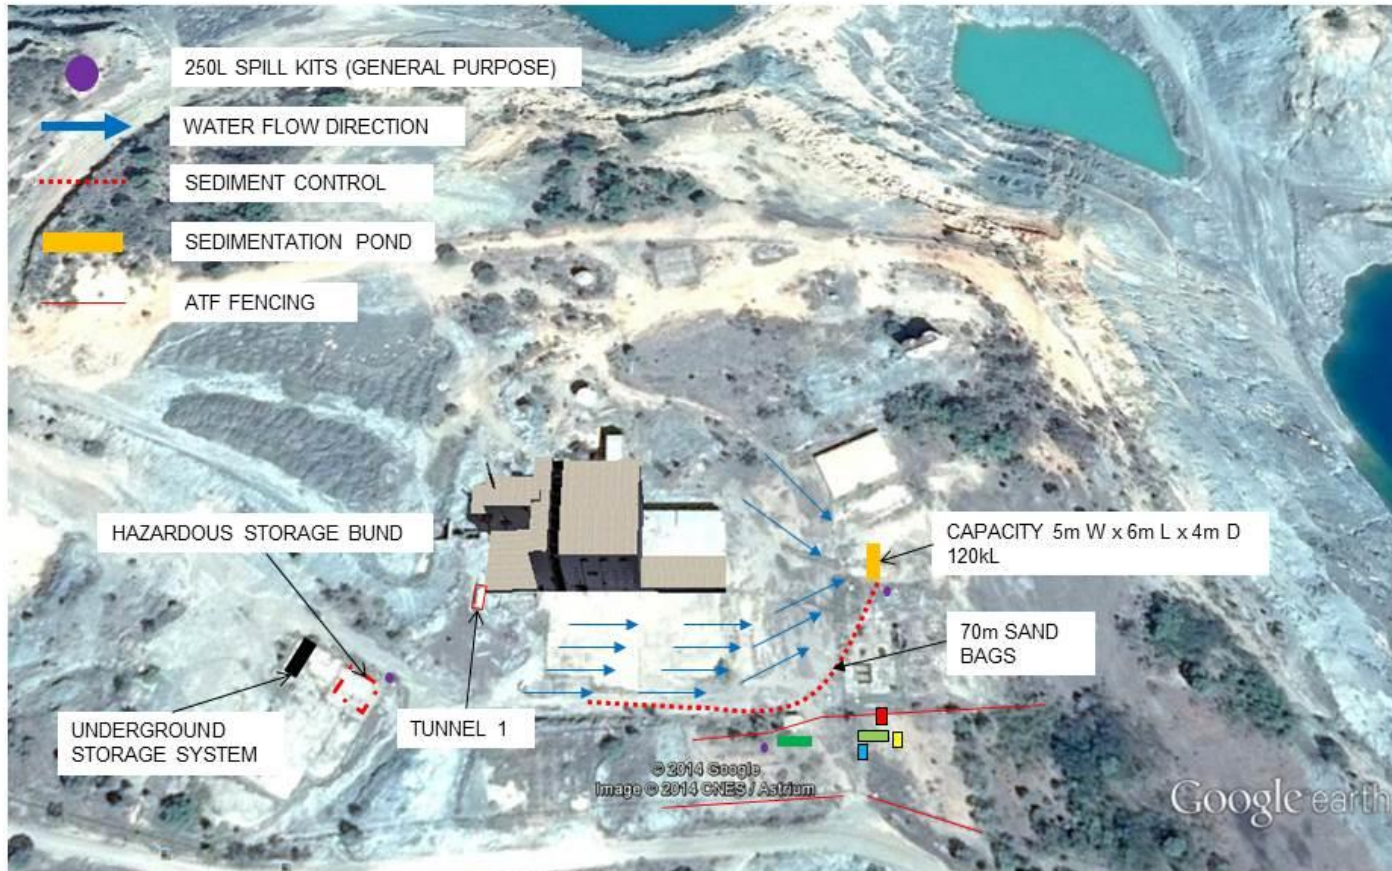
Figure 2 – Soil and Water Management Plan 1

SOIL AND WATER MANAGEMENT PLAN

Silt sock or silt fences will be utilised to prevent sediment laden water leaving site from dust suppression activities or weather conditions. This will also allow the redirection of the flow of water from leaving site as proposed in *Figure 2 – Sediment and Water Management Plan*

Run off will be captured in the sediment pond created as per *Figure 2 – Sediment and Water Management Plan*

evaporate, water will flow towards the northern side into a sediment pond as shown in Figure 2 – Soil and Water Management Plan 1. Once sediment pond is full, water will be transported to the closest pit via the water truck. Prior to discharge water will need to be tested and records kept.

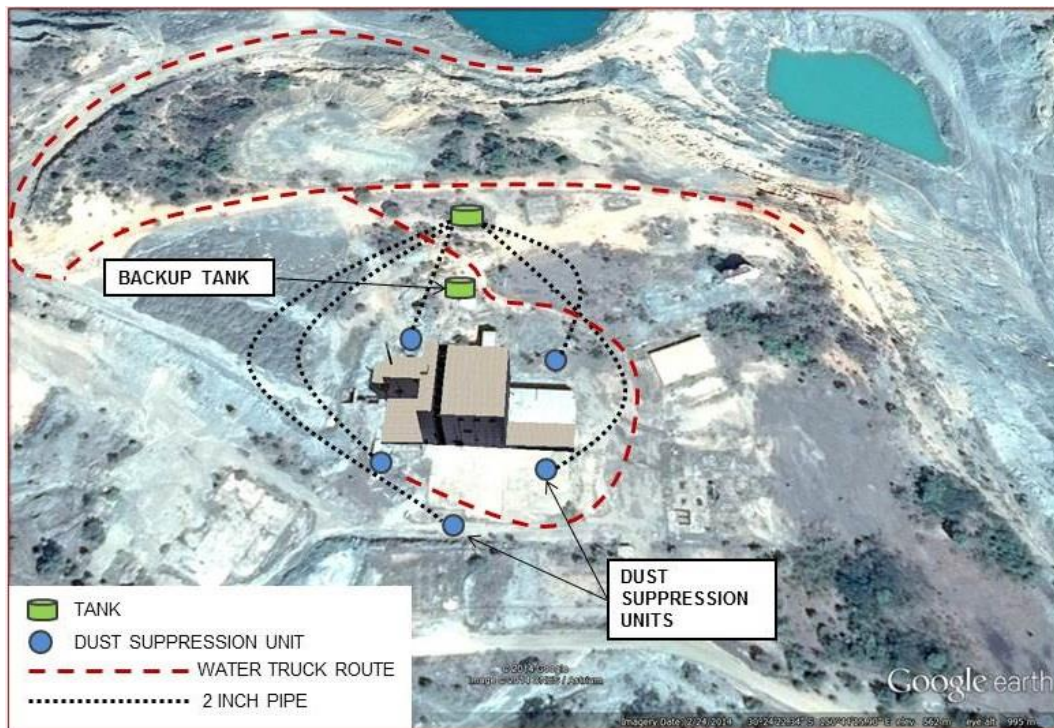
Figure 6 – Dust Suppression Water System.

- Demolition works that will produce dust will not commence unless planned dust suppression method is in place and operational. Verified in pre-start inspection.

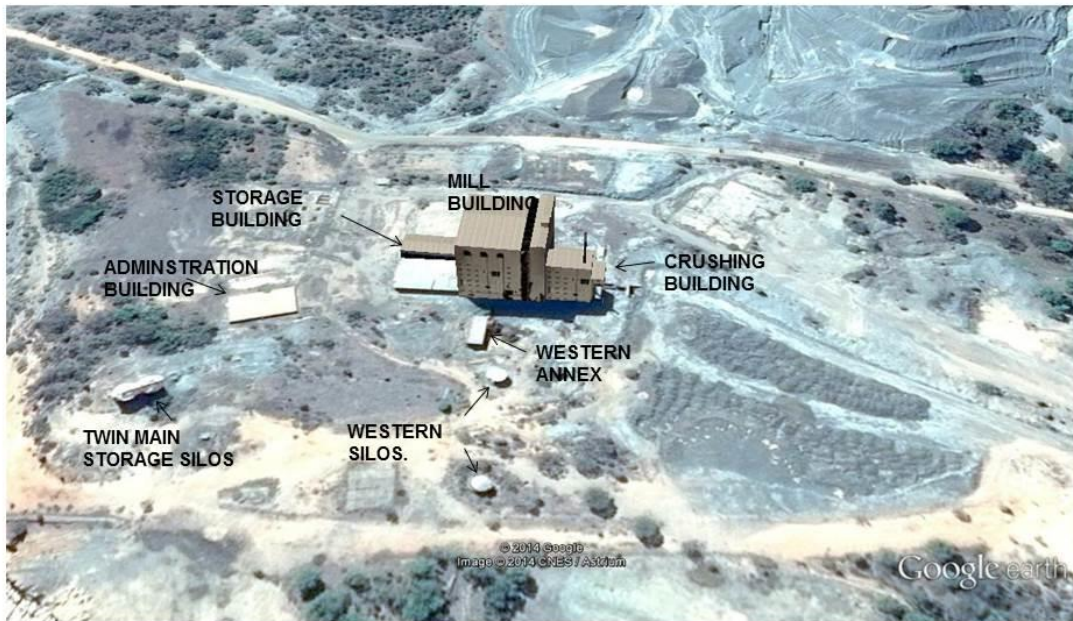
Figure 8 – Structure Locations

Figure 7 shows demolition phases of the Mill Building, while *Figure 8* shows surrounding structures locations to the Mill Building referred to in the above sequence.

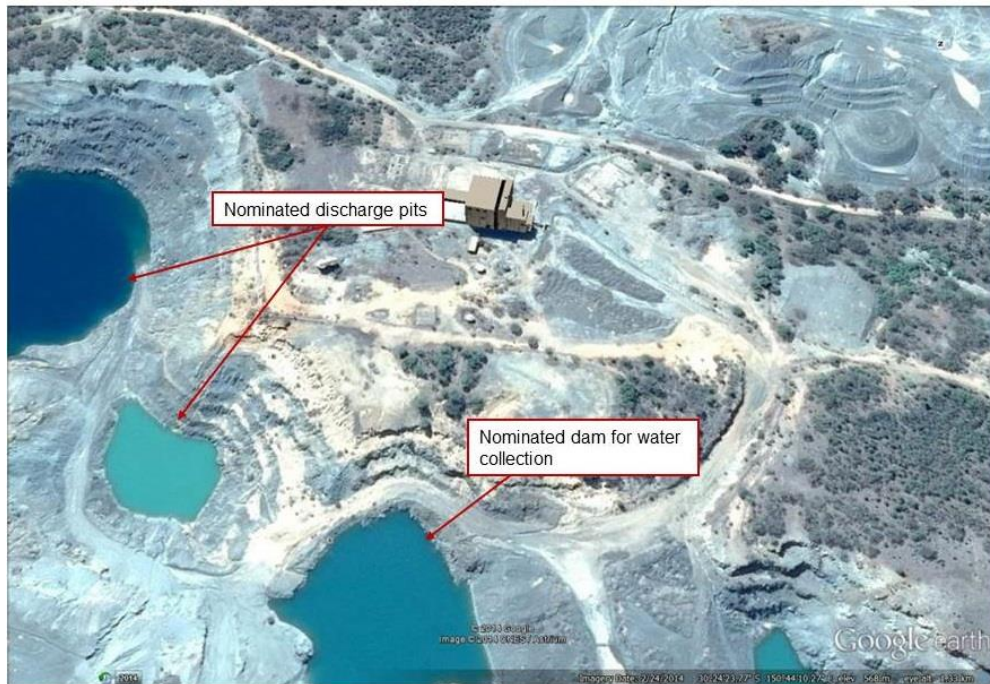
Figure 9 - Water collection

Please refer to *Figure 9 – Water Collection* for nominated open cut pit used for water collection and discharge and *Figure 6 – Dust Suppression Water System*.

Refer to *Figure 9 – Water Collection* for nominated mine pits for discharge and section 22.d for water collection and discharge

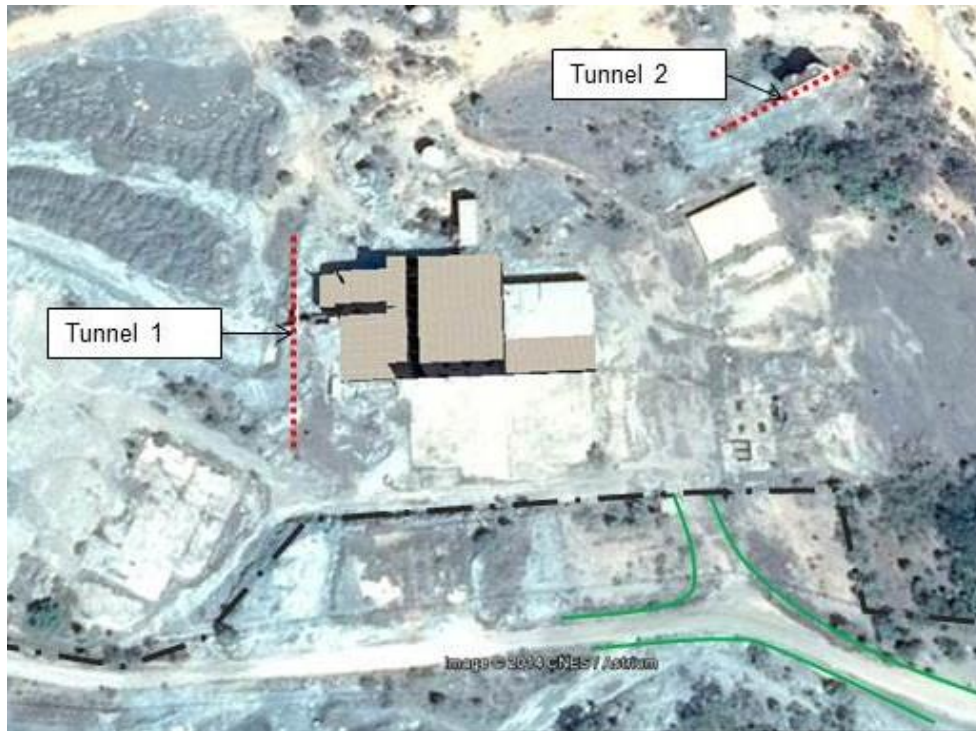
Figure 10 – Tunnel Locations for tunnels

All significant flora and fauna on site must be protected as highlighted in *Figure 4 – Location of Sensitive Areas*. The fauna in question is the Large Eared Pied Bat (LEPB) located in the Mill Building, where they will be relocated by a qualified ecologist to tunnels 1 & 2.

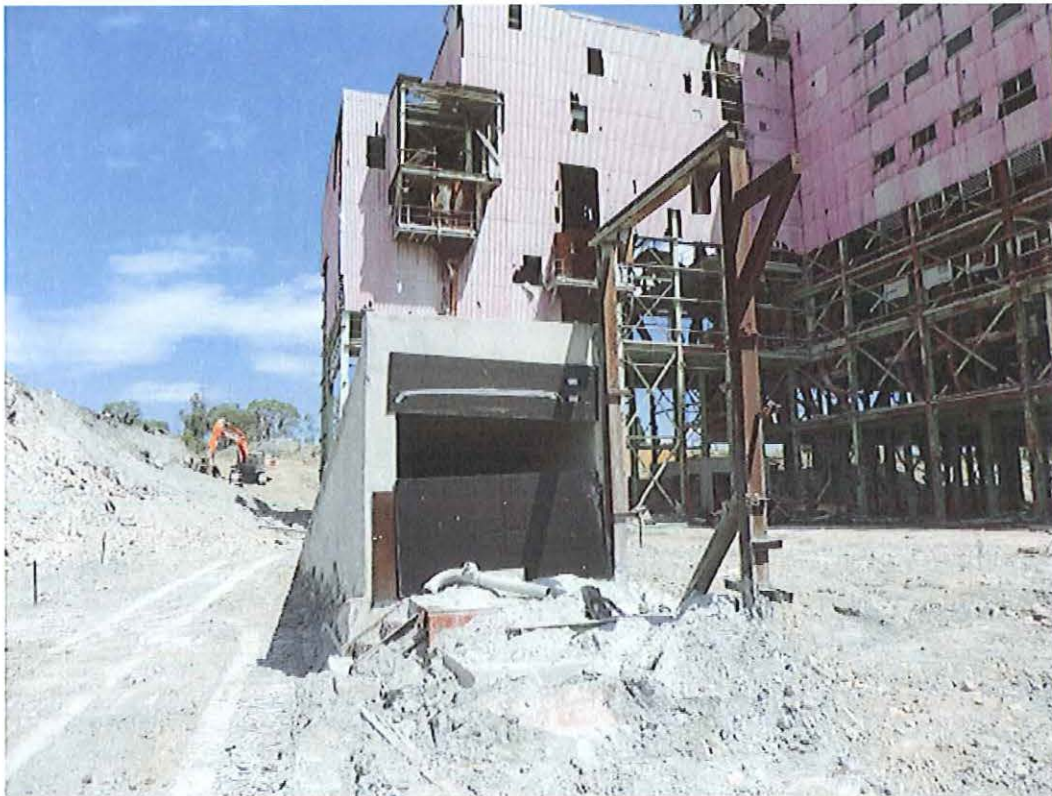
Tunnel 1 entrance restored to exclude feral animals and provide bat roosting habitat, two Large-eared Pied bats had already moved in.

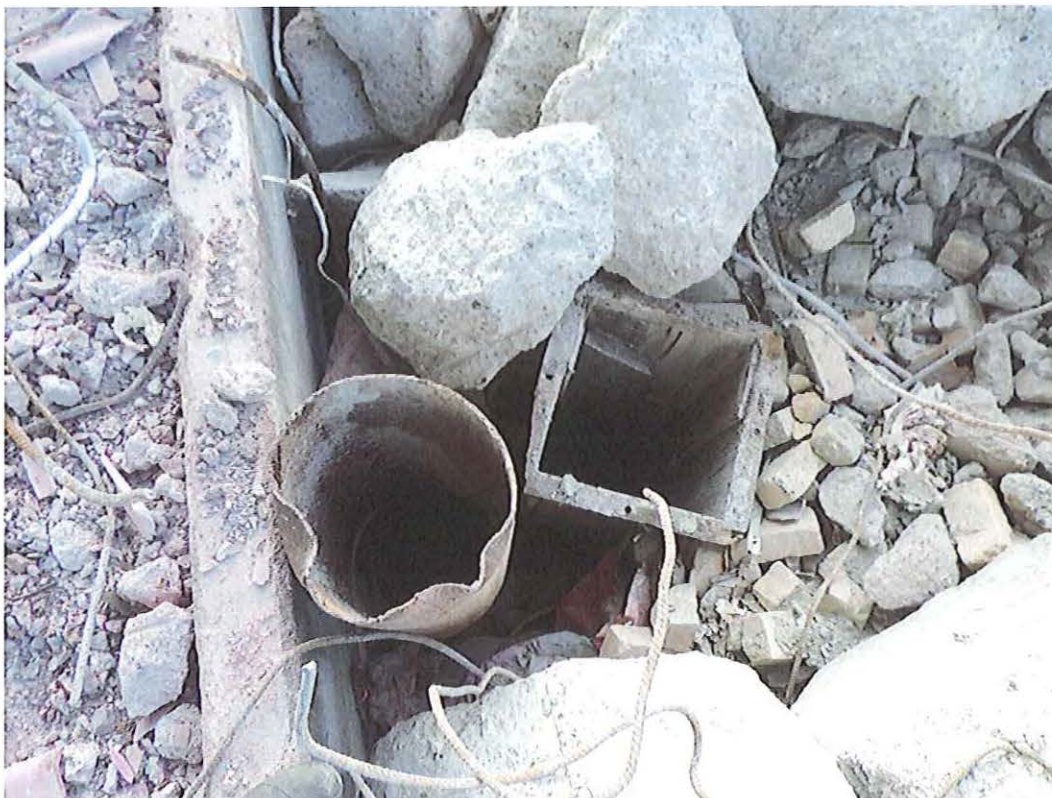
The two pipes inserted into the end of Tunnel 1 to provide ventilation

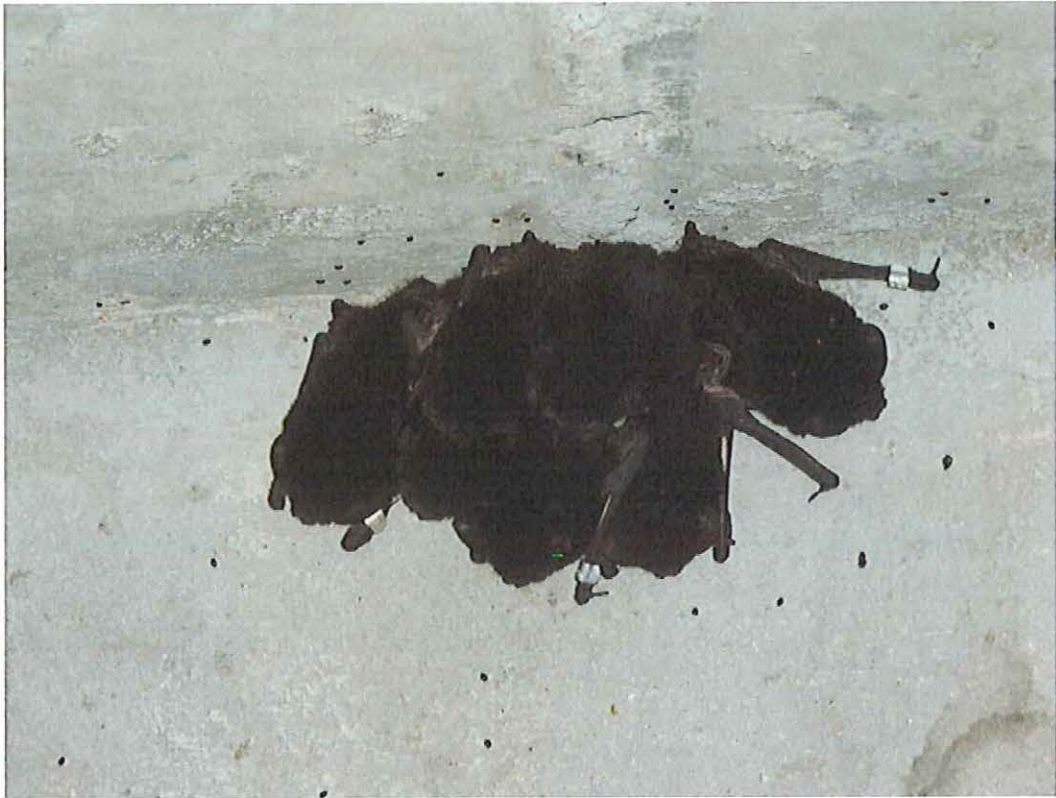
The cluster of bats recorded in the safe refuge of Tunnel 1

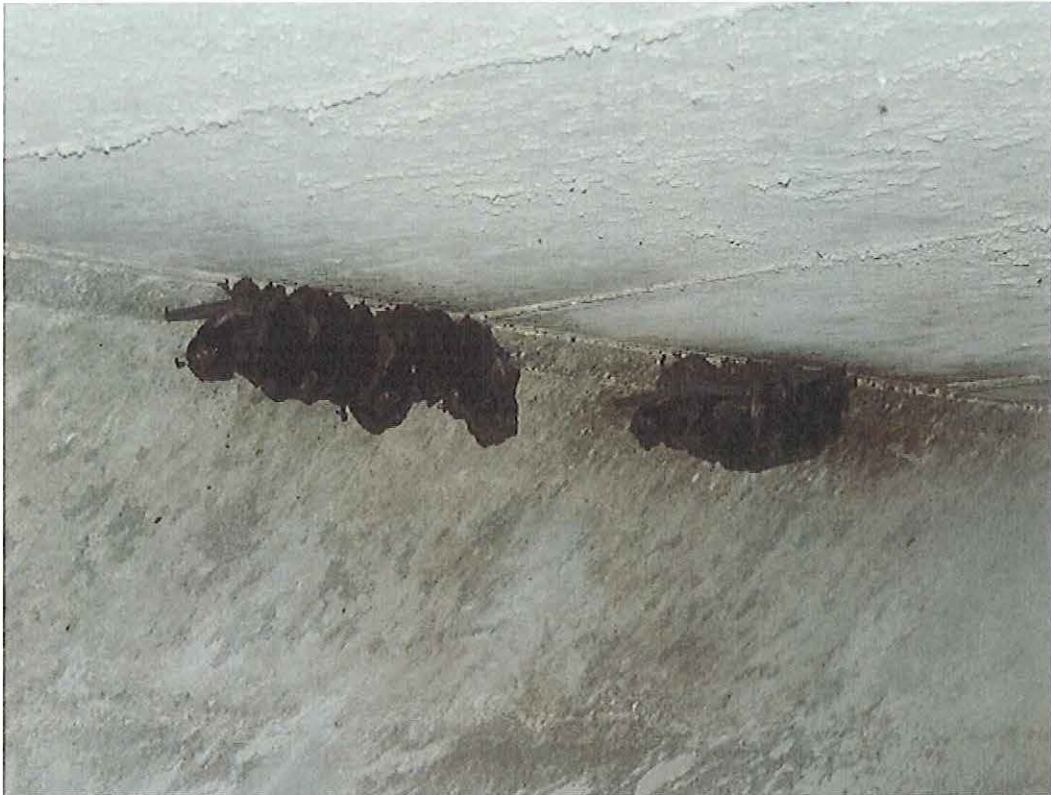
The cluster of 21 bats roosting in the safe refuge of Tunnel 2

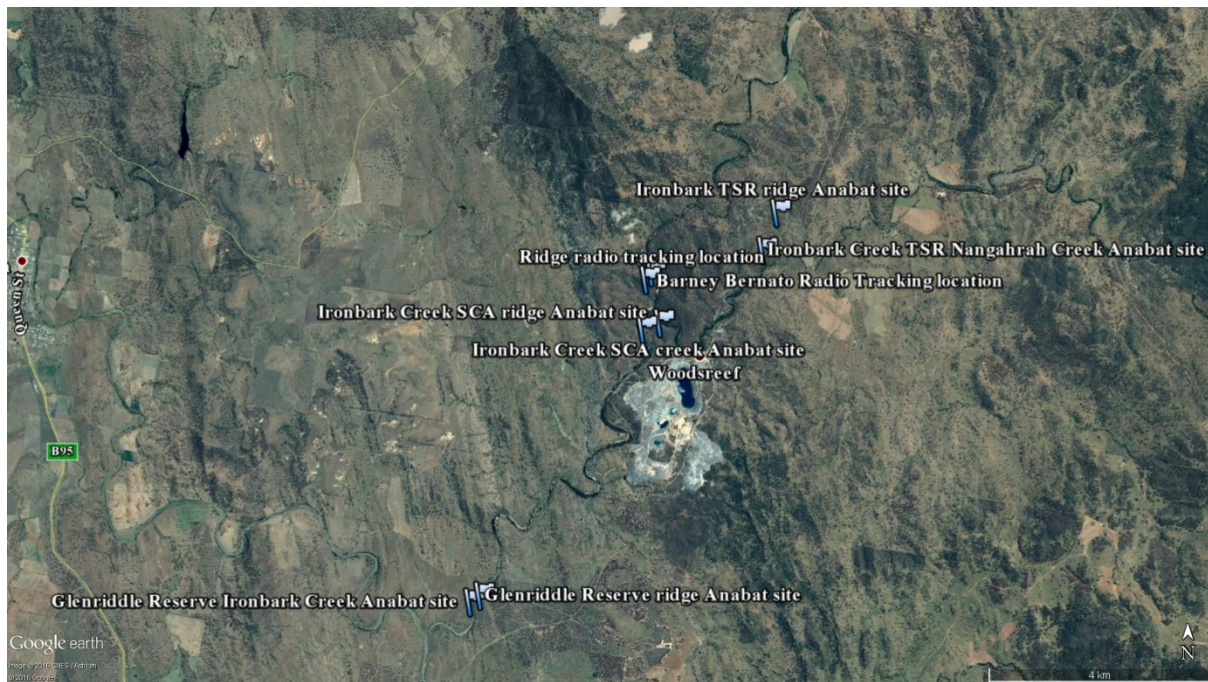
Anabat set up for all night recording with the sound and lights turned off.

20th Monday

Anabat files downloaded

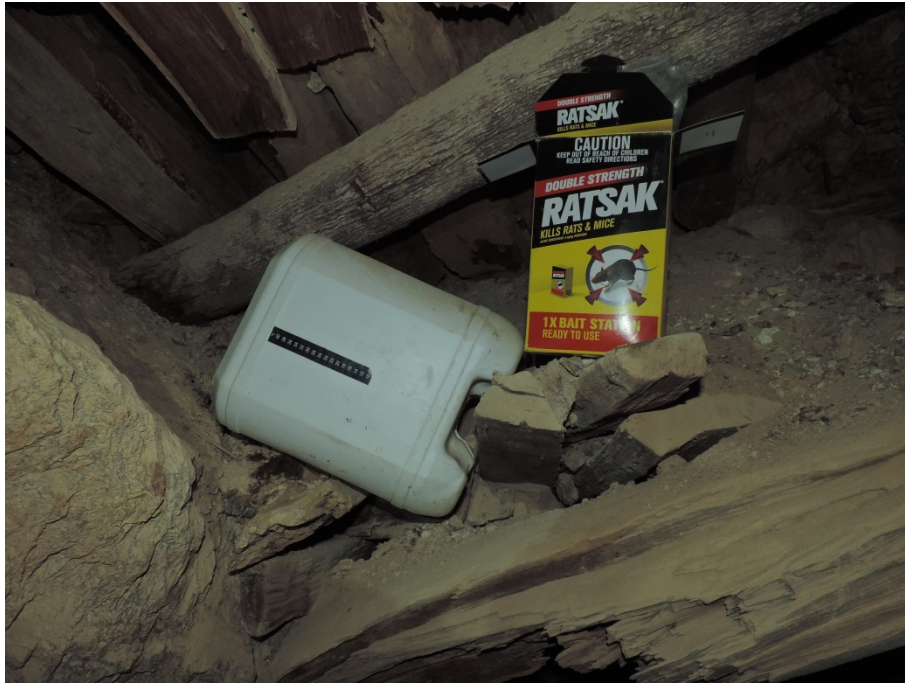
Water flow into Tunnel 2 appears to have been very significant, the water level on the concrete indicates that the tunnel has been full to the ceiling.

Water has been pouring into the stairwell entry at the northern end of the tunnel and also through the holes in the ceiling covered by the big rocks.

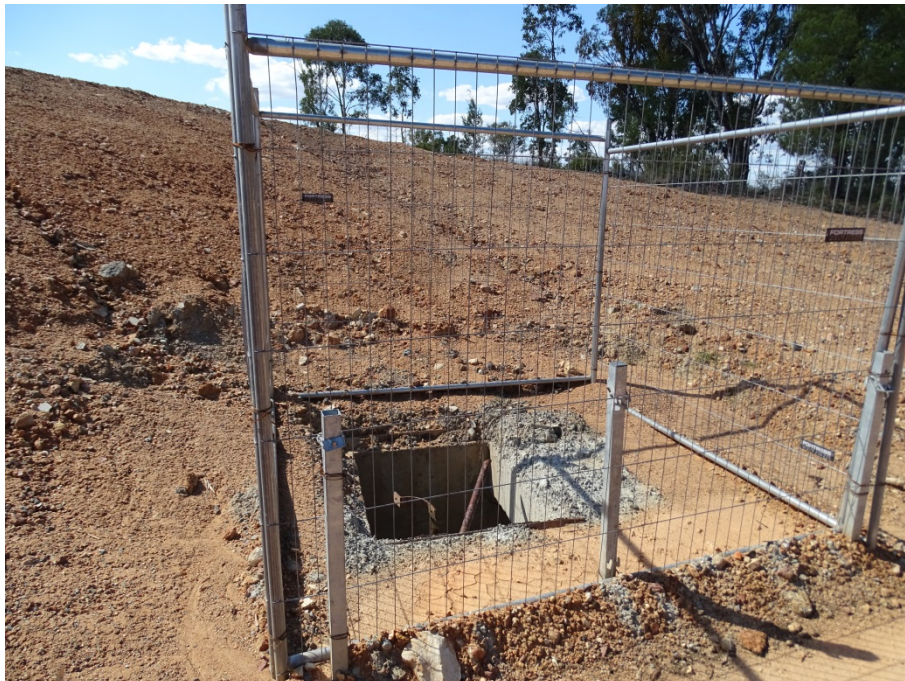
Water from the bare embankment is running into the stairwell at the end of Tunnel 2

The catchment should be drained away to the north and seeded with native grasses to decrease runoff.

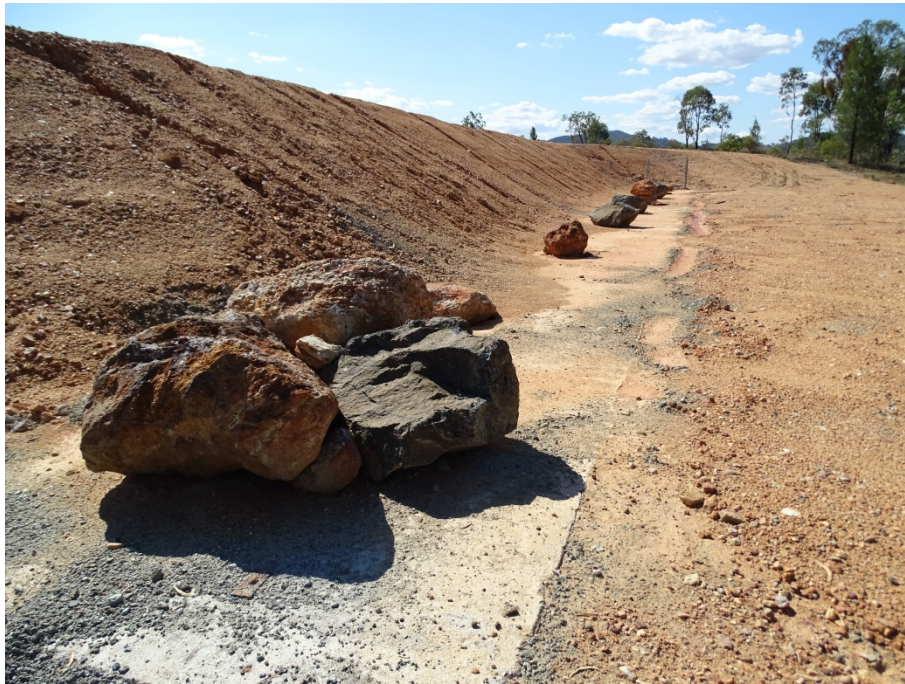
Big rocks are not preventing the flow of water into Tunnel 2

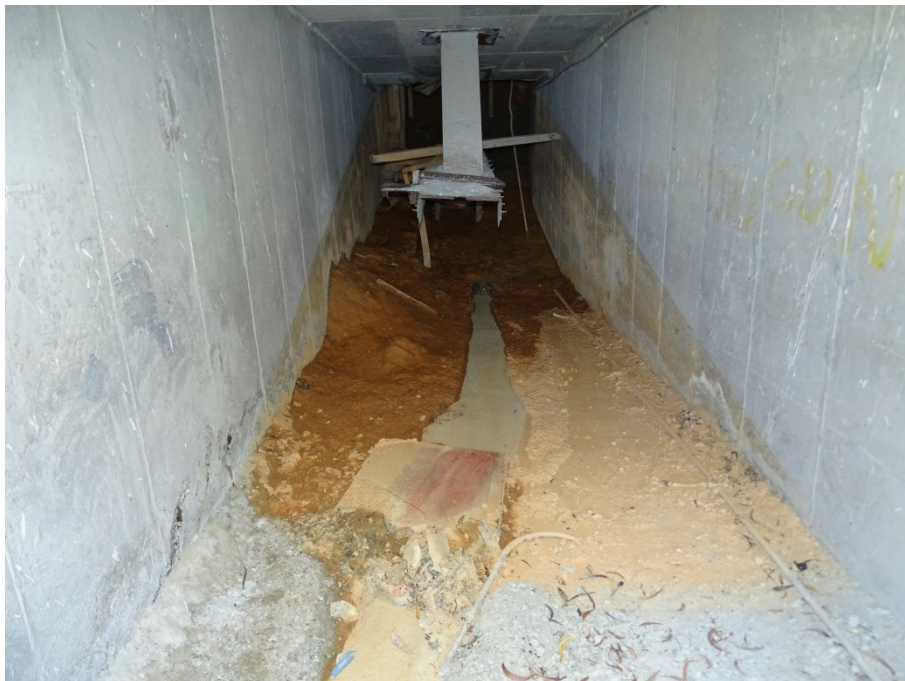
Water has also poured into Tunnel 1 as shown by the water level on the concrete wall. High water levels in the tunnel blocks the snorkel fitted to provide ventilation through the tunnel.

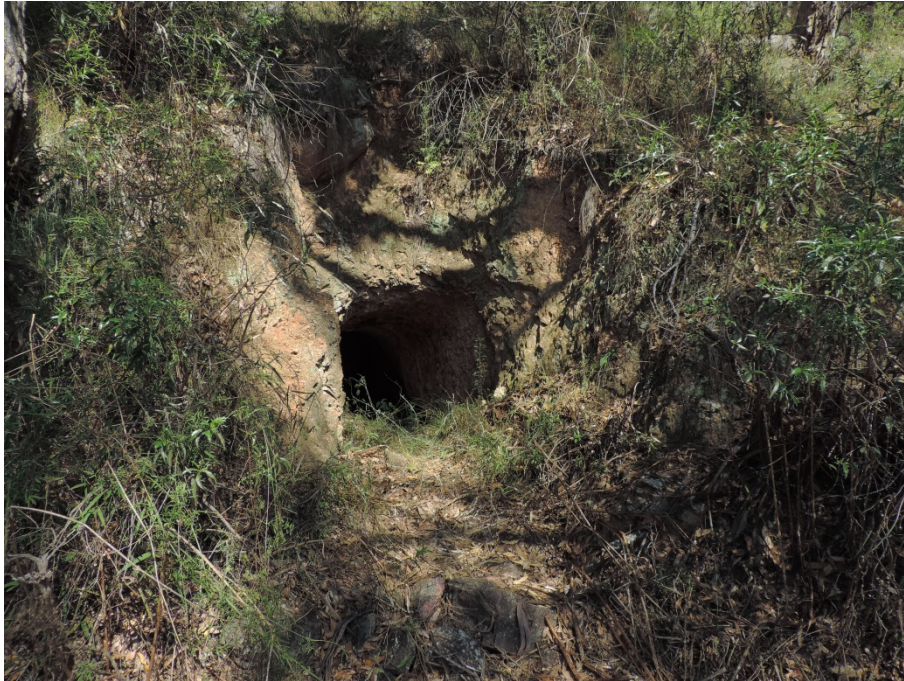
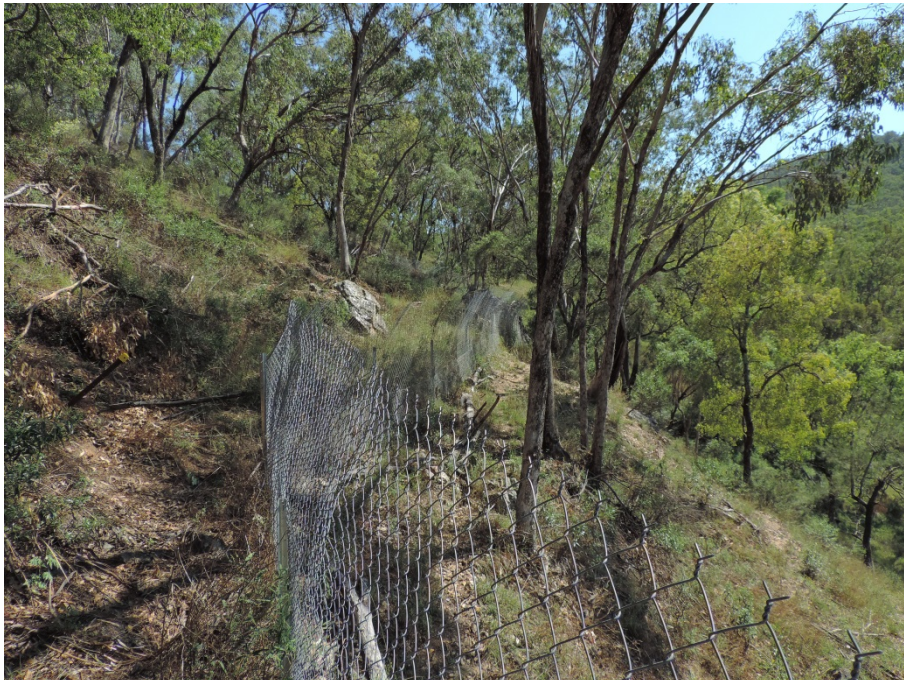
Without goat and wallaby browsing the vegetation in the enclosed area is regenerating to the point that the entrance to the mine adits will need to be maintained to enable bats access. Shrubs were cleared from the entrance to Barney Bernato below and limbs removed from the fence.

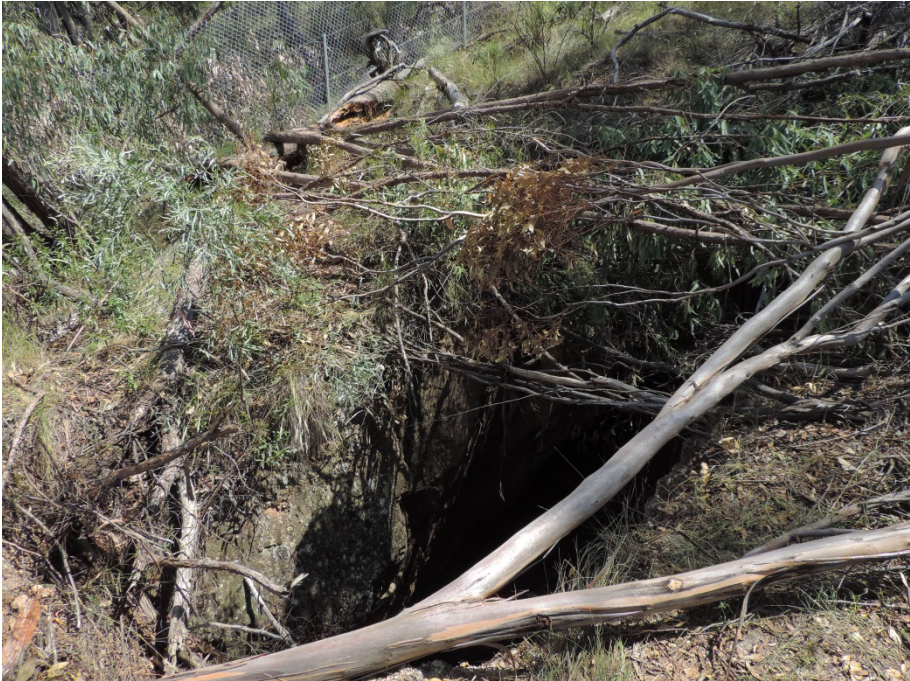
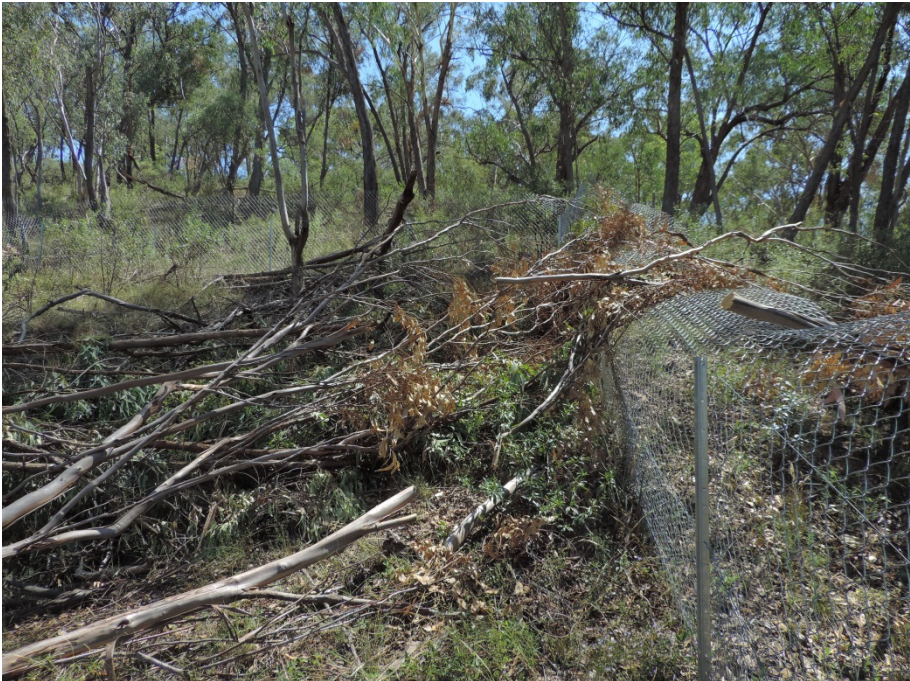
Fallen limbs and trees blocked the entrance to top King Solomon shaft and fell across the fence.

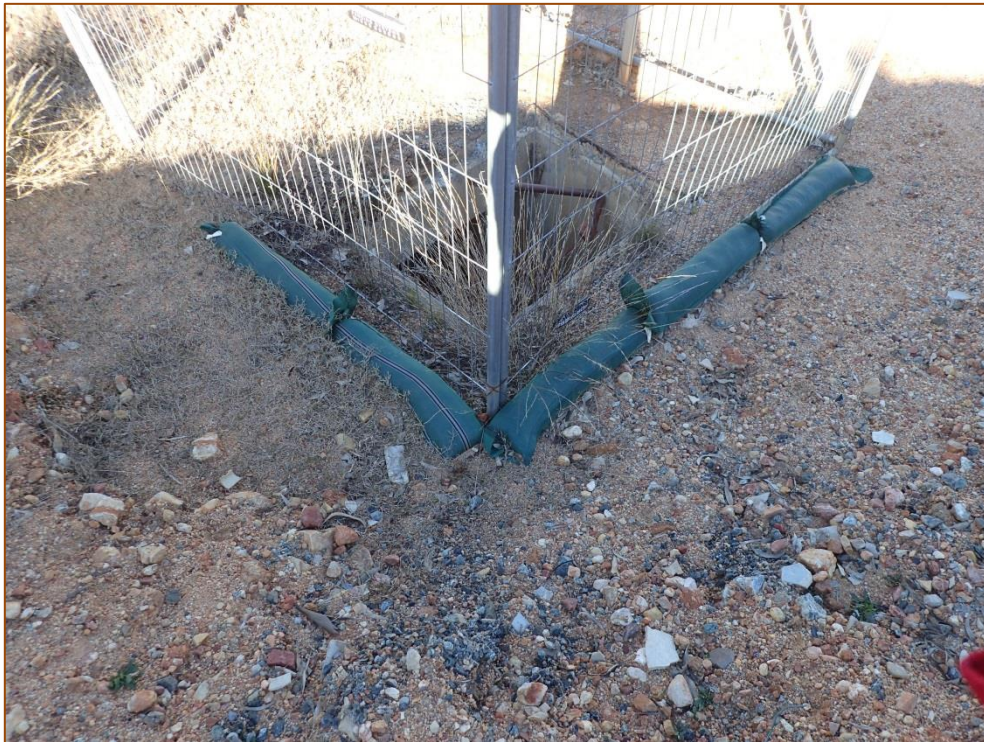
Man hole entrance into Tunnel 2 has been sandbagged but it is totally ineffective to stop water pouring into the tunnel. It is a large cathment with a large volume of runoff, sand bags cannot divert such a large volume of water.

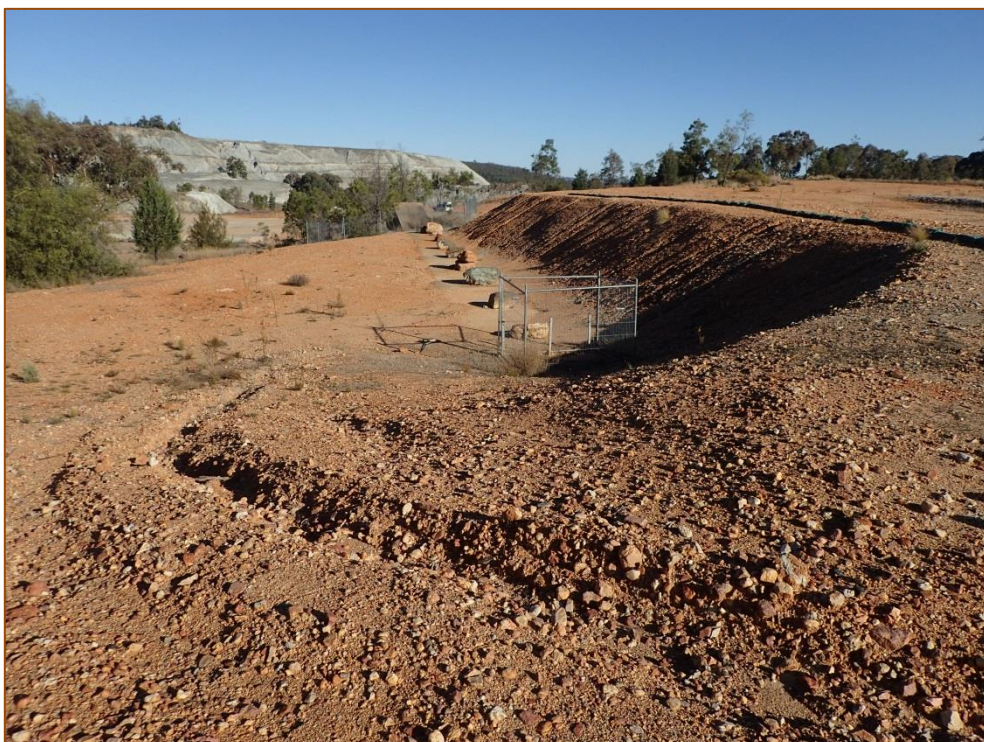
Note the eroded channel in the foreground that floods into the man hole

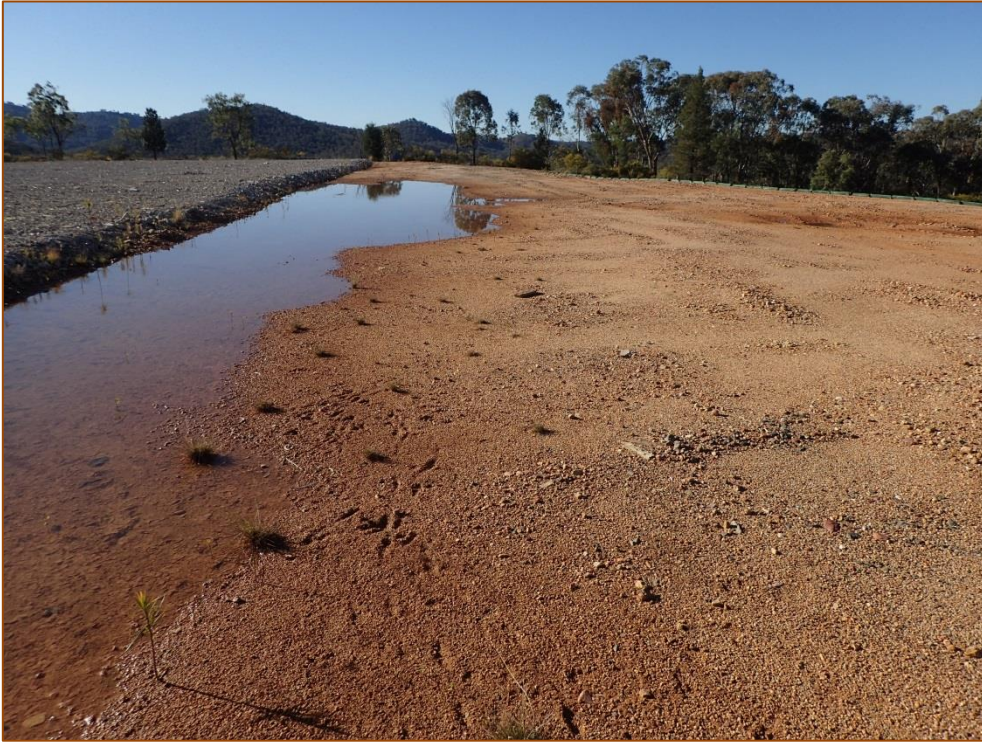
Note two eroded channels were water pours over the edge and into Tunnel 2, water runs into the tunnel under each of the rocks shown on top of the tunnel

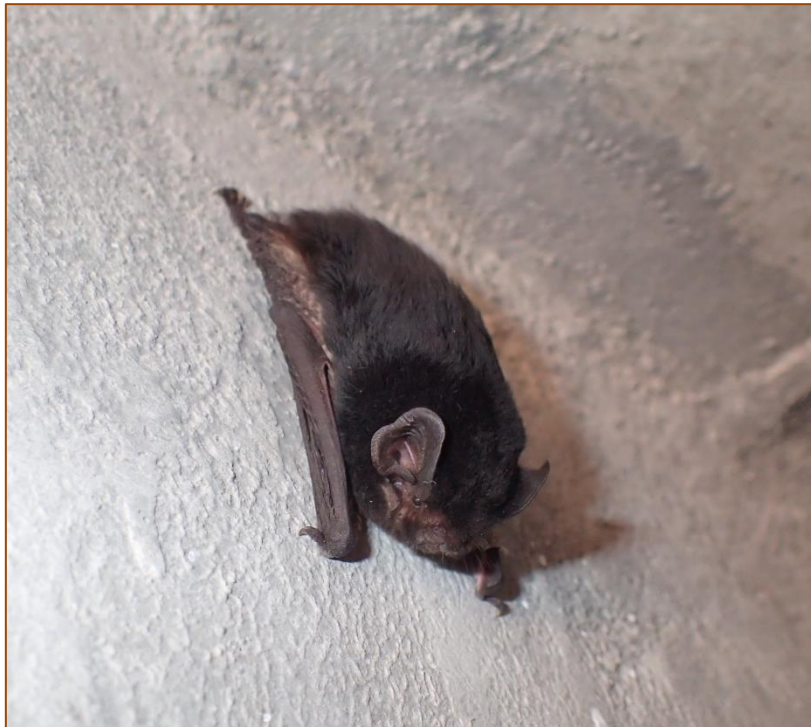
Tunnel 1 – 22nd July 2017 – one female banded bat found roosting on the concrete wall

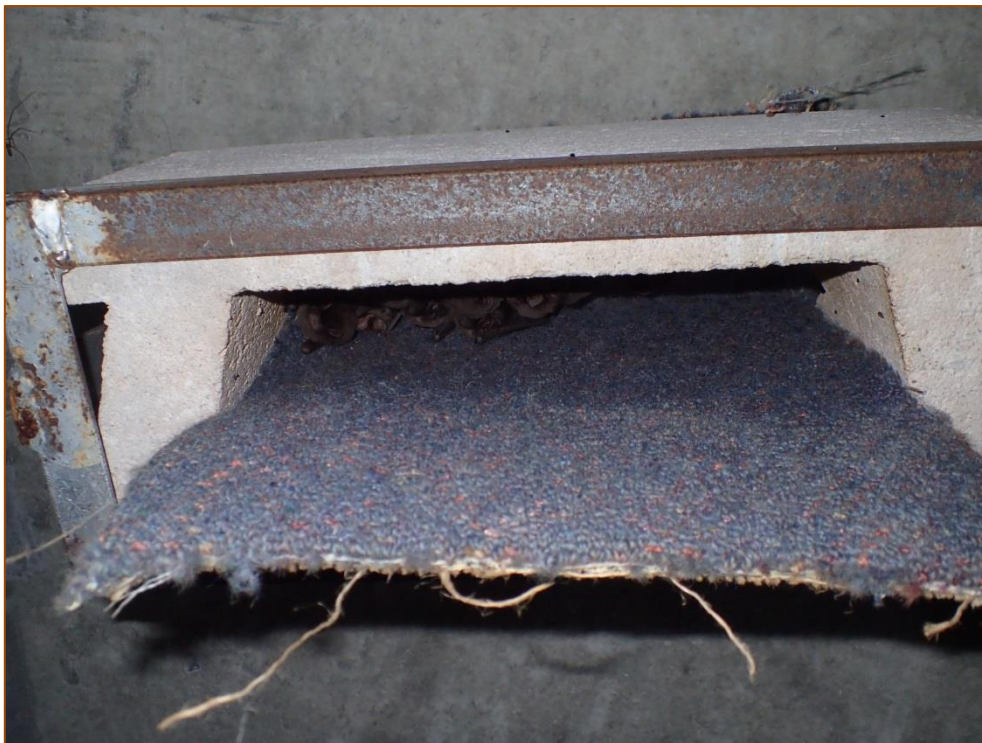
27 Eastern Bentwing bats were found roosting in two of the artificial habitat concrete blocks with carpet lining, some bats were banded but they were not disturbed

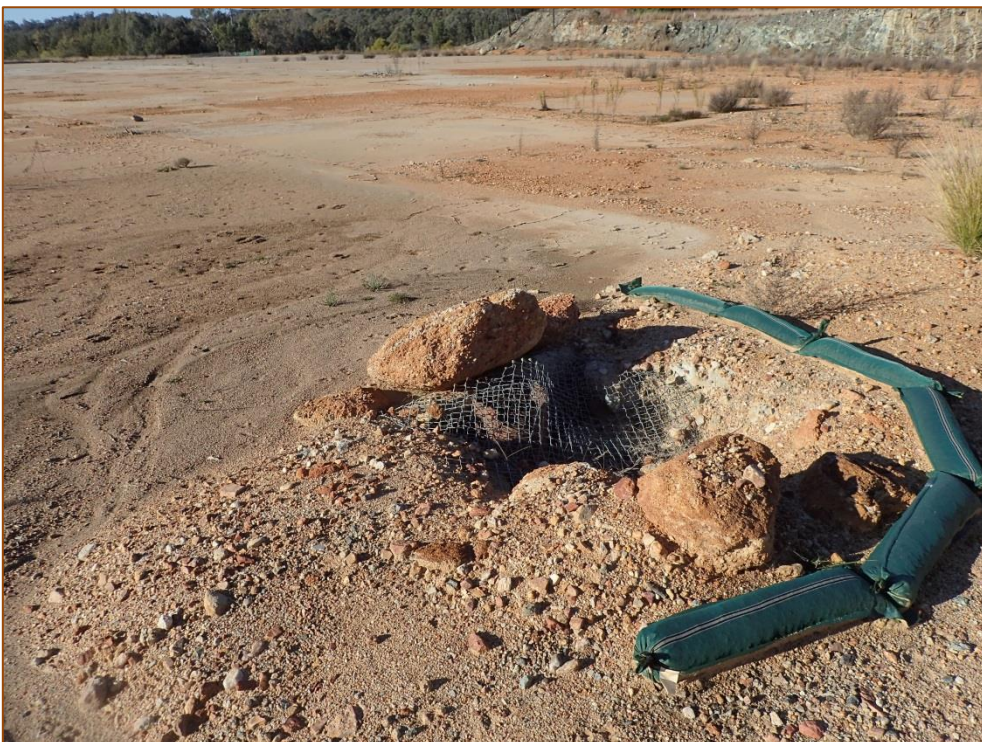
The water from the tailings piles runs straight of the bare slopes into the snorkel of Tunnel 1, which is rapidly getting filled with sediment. To seriously address the problem requires diverting the water at the source using earthworks and rehabilitation with native grasses. The life span of the offset artificial habitat in Tunnel 1 will be dramatically reduced if this is not fixed permanently.

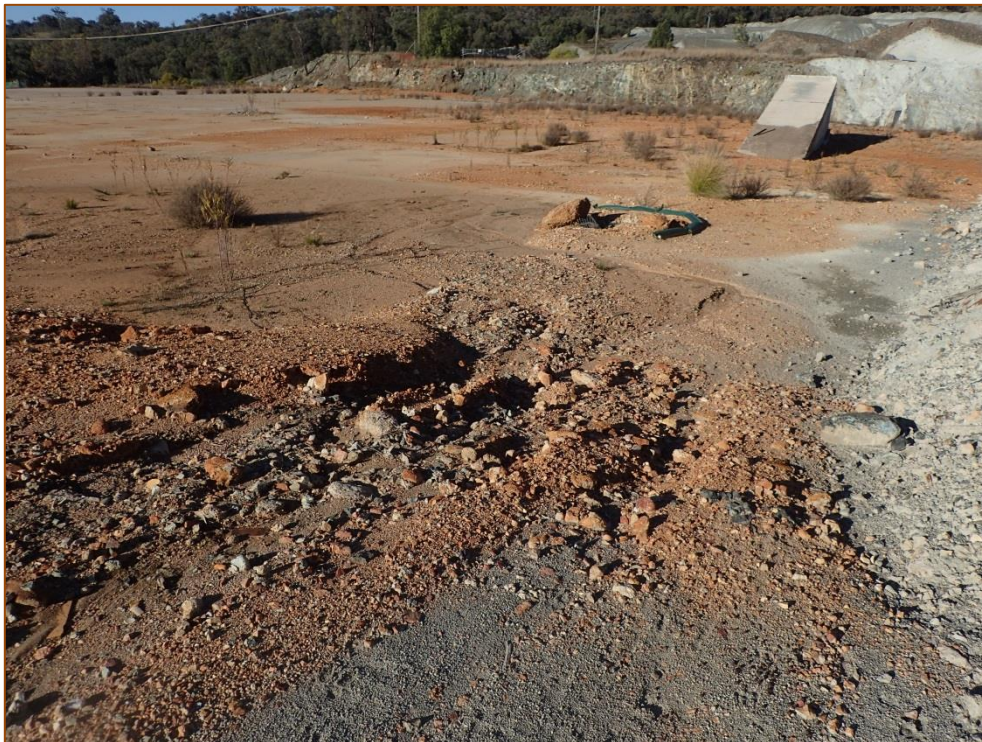
The erosion is also exposing the buried asbestos material from the building
