Compliance Report

Woodsreef Mine Major Rehabilitation Project

EPBC 2012/6437

15 August 2016 to 15 August 2017

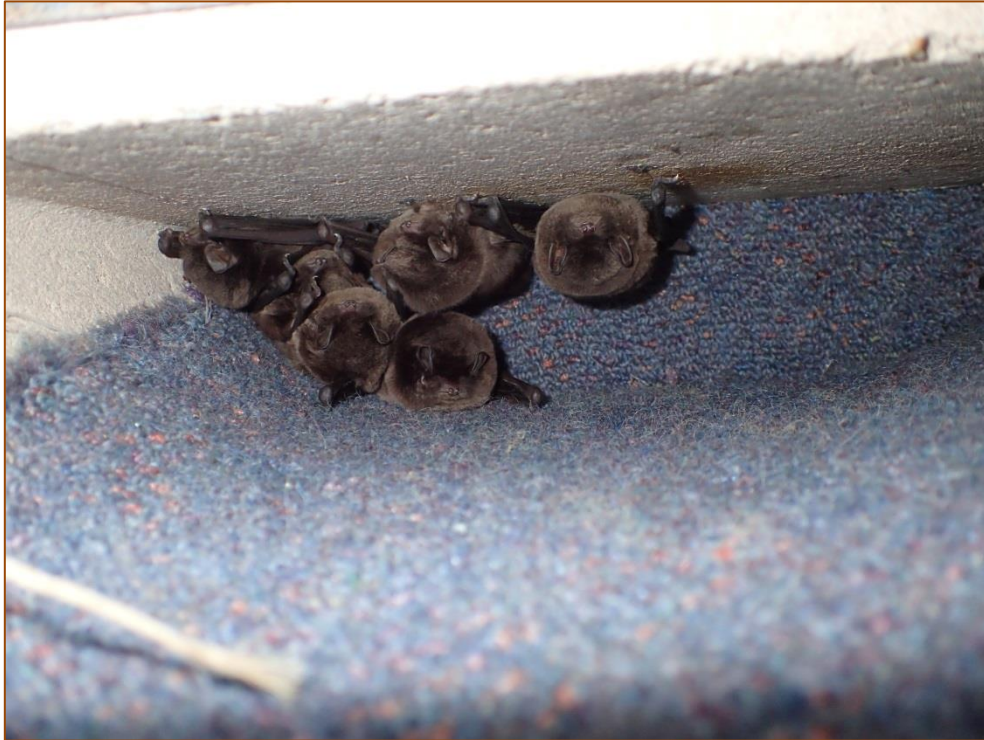
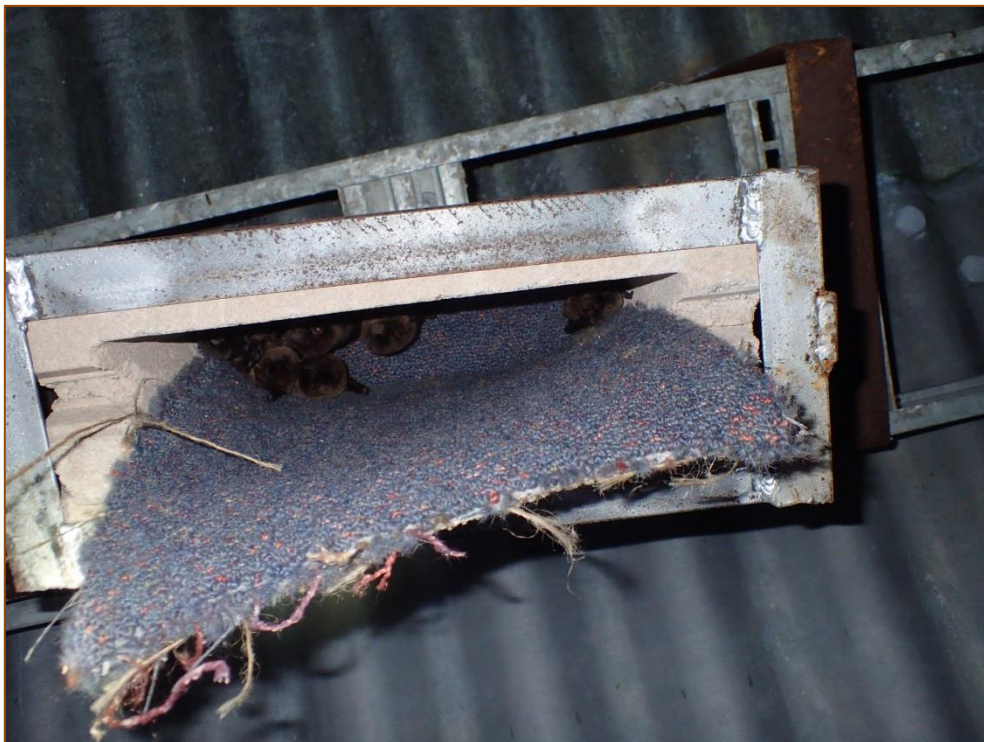
Results from Tunnel 3 – 22nd July 2017 – fourteen Eastern Bentwing bats found roosting in the concrete artificial habitat blocks with carpet, some were also on the steel wall, did not disturb. They also appear to be increasingly using the artificial habitat created in Tunnel 3 for overwintering

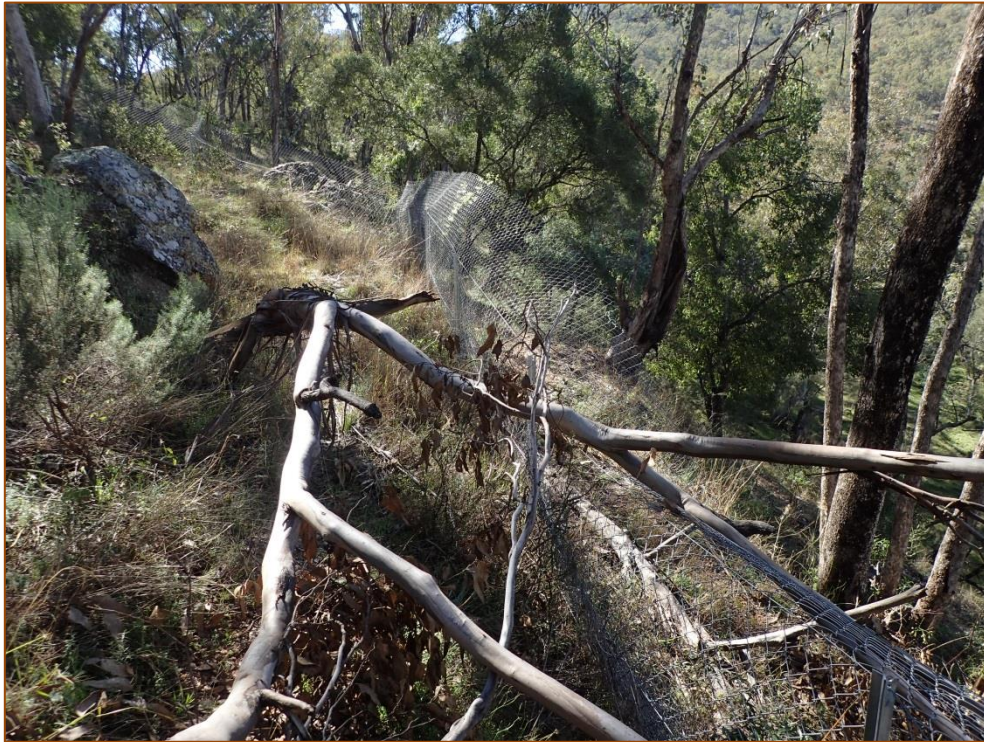
Fence security must be maintained as shown below by a limb over the fence at Barney Bernato repaired in July 2017

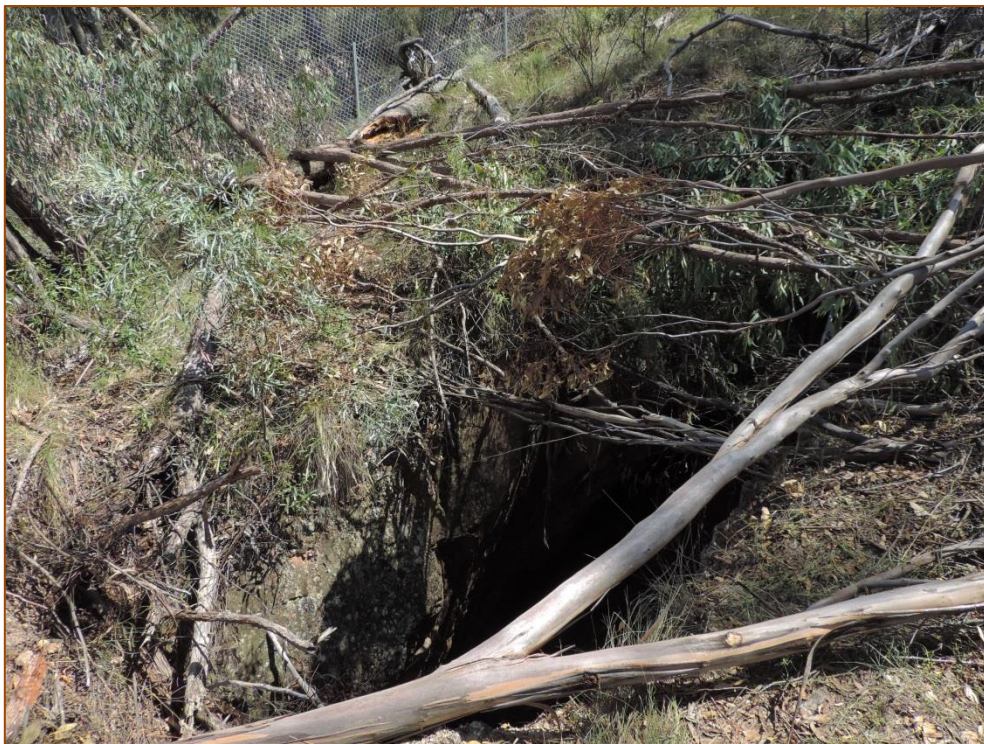
Flyway access into mine shaft entrances must also be maintained by removing limbs

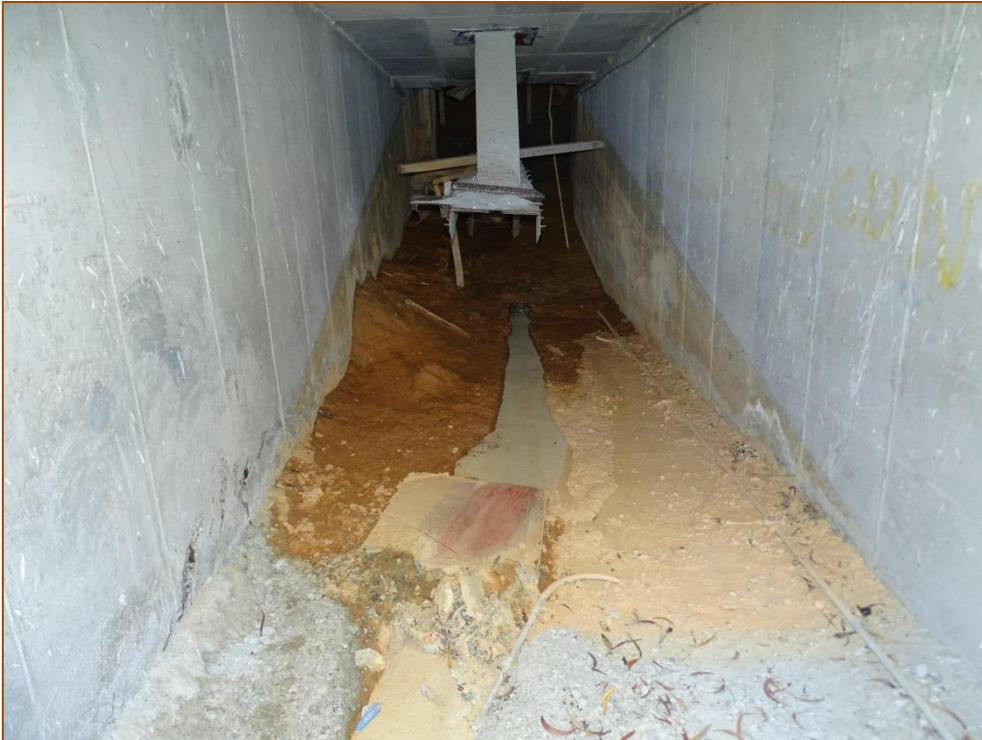
Water flooding into Tunnels must be prevented, you can see by the water mark on the walls of Tunnel 2 that water completely filled the tunnel, it could wipe out a breeding event

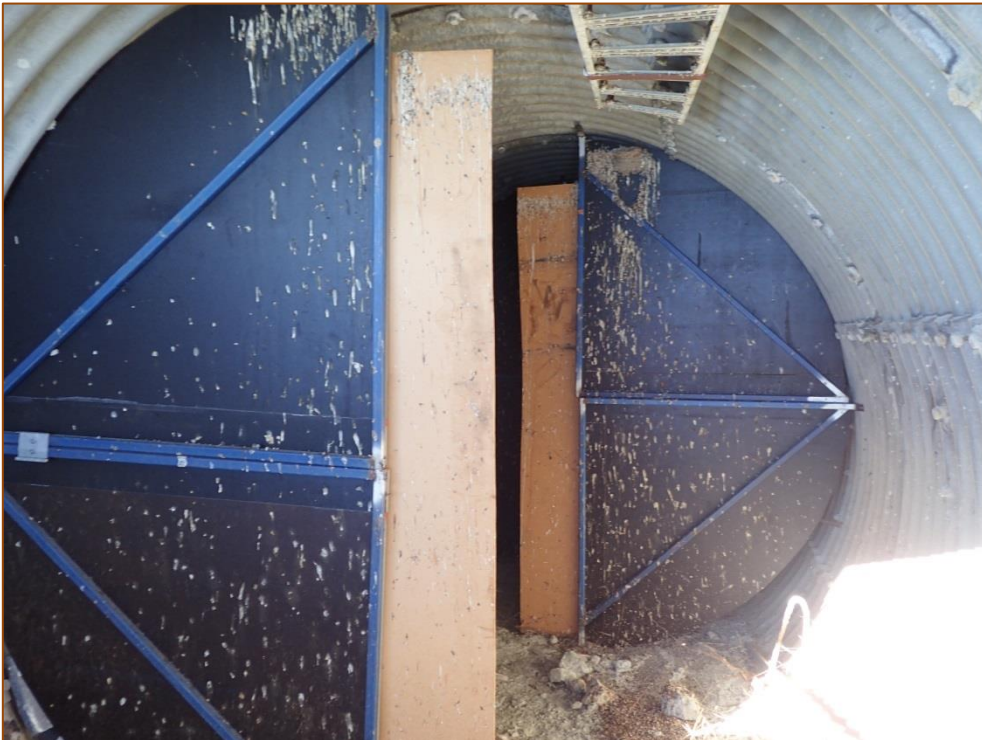
The baffles in Tunnels 1 and 3 must be maintained to limit light and control temperature

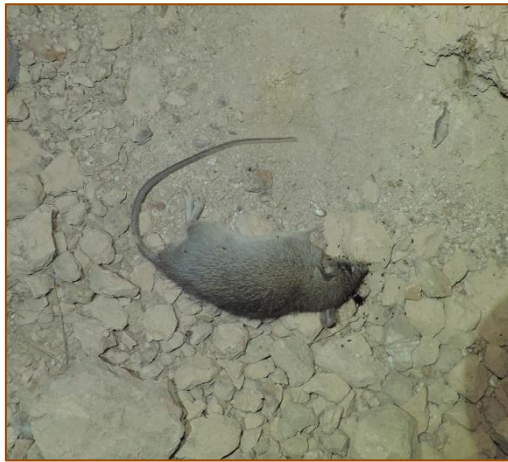
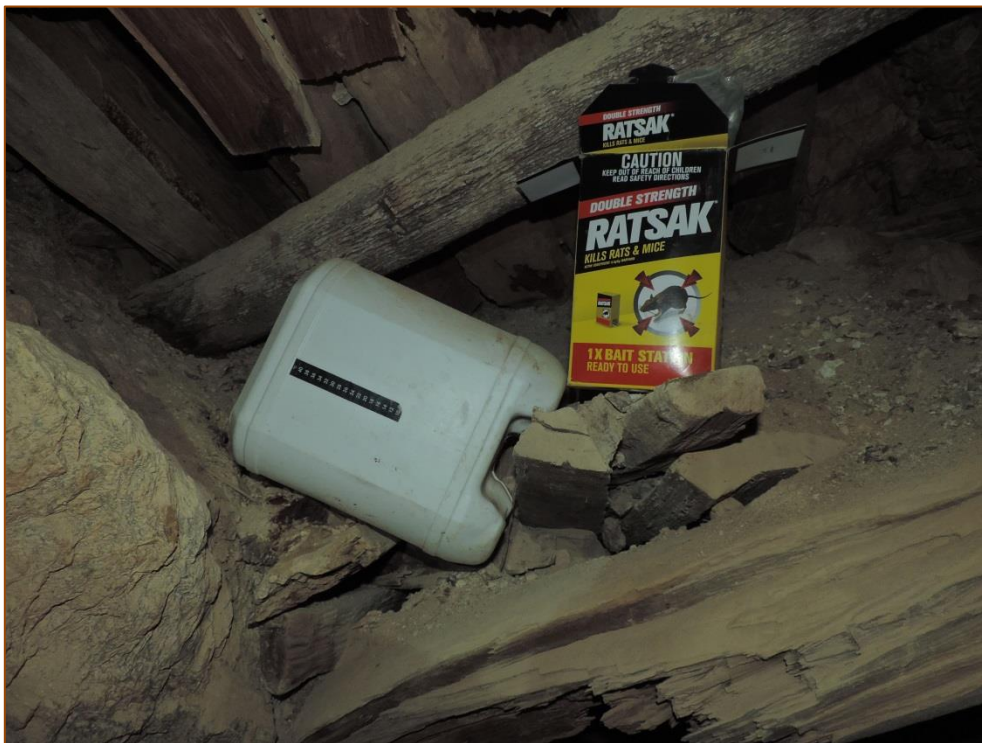
Rat baiting should be maintained by topping up containers that only rats can enter
