# WEEKLY INCIDENT SUMMARY

Week ending Friday 25 March 2022

This incident summary provides information on reportable incidents and safety advice for the NSW mining industry. To report an incident to the NSW Resources Regulator: phone 1300 814 609 24 hours a day, 7 days a week.

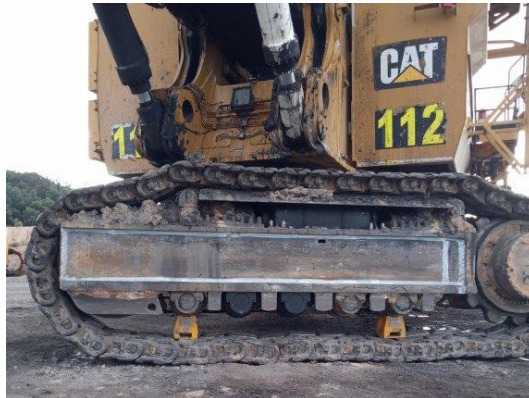
INCIDENT TYPE	SUMMARY	COMMENTS TO INDUSTRY
Dangerous incident IncNot0041896 Open cut coal	A hydraulic shovel was set up to change rollers. Two stands were put in position to support the shovel. Additional repair works to the bucket were then identified which required the shovel to be moved. While repositioning the bucket, the shovel became unbalanced and slid off the support stands. The stands were pushed into two load rollers, breaking their mounting bolts and causing them to become dislodged.	When a machine is sitting on support stands and must be operated, a risk assessment should be conducted and additional controls required put in place prior to proceeding. When planning multiple maintenance tasks on a piece of equipment, risk assessments must be undertaken to ensure that workers carrying out one task do not introduce risks to workers undertaking other tasks.

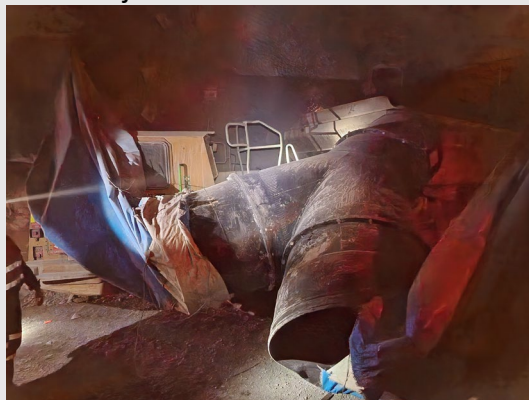
Dangerous incident  
IncNot0041898  
Underground  
metals

A haul truck was travelling on a decline and pulled into a return air drive to allow another vehicle to pass.

The truck struck a poly Y coupling on the ventilation ducting, tearing the duct, which resulted in a large amount of dust being stirred up.

As the operator exited the haul truck, the poly coupling, weighing approximately 200 kg, fell from the headboard of the truck and struck the operator. The operator was knocked to the ground but was uninjured.

When developing control measures to manage the risks of roads or other vehicle operating areas, the interaction between mobile plant and fixed structures must be considered. This includes overhead ventilation ducting and accessories. Factors to consider include:

- roadway height and width
- load height and width
- location of services suspended from the roof
- loss of clearance due to additional material on roadways.

Mine operators and suppliers should review how services such as ventilation Y couplings are hung and supported.

Mine supervisors should conduct frequent physical inspections of mine roadways to ensure there is adequate clearance for plant to operate.

Equipment operators must remain alert to operating heights and clearances around their vehicle.
