# WEEKLY INCIDENT SUMMARY

Week ending Friday 3 June 2022

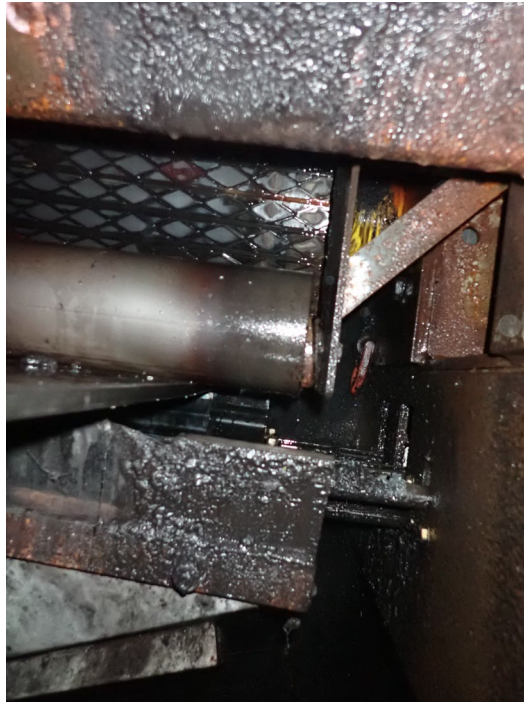
A flame was observed on a flat return roller at the jib of a longwall drivehead and was extinguished immediately. The high reliability flat return roller was found to have an extra 30 mm of shims in the adjustment bracket that increased the load on the roller leading to a premature bearing failure.	Workers must be provided with suitable information to install infrastructure to meet the engineered design. Workers must follow this information to ensure the safe installation of fixed plant. Workers conducting conveyor inspections must be aware of the increased risk of roller failure at high tension areas of conveyors.

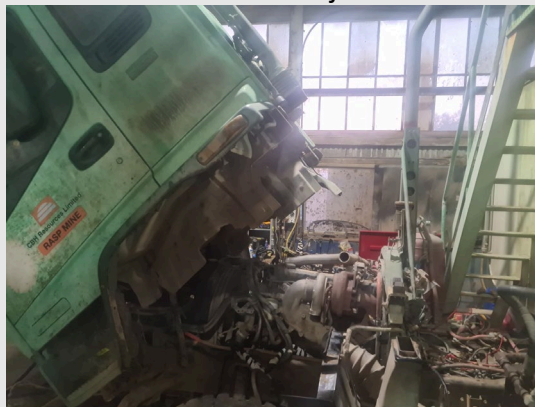
A fitter was working on a truck while the cab was tilted forward. While working, the fitter bumped the stay, allowing the cab to fall on him. Another worker helped free the fitter from under the cab. The fitter was not injured.

When working under a tilted cab or tray, the support stay must be secured to protect workers from being trapped, pinned or crushed. Stays require a two-step action to ensure they are adequately protected from inadvertent release.
