SAFETY ALERT

Worker swims to shore after pontoon pump and boat sink

This safety alert provides safety advice for the NSW mining industry.

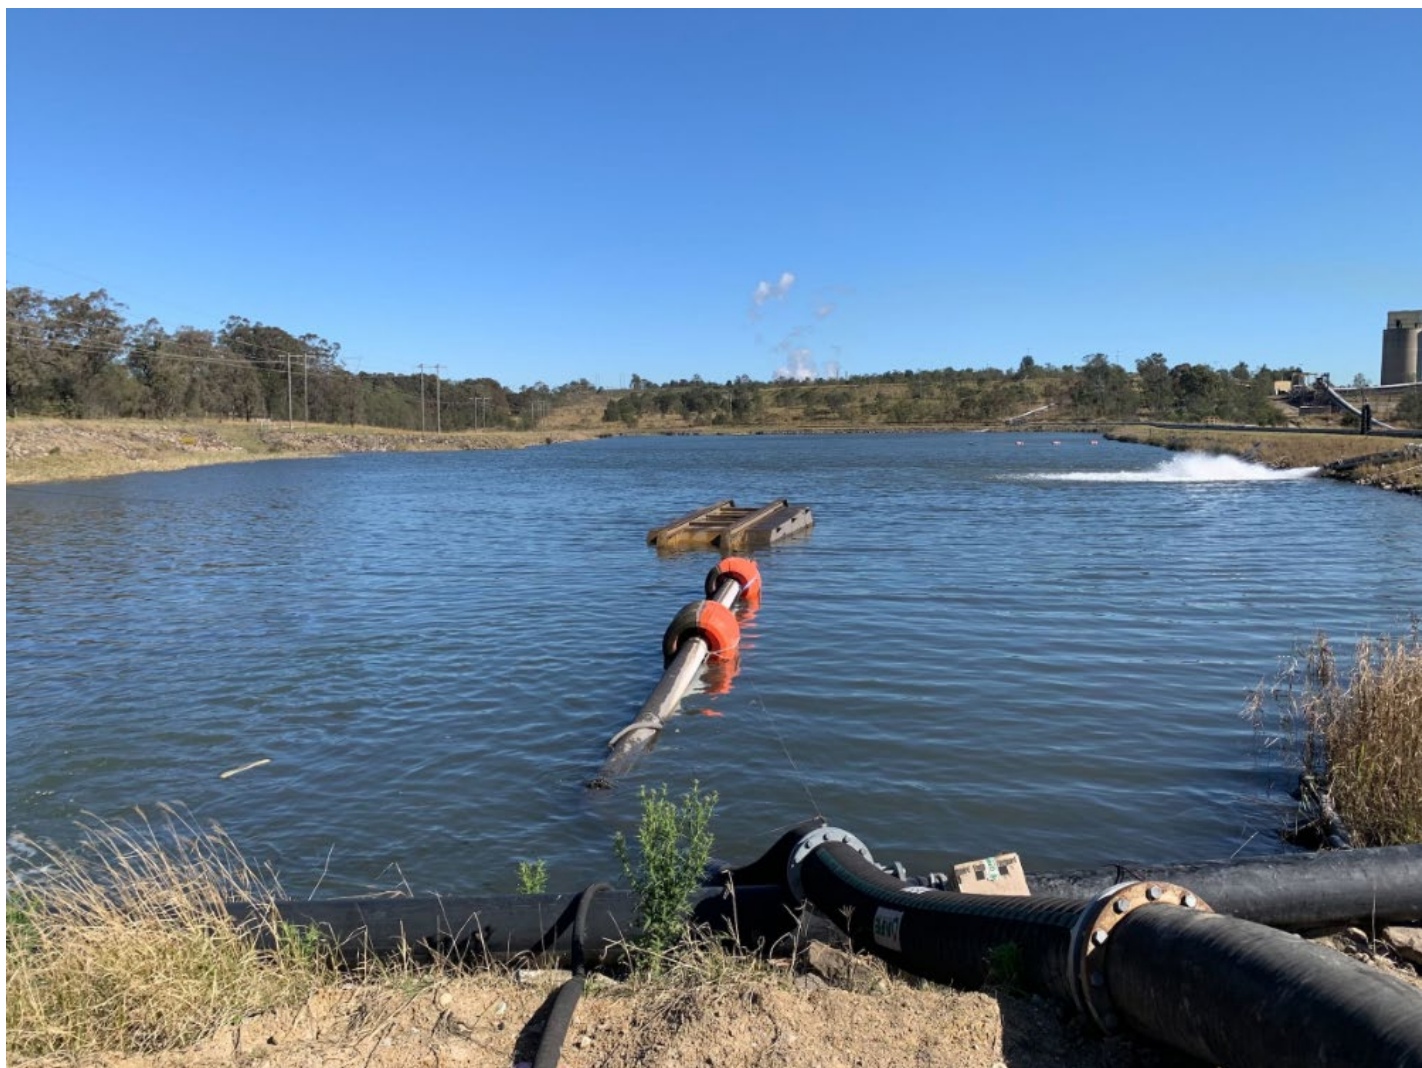
The subsequent change in the centre of gravity of the whole unit caused the pontoon to overbalance and overturn.

Within minutes, the worker noticed the pontoon tilt and jumped in the water to swim 30 m to the bank. As he swam, the pontoon overturned, dragging the boat under the water with it. The worker was not injured.

Figure 1 Pontoon on the dam after the incident

- verify awareness of the roles and responsibilities for maintaining compliance to their site's standards for working on or near water.
- review the use of work authorisation standards.
- review safe work systems for this type of task considering:
 - the requirement for wearing flotation devices on pontoons
 - the requirement for a spotter while undertaking maintenance activities on water
 - emergency response capability around water
 - and the suitability of boats for transporting workers, and equipment.
- consider building a jetty for long-term access to pumps on dams.

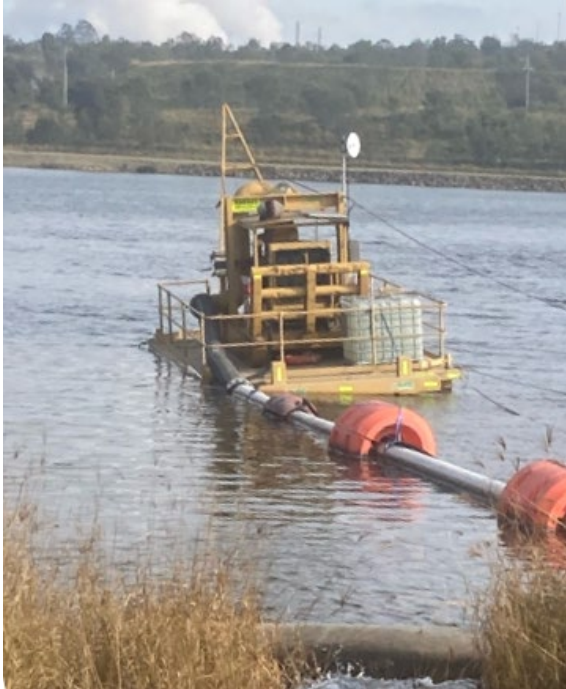
The worker used a boat to access the pontoon. The pontoon and pump configuration had a dry weight of about 15.7 tonnes and a wet weight (fuel/water in pump line) of about 17 tonnes. The pontoon had a cube container filled with water on one side as a ballast control.

Figure 2 Pontoon on the dam before the incident
