# Weekly incident summary

## Week ending Friday 21 October 2022

This incident summary provides information on reportable incidents and safety advice for the NSW mining industry. To report an incident to the NSW Resources Regulator: phone 1300 814 609 24 hours a day, 7 days a week.

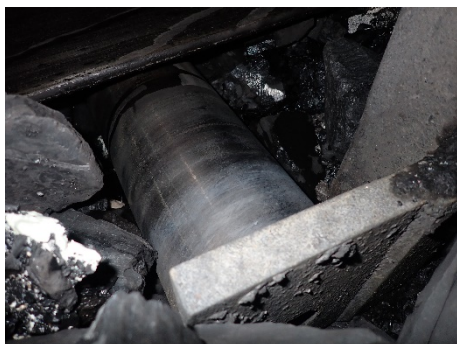
Incident type	Summary	Comments to industry
Dangerous incident IncNot0043240 Underground coal mine Fire or explosion	A small fire occurred at the outbye end of a longwall bootend. Workers on the face smelled smoke and found a flame about 100 mm in height. The fire was on a fist-size lump of coal.	When defects exist on equipment, additional controls should be put in place to manage any increase in risk until repairs can be completed.  Mines should review the adequacy of conveyor and strata inspections conducted of the off-walk side of conveyors.

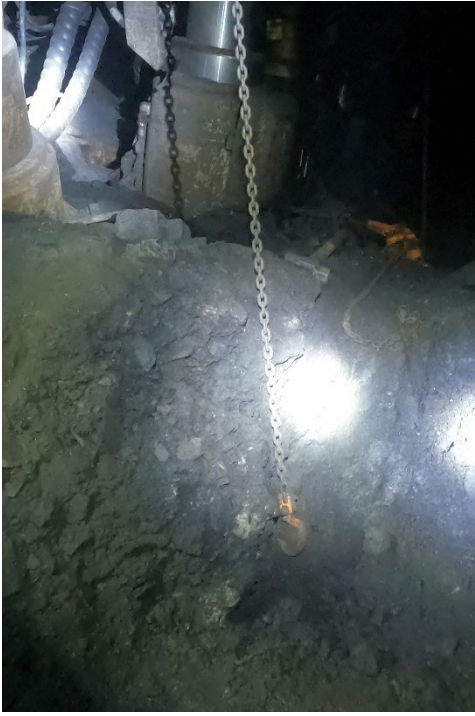
Incident type	Summary	Comments to industry
<p>Dangerous incident IncNot0043253 Underground coal mine</p>	<p>A mechanical tradesman was directed to separate the tailgate drive from 4 roof supports. A lever hoist chain was wrapped around the relay bar clevis pin to remove it.</p> <p>Load was applied to the lever hoist and then the tailgate drive moved with a heavy lift machine. The worker then applied additional load to the lever hoist.</p> <p>The chain released from the pin and hit the worker in the face.</p>

<p>Refer to Safety Alert <a href="#">SA22-04 Dangers of lifting and pulling activities revealed</a></p>
<p>Dangerous incident IncNot0043262 Open cut coal mine</p>	<p>Several workers were preparing to remove a conveyor drive assembly (motor, gearbox and torque arm).</p> <p>An electrician was disconnecting the motor and another worker was removing the coupling covers.</p> <p>The worker proceeded to unbolt the coupling before the assembly was slung or supported. The unit rotated forward narrowly missing the workers.</p>	<p>Before removing components, procedures must include hold points when lifting or chocking must be in place to secure loads.</p> <p>Supervisors must confirm workers understand the tasks and steps required to safely complete tasks.</p> <p>Where multiple work groups are working in the same area, risk assessments must include the interaction between the work groups.</p>

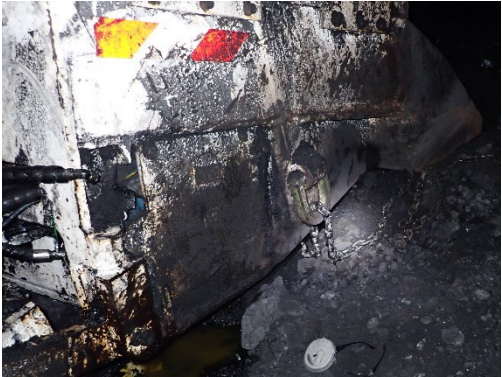
<p>Dangerous incident IncNot0043272 Underground coal mine</p>	<p>A continuous miner was being prepared to be trammed out of the panel for repairs to the shovel lift cylinder and clevis.</p> <p>Due to the damage, the shovel had to be supported from the cutter boom. The cutter boom was lowered and a 10 mm chain connected to RUD lugs on either side of the shovel.</p> <p>The miner driver powered up the miner and started the hydraulic pumps and moved to what he thought was a safe place, clear of the chain on that side of the miner.</p> <p>As the cutter boom was raised, the chain failed on the opposite side of the cutter boom and flung in an arc.</p> <p>The chain hit the worker on the face and shoulder. The worker required stitches to their cheek and neck.</p>

<p>Refer to Safety Alert <a href="#">SA2-04 Dangers of lifting and pulling activities revealed</a></p>
