Safety Bulletin

Date: December 2022

Fires on battery powered tools increase

Safety Bulletin SB22-17

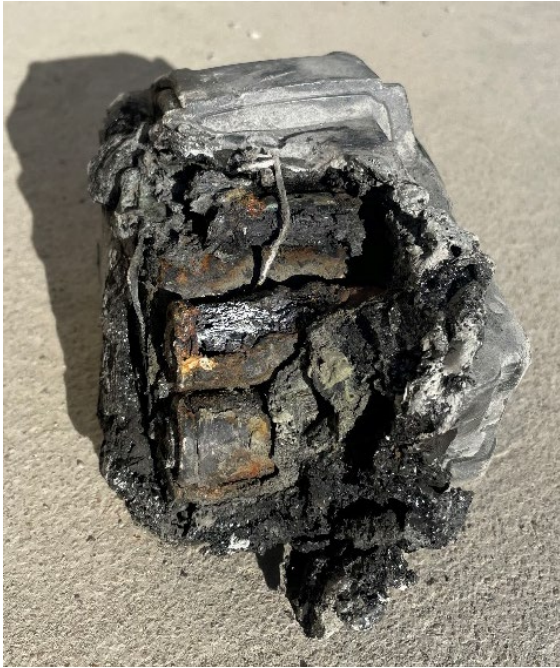
Figure 1 - Damage to battery after being run over

- Only use charging equipment recommended by the manufacturer for that particular battery.
- Ensure that transporting of spare batteries does not expose them to risk of physical damage or short circuit of the connecting pins.
- Do not expose batteries to water as this can cause a short circuit between the battery connections.
- Do not expose batteries to temperatures greater than 50°C, or as recommended by the manufacturer. It should be noted that temperatures inside a vehicle can be much greater than external ambient temperatures. For example, the internal temperature of a vehicle left with

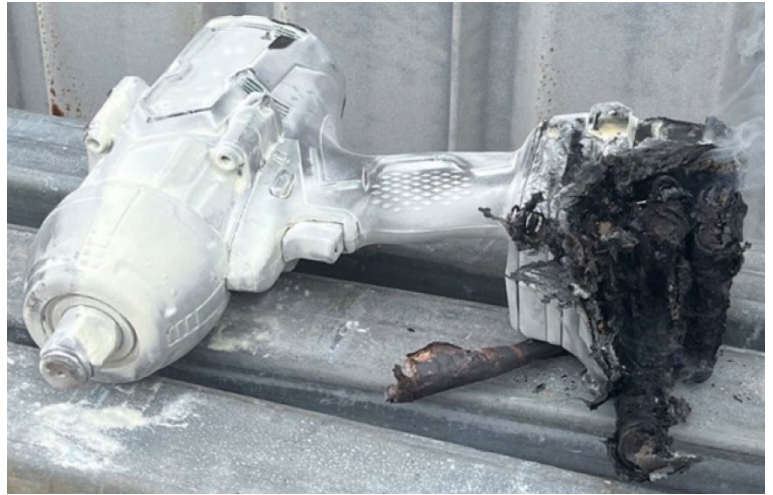
Figure 2 - Tool left unattended in vehicle

windows up with an ambient temperature of 35°C can reach 60°C in 60 minutes. The temperature in an open cut mine in full sun can be up to 10°C higher than surface temperatures. These factors need to be considered when transporting and storing batteries in vehicles regardless of whether they are attached to a tool.

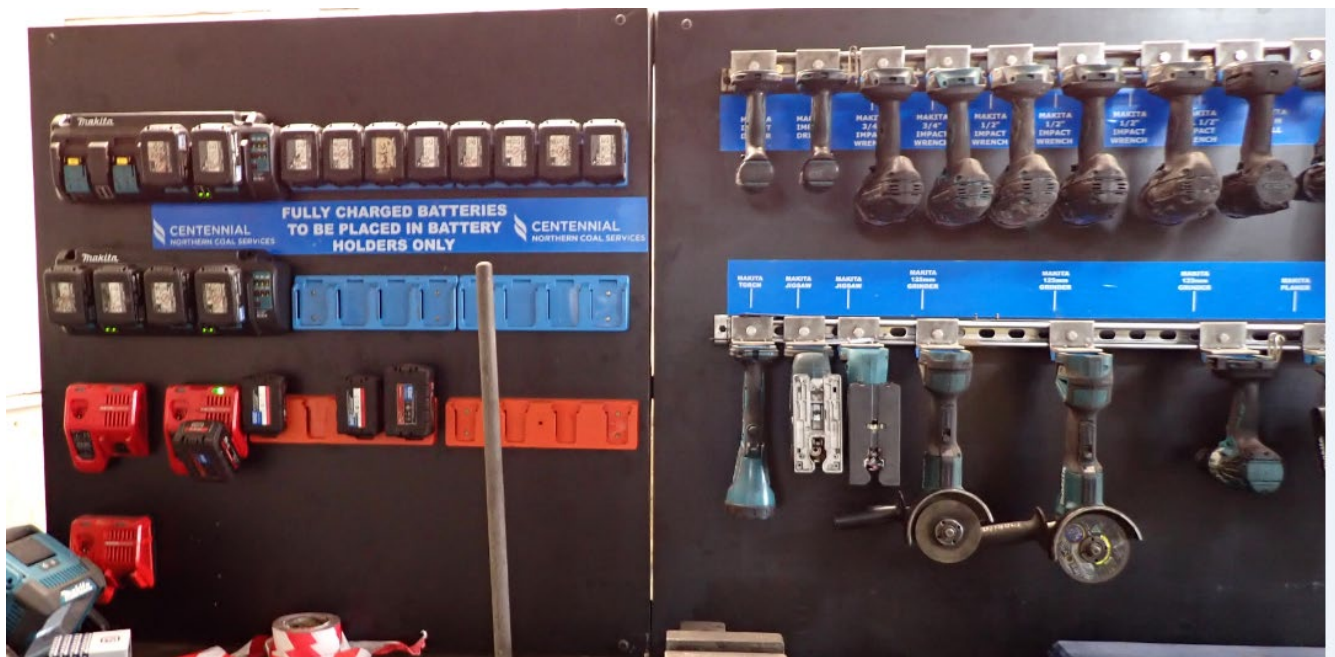
Figure 3 - Example of a well laid out charging station

- Follow manufacturers' safety instructions.
- Have systems in place for managing the use of lithium-ion batteries including tracking of where batteries are being used and who is in control of the batteries, pre-use inspections, regular maintenance inspections, and training of personnel in how to respond in event of emergencies.
