Weekly incident summary

Week ending 24 February 2023

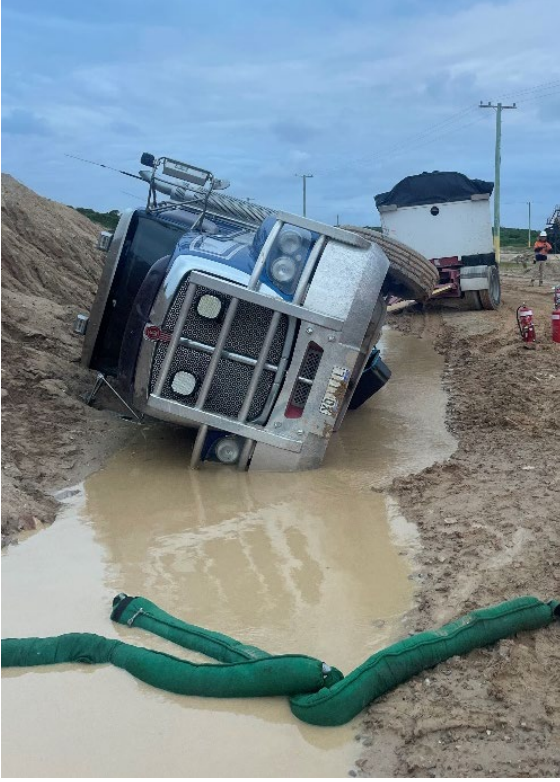
| Incident type | Summary | Comments to industry |
|--|---|---|
| Dangerous incident IncNot0044140 Construction materials Roads or other vehicle operating areas | A truck and dog were loaded and leaving a quarry on a single lane road. Another truck had stopped on the road, so the first truck tried to drive around it, leaving the roadway. The truck drove into a drain and slipped, rolling onto its side. The driver was unable to climb out of the truck. Emergency services were called to help the driver to exit the vehicle. The driver was not injured. | When operating vehicles and machinery, workers must follow procedures related to roads and other vehicle operating areas, in this case, the worker should not have attempted to pass on a single lane road. Mine operators should review bunding and delineation of access roads. Control measures in place around sumps and drains near roads and vehicle operating areas should be reviewed. |

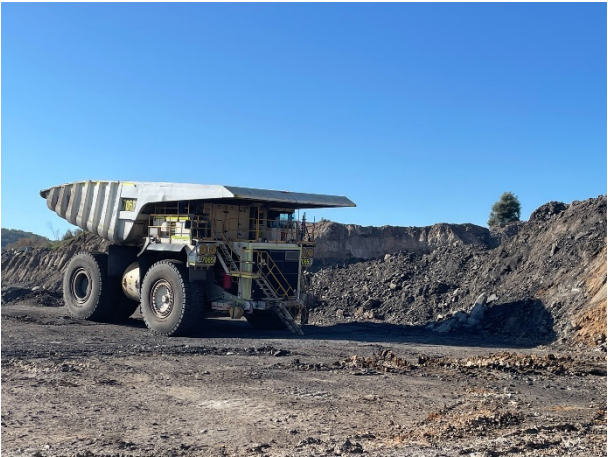
| Incident type | Summary | Comments to industry |
|---|---|--|
| <p data-bbox="124 1003 379 1205">Dangerous incident IncNot0044124 Open cut coal mine Roads or other vehicle operating areas</p> | <p data-bbox="424 1003 1034 1256">A dump truck was stationary in a queue for a digger when a ladder alarm sounded in the cabin. The operator contacted the workshop, and was directed to shut down the truck and isolate it. The operator applied the park brake and exited the cabin. A second alarm sounded and the operator sought further advice from the workshop, and was directed to isolate the truck.</p> <p data-bbox="424 1272 1034 1458">The operator reached the ground and once the truck was isolated, it began to roll forward. The operator then climbed back up the stairs, entered the cabin and applied the service brake, which needed to be held on with the park-brake activated.</p> | <p data-bbox="1059 1003 1449 1070">A safety alert will be published regarding this incident.</p> |
