Weekly incident summary

Week ending 19 May 2023

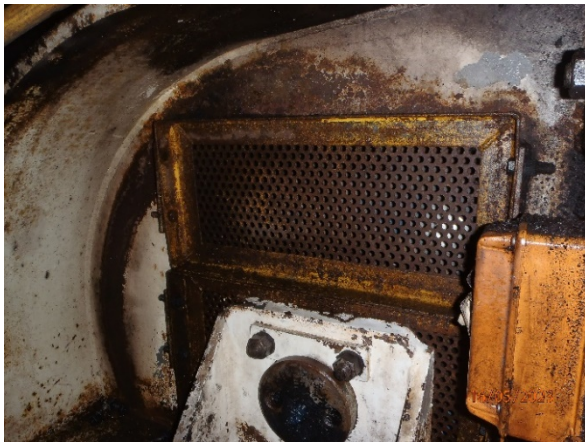
Picture 1: original guarding

Incident type	Summary	Comments to industry
Dangerous Incident IncNot0044684 Underground coal mine Fire or explosion	A crew was driving into a mine and noticed smoke while passing a transfer. Smouldering coal was found behind the guard of the boot end. The crew stopped the belt, removed the guard and started hosing down. The conveyor was restarted to wash out additional material. The conveyor was stopped and the area cooled and the scene was preserved. A fire watch was put in place.	Mine operators should review transfers and boot ends for areas where coal fines and spillage could accumulate. Guards should be designed for ease of inspection and cleaning.

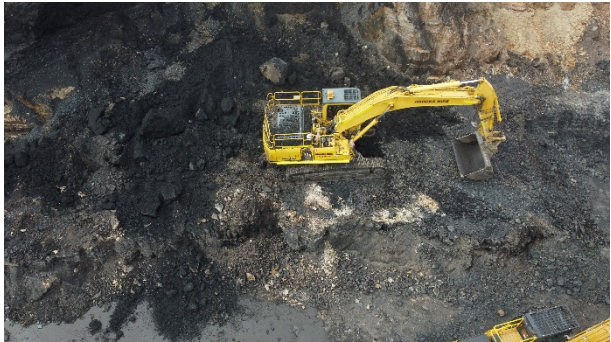
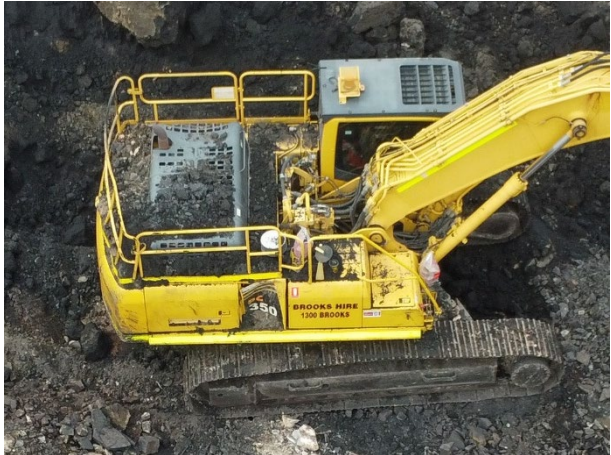
<p data-bbox="124 712 373 920"> Dangerous Incident IncNot0044701 Open cut coal mine Ground or strata failure </p>

<p data-bbox="416 712 1029 936"> An excavator was being used to dig out a sediment dam. The bench above the excavator let go, releasing about 20 tonnes of consolidated fines onto the excavator. The operator was able to tram the excavator clear of the material and was not injured. The task was being carried out under a generic procedure. </p>

<p data-bbox="1050 712 1465 875"> When working under benches and walls, a safe stand-off distance should be defined, communicated with workers and maintained throughout the task. </p> <p data-bbox="1050 887 1465 1010"> Supervisors should increase the frequency of inspections when workers are conducting tasks near benches. </p> <p data-bbox="1050 1025 1465 1149"> Specific task risk assessments and procedures should be used and include assessment of the work environment. </p>
