Review of Environmental Factors

Mallee Bull Exploration Project

RWCorkery&co

February 2023

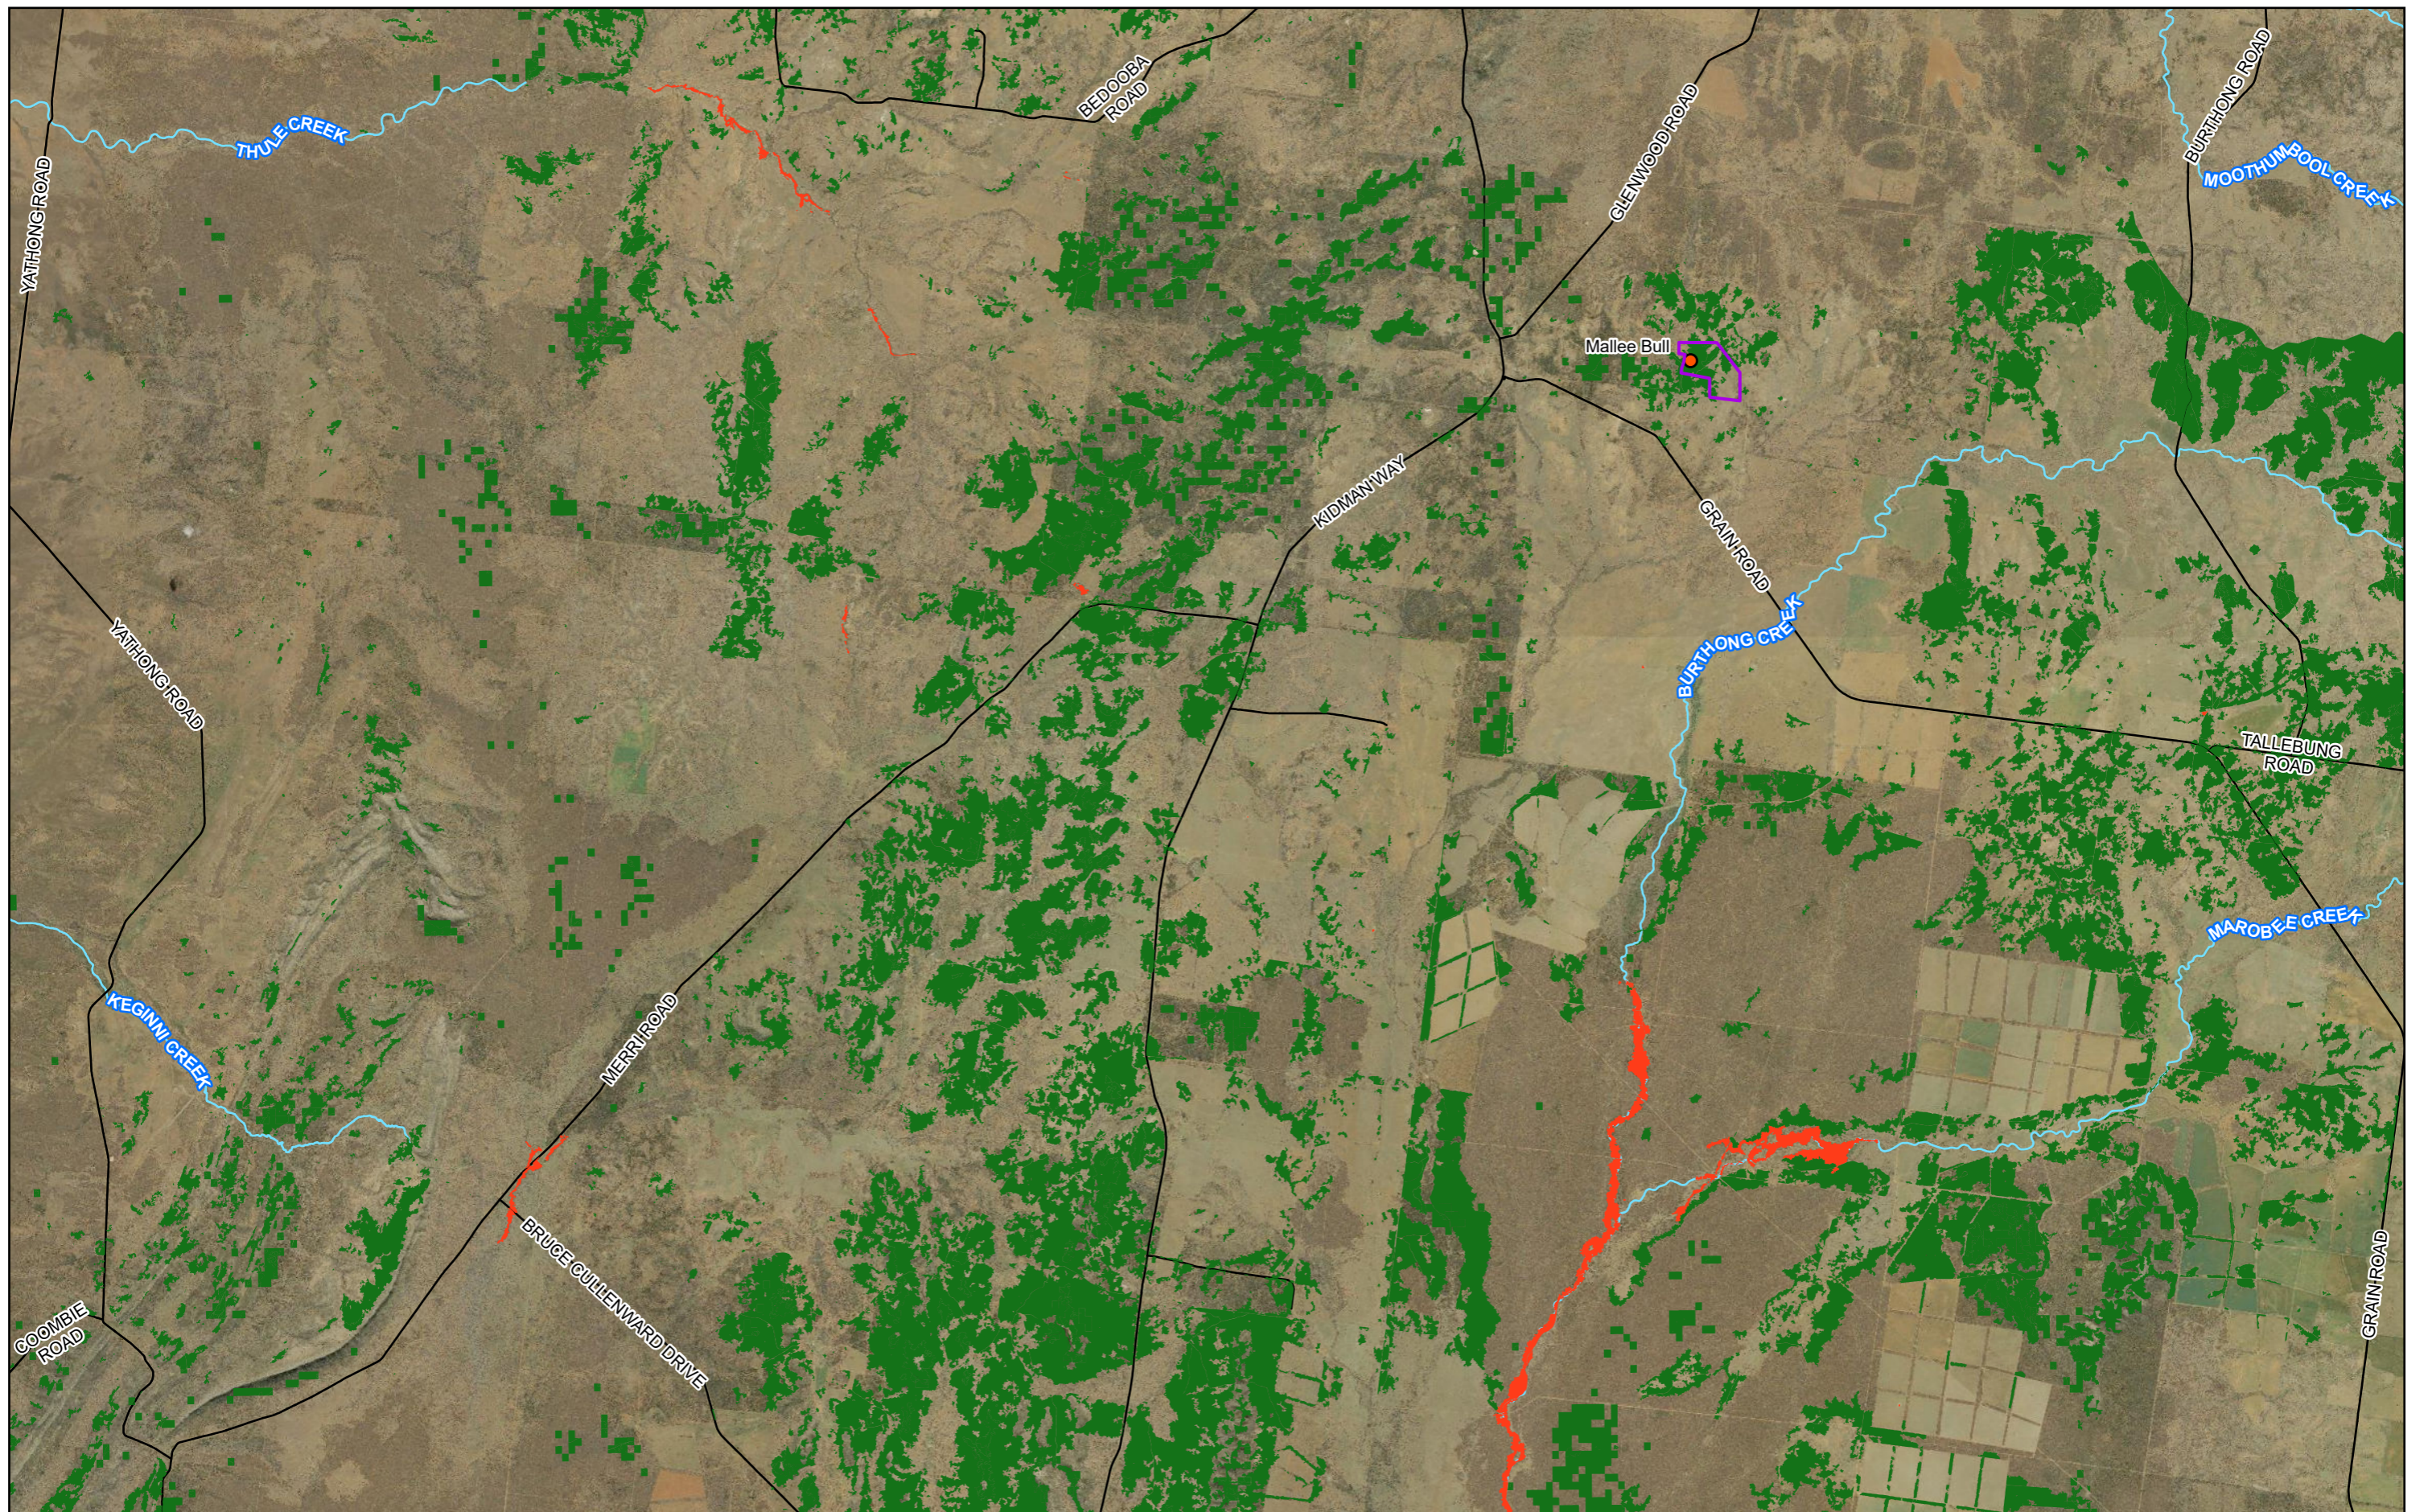
FIGURE 3-9

Identified potential terrestrial GDEs are shown in Figure 3-9. It is considered unlikely that these aquatic and vegetative communities are GDEs given the deep water levels identified at Mallee Bull.

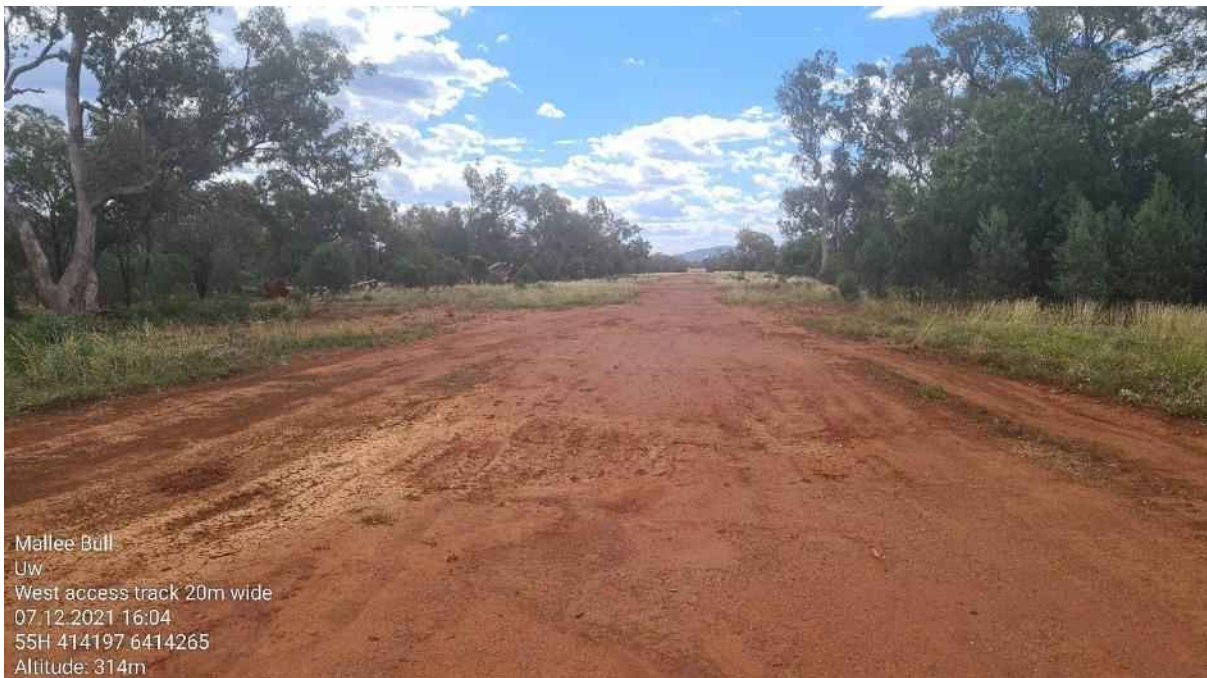
Photo 1: Existing western site access road

The southern access road is an existing road which will be used for light vehicles only. See Photo 3. The location of these excluded impacts are shown on Figure 7.

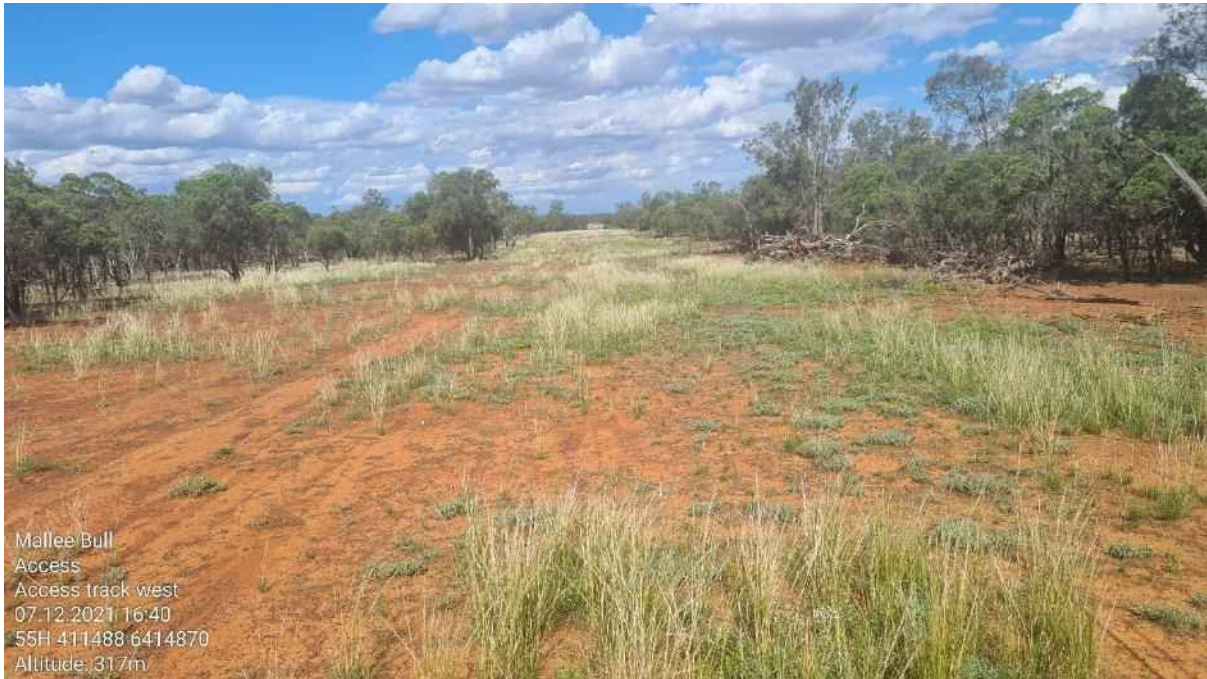
Photo 2: Existing western site access road

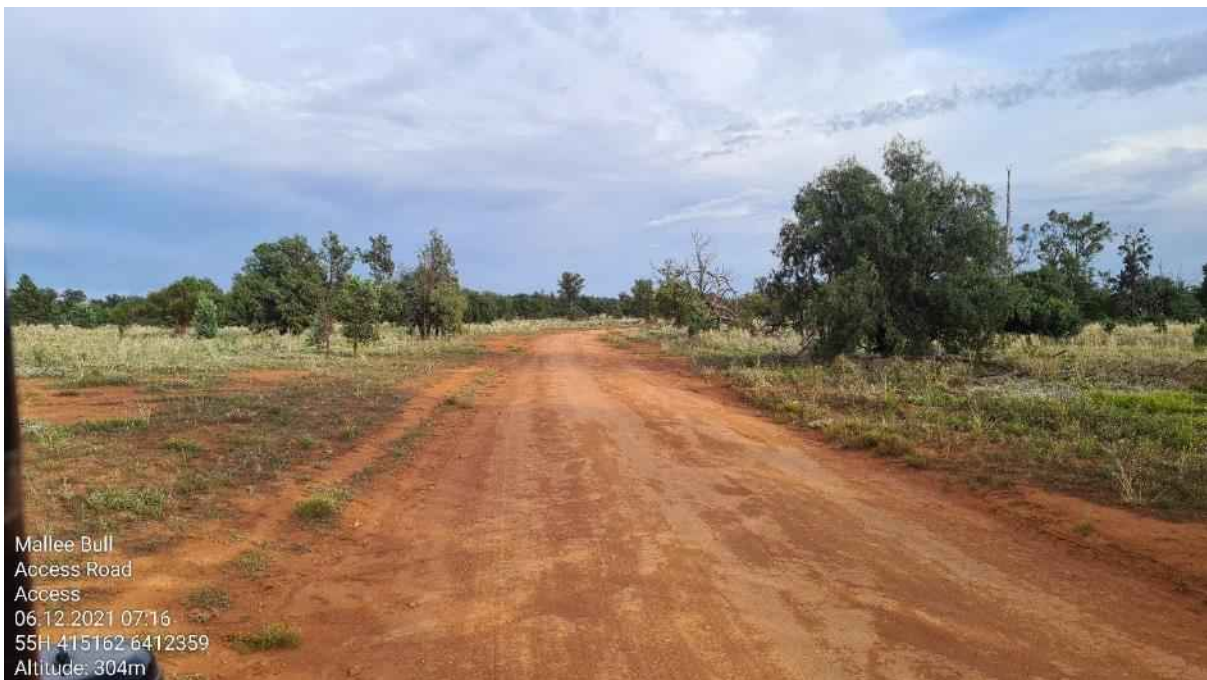
Photo 3: Existing southern site access road

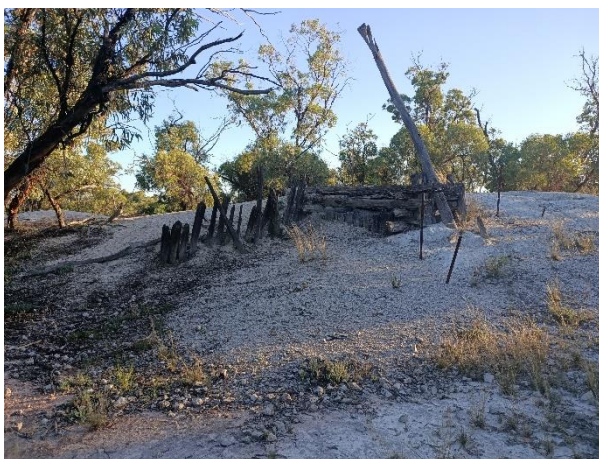
Figure 5-5: Mine shaft from historic Four Mile Mine

Survey unit 2 (SU2) is comprised of the western section of the study area and measures 75.9 ha in area. SU2 is highly disturbed as evidenced by mine shafts from the 1800s Historic Four Mile Mine, historical clearing, modern exploration drilling and unsealed tracks (Figure 5-5 to Figure 5-8). SU2 is within a flat landform context and is comprised of Bimble Box grassy woodland, White Cypress Pine, Gum-barked Coolabah trees and native grasses (Figure 5-9). GSV within the survey unit is low (20%) due to the dense grass, however large exposures were observed within the survey unit (Figure 5-6).

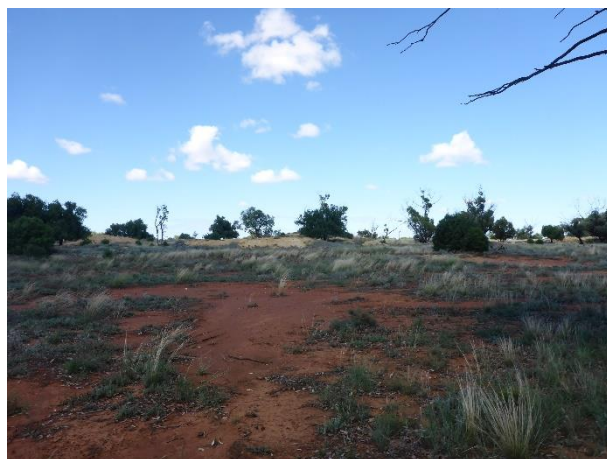
Figure 5-6: View south across the southern section of SU2 showing topsoil stockpiles from historic Four Mile Mine shaft

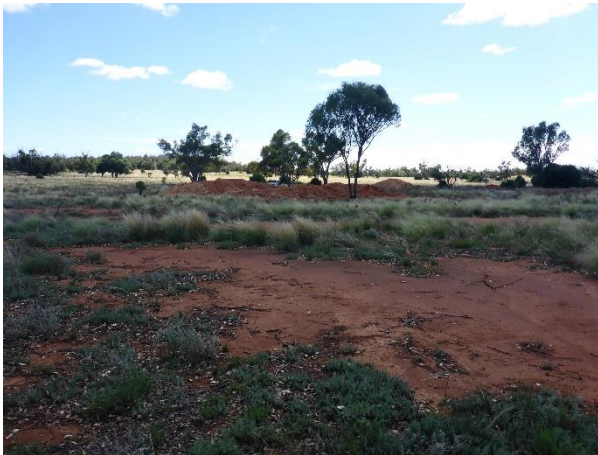
Figure 5-7: Example of disturbance from exploration drilling

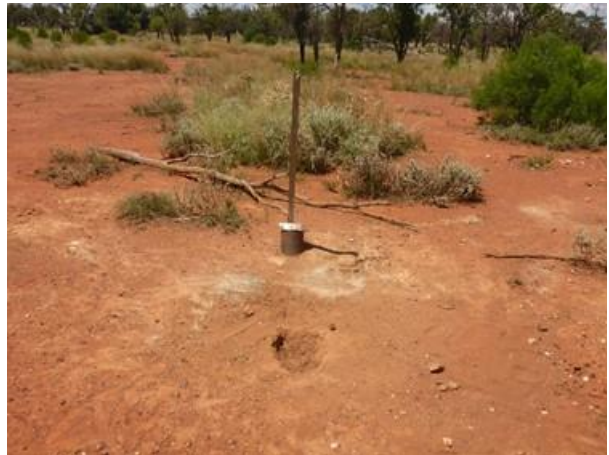
Figure 5-8: Evidence of exploration drilling collars

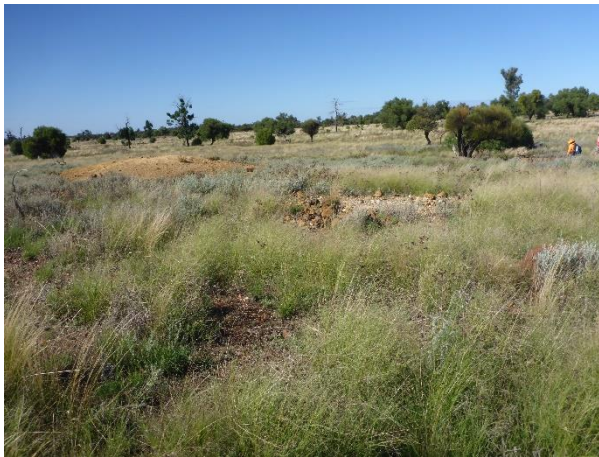
Figure 5-17: Evidence of mining and exploration drilling activities

Survey unit 4 (SU4) is the eastern section of the study area and measures 36.5 ha. The survey unit is within a gently undulating landform context that slopes gently downwards towards the southeast, with vegetation comprising of a Bimble Box grassy woodland (Figure 5-15) to the east surrounding several drainage lines, areas of dense native grass and sporadic White Cypress Pine (Figure 5-16). The southwest section of SU4 is heavily disturbed as evidenced by mining activities, clearing, and construction of unsealed tracks (Figure 5-17). GSV across SU4 was low (30%) with some exposures with high (90%) GSV.

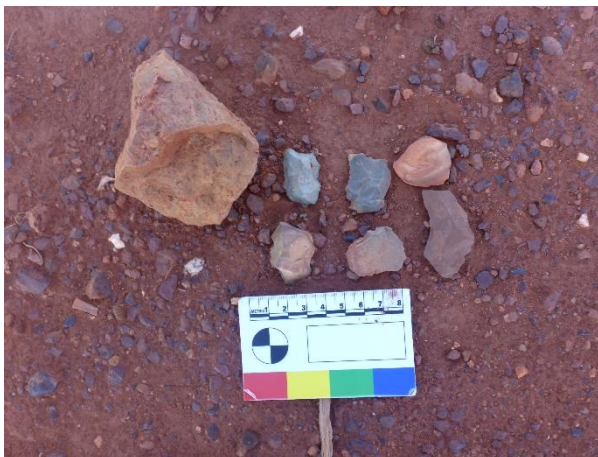
Figure 6-49: Artefacts observed within Mallee Bull AS09

Mallee Bull AS09 is located on a flat landform within a large exposure measuring 50m north to south and 35m east to west (Figure 6-163). The artefacts within the scatter are comprised of 12 chert flakes and cores some with retouch (Figure 6-47). A sandstone hammerstone or possible axe head was also observed within the scatter (Figure 6-48). The exposure extends across an unsealed access track. Vegetation within the exposure is sparse and included small tufts of native and introduced species of grass (Figure 6-50). Outside the exposure the vegetation is comprised of White Cypress Pine and grasses (Figure 6-51).

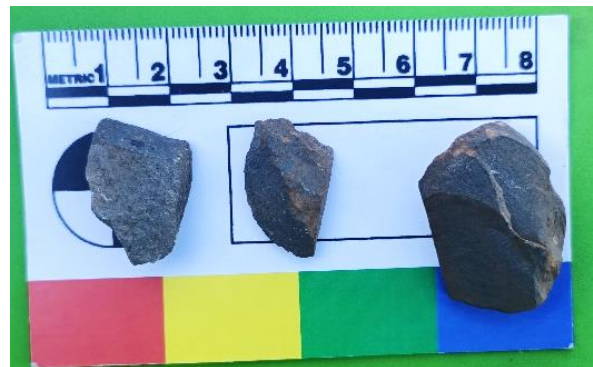
Figure 6-56: Close up of basalt fragments

Mallee BullAS10 is located on the south western side of an exposure 60m north of an unsealed access track in the central portion of the study area (Figure 6-162, Figure 6-53 to Figure 6-55). Three possible artefacts were observed in an area of high GSV (90%) and comprised of basalt (Figure 6-56).

The archaeologist determined these fragments are not Aboriginal objects but are crushed basalt/blue metal left behind by exploration drilling practices as definitive lithic attributes were not present. The stone pieces observed were recorded as an Aboriginal site by requested of the Ngemba, Ngiyampaa, Wangaaypuwan and Wayilwan Registered Native Title Claimants.

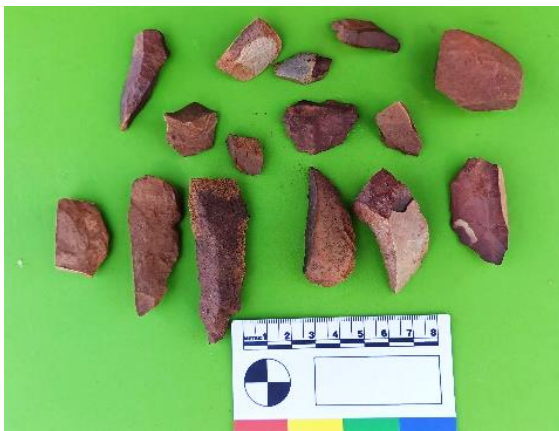
Figure 6-59: Example of artefacts recorded within Mallee Bull AS11

The Aboriginal site is comprised of a least eight stone artefacts of the same brown material, possibly indurated mudstone (Figure 6-59). Cortex was observed on the flakes, no backing or retouch was noted (Figure 6-60). Due to the dense grass outside the exposures, there is a potential for more artefacts. The likelihood of intact subsurface artefacts is low based on the landform and shallow thin deflated soils.

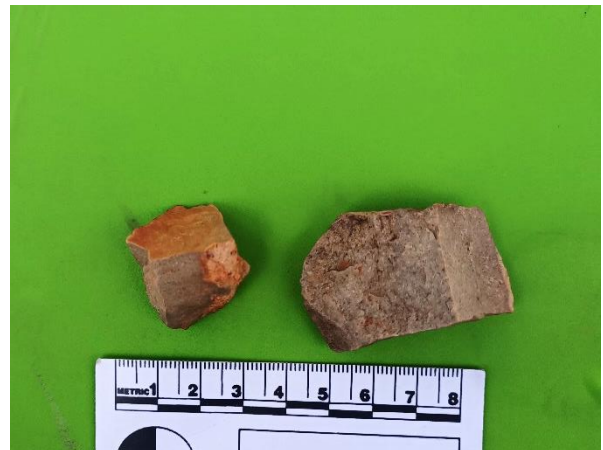
Figure 6-64: Artefacts recorded within Mallee Bull AS12

Mallee Bull AS12 is located within an exposure on flat landform context (Figure 6-165). The northern side of the exposure contains a Budda Bush (Figure 6-61 to Figure 6-63). This bush is used for men's business and smoking ceremonies (pers. Coms Peter Harris). The Aboriginal site contains two pale pink basalt artefacts, a flake and possible core (Figure 6-64).

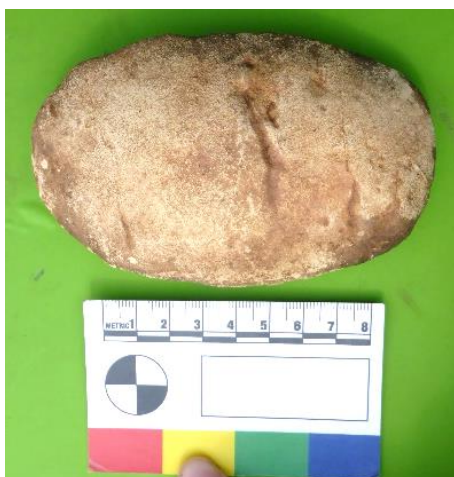
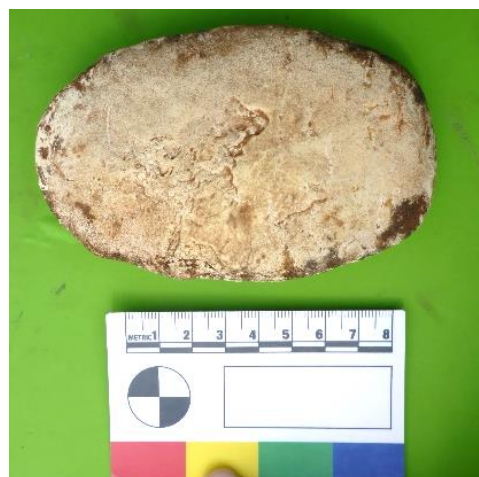
The artefact is likely an *arapia* (woodworking tool) made of white sandstone, it measures 11.5cm long, 7.5cm wide and 3cm thick (Figure 6-67 and Figure 6-68).

Figure 6-67: Dorsal side of Mallee Bull IF01

Figure 6-68: Ventral side of Mallee Bull IF01

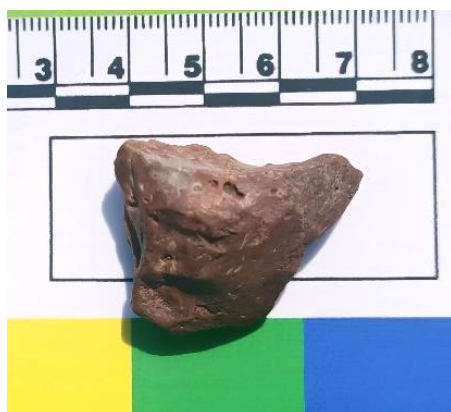
Figure 6-75: Flake observed within Mallee Bull IF03

Mallee Bull IF03 is located in the eastern portion of the study area and approximately 500m northeast of Mallee Bull AS05 (Figure 6-165). The site is located within a small exposure surrounded by dense native grass. Vegetation outside the exposure is comprised of young White Cypress Pine, Mallee trees, and grasses (Figure 6-73 and Figure 6-74). A flake was observed within the site (Figure 6-75). A rectangular block of white basalt was also observed approximately one metre south of the flake (Figure 6-76).

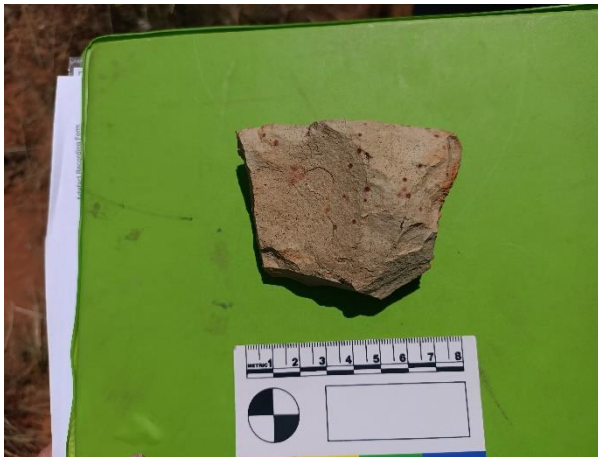
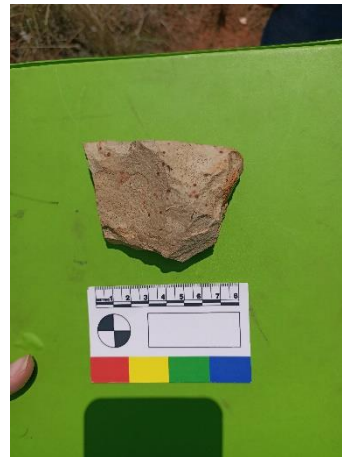
Mallee Bull IF04 is located on a small top slope in the southeast portion of the study area (Figure 6-165). This Aboriginal site is located within an exposure with high GSV (90%) and several Warrior Bushes were surrounding the site (Figure 6-77 and Figure 6-78). Soils were stone and shallow with fragments of sandstone protruding from the soil. The artefact is a large flake or possible core made of pale brown basalt (Figure 6-79 and Figure 6-80).

Figure 6-79: Flake or possible core within Mallee Bull IF04

Figure 6-80: Flake or possible core within Mallee Bull IF04

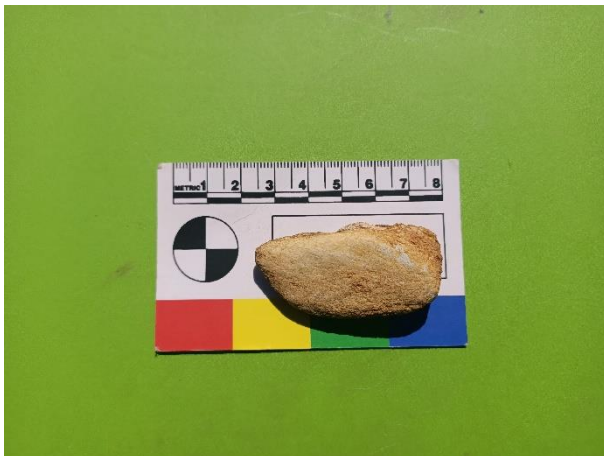
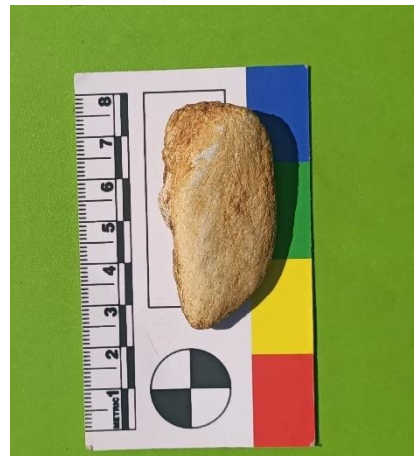
Mallee Bull IF05 is an isolated stone artefact located on a slight mid slope at the southern end of the study area (Figure 6-165). The site is within an exposure with high GSV (90%) surrounded by dense native grass and Saffron Thistles, GSV decreases outside Mallee Bull IF05 to less than 5%. The artefact is a degraded sandstone tool, possibly an *arapia*, a woodworking tool.

Figure 6-83: Dorsal side of Mallee Bull IF05

Figure 6-84: Ventral side of Mallee Bull IF05

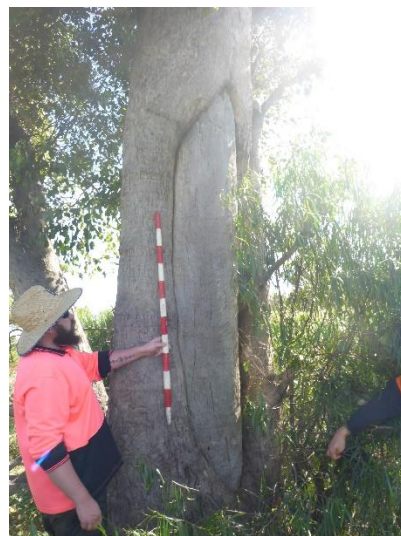
Figure 6-86: Close up of scar on Mallee Bull CMT01

Mallee Bull CMT01 is located within a grove of Bimble Box trees in the northeast section of the study area (Figures 6-163, Figure 6-85). It is within immediate proximity to Culturally Modified Trees 2,3,4,5 and 6. The scar is located on the southern face of a large Bimble Box tree and measures 2.5 m long by 0.7 m wide and with 0.55 m of regrowth (Figure 6-86). The scar is 55 cm above the ground level and contains axe marks, possibly stone, in a horizontal linear dash pattern not unlike ring barking across the top and bottom of the scar face (Figure 6-87 and Figure 6-88).

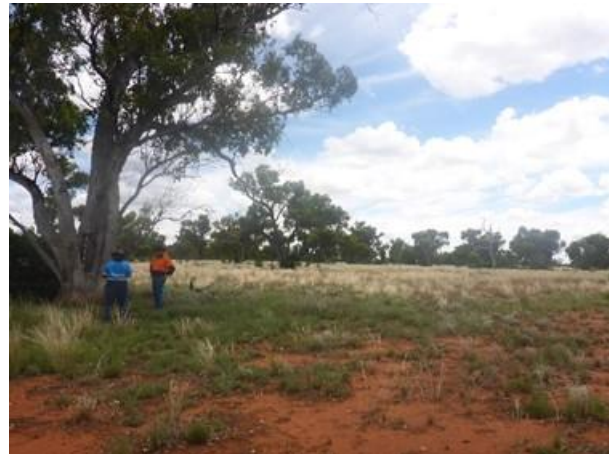
Figure 6-130: Scar located of the central trunk of the tree

Mallee Bull CMT 15 is located 15m south of the eastern end of the proposed haul road, a second unsealed track is located approximately 10m south of this site (Figure 6-162, Figure 6-130). The scar is located on the western side of the mature Bimble box with multiple trunks. The scar measures 1.75 m long, 0.8 m wide and with 0.9 cm of regrowth. Vegetation surrounding the site includes Ironbark, Bimble Box, White Cypress Pine, and small shrubs and grasses (Figure 6-131).

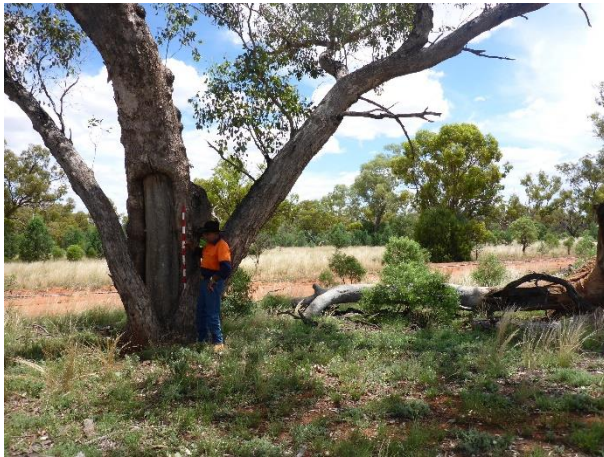
Figure 6-134: Close up of the scar on Mallee Bull CMT 16

Mallee Bull CMT 16 is located 20m south of the eastern end of the proposed haul road, a second unsealed track is located approximately 10m south of the site (Figure 6-161). The site is located approximately 30 m west of Mallee Bull CMT 15 (Figure 6-132). Mallee Bull CMT 16 contains a single large scar on the main trunk of a mature living Bimble Box, the other trunks are epicormic growth from the scar. The scar is on the northeast side of the tree, is rectangular in shape and measures 2.0m long, 0.67m wide, and with 0.15m of regrowth (Figure 6-133). The size of the scar suggests that the bark would have been used as a shelter. Given the location of the tree near historic mining activity in the 1800s, it cannot be determined if the scaring was historic or prehistoric. In this instance the precautionary principle has been applied where it is assumed as Aboriginal in origin. Vegetation surrounding the site includes Ironbark, Bimble Box, White Cypress Pine, and small shrubs and grasses (Figure 6-134).

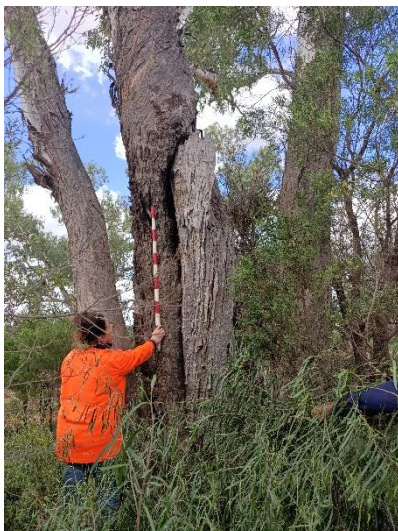
Figure 6-138: eastern side of Mallee Bull CMT 17

Mallee Bull CMT 17 is located 13 m north of proposed haul road and unsealed track at the western edge of the study area (Figure 6-162, Figure 6-135). The area surrounding the site is flat with vegetation comprising of Gum-barked Coolabah, Ironbark, Wilga and other shrubs (Figure 6-136). The tree is large living Gum-barked Coolabah with the scar located on the main trunk. The other trunks are epicormic growth as a result of the scar. The scar is located on the south side of the tree and measures 3.1m long, 0.65m wide and with 0.25m of regrowth (Figure 6-137 and Figure 6-138). Due to the large size of the scar the bark was potentially used to construct a shelter. Given the location of the tree near historic mining activity in the 1800s, it cannot be determined if the scarring was historic or prehistoric. In this instance the precautionary principle has been applied where it is assumed as Aboriginal in origin. GSV within the site is low due to the leaf litter but increasing to the south and east where large exposures and unsealed tracks are present.

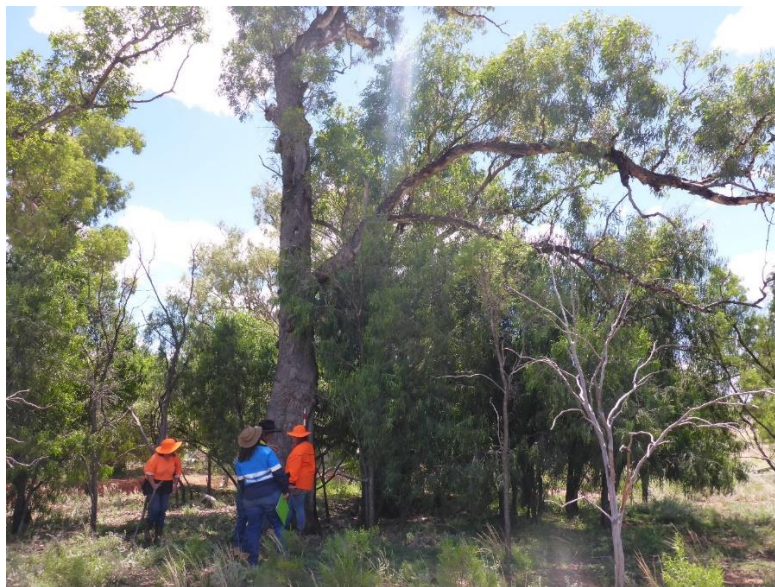
Figure 6-140: Top of the scar

Mallee Bull CMT 18 is located within a valley 10m east of a 1st Order drainage line and 30m west of an unsealed track that accesses the weather station for Mallee Bull (Figure 6-162, Figure 6-139). Within the drainage line is Mallee Bull AS 07 (Section 0). The tree is a tall Gum-barked Coolabah with the scar located on the eastern side (Figure 6-140). The scar measures 2.1m long, 0.5m wide and with 0.15m of regrowth (Figure 6-140 and Figure 6-141). The large size of the scar suggests that the bark would have been used for a shelter. Given the location of the tree near historic mining activity in the 1800s, it cannot be determined if the scaring was historic or prehistoric. In this instance the precautionary principle has been applied where it is assumed as Aboriginal in origin. Vegetation within the area is comprised of coolabah, wilga, and White Cypress Pine with an understory of small shrubs and grasses.

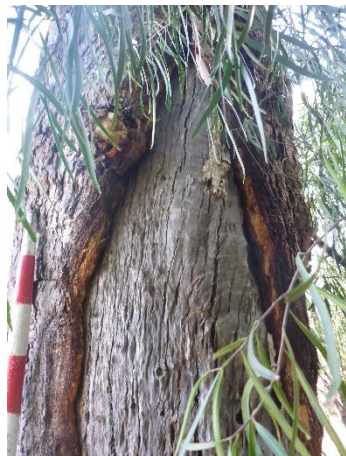
Figure 6-141: Bottom of the scar

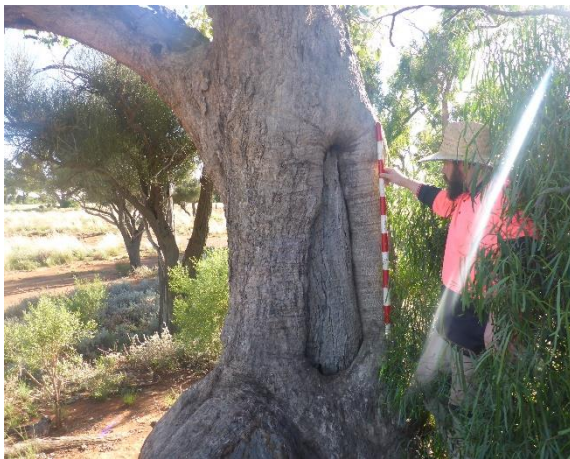
Figure 6-143: Close up of the scar on Mallee Bull CMT 19

Mallee Bull CMT 19 is located on a flat landform context within close proximity of a 1st Order drainage line (Figure 6-163). The scar is located on the southern side of an old growth living Bimble Box tree. The scar measures 1.2m long, 0.40m at its widest point and with 0.3m of regrowth. Vegetation surrounding the tree includes Warrior Bush, Mallee, Bimble Box with ground cover comprising of small native shrubs and grasses.

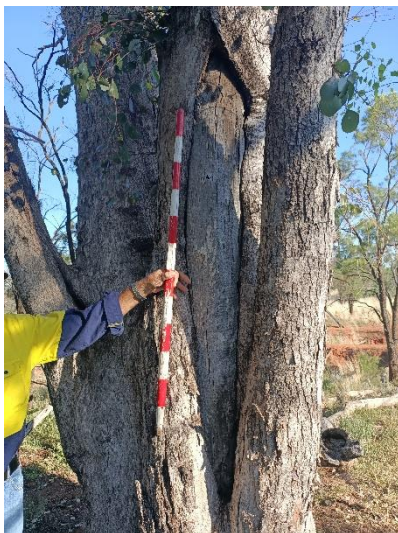
Figure 6-149: Close up of the steel axe hatching at the top of the scar

Mallee Bull CMT 20 is located 10m south of a 1st Order drainage line within the northern section of the study area (Figure 6-162, Figure 6-146). The site is located on a flat landform within a grove of Bimble Box grassy woodland with Mallee and White Cypress Pine (Figure 6-147). The scar is located on the south eastern side of the living Bimble box tree and measures 1.6m long by 0.28m wide and with 0.9m of regrowth (Figure 6-148). An epicormic growth is growing at the base of the scar and the top of the scar contains a hatching pattern made by a steel axe (Figure 6-149).

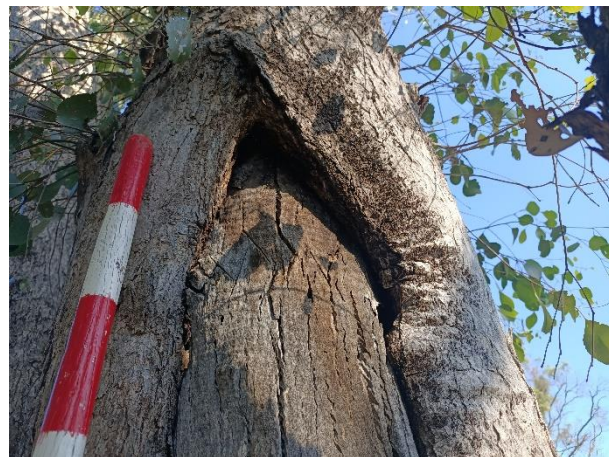
Figure 6-150: Two grinding grooves on a sandstone fragment

Mallee Bull GG01 is located on a toe slope on the southern side of a hill dominated by Green Mallee in the central section of the study area (Figure 6-166). The slope contains an outcropping of sandstone rocks and fragments, two of the sandstone fragments contain several grinding grooves (Figure 6-150 and Figure 6-151). The term 'Grinding Groove' has been used as it reflects discussions with the Ngemba, Ngiyampaa, Wangaaypuwan and Wayilwan Registered Native Title Claimants during the fieldwork. This artefact could also be called a 'Whetstone' where some have a grinding groove on both sides while others just on one surface. The principle use for Whetstones was for grinding and resharpening the blades of axes, chisels and knives. The grooves measure on average 15cm long, 5cm wide and 3cm deep, and have a U-shaped bottom. GSV within the site is moderate (60%) with vegetation comprising of grass, small shrubs, and grey box (Figure 6-152 and Figure 6-153).

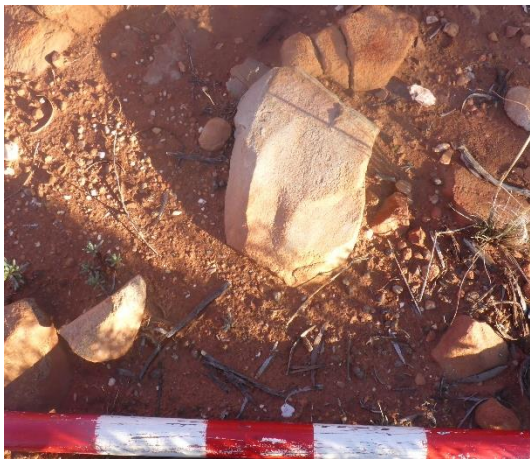
Figure 6-151: One grinding groove on a fragment of sandstone

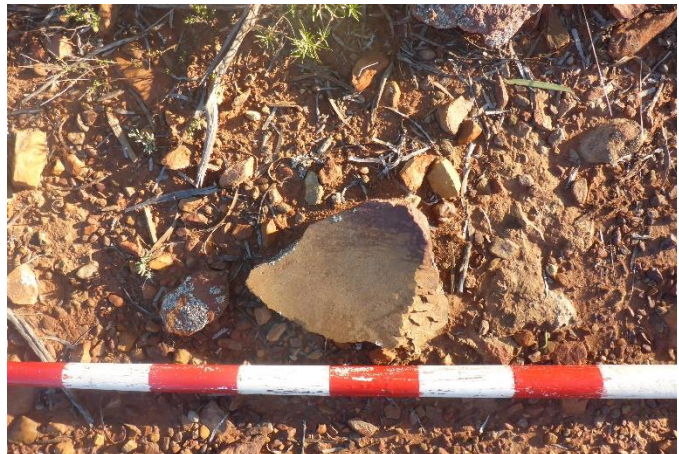
Figure 6-155: Grinding groove fragment

Mallee Bull GG02 is located on a mid slope on the southern side of a hill dominated by Green Mallee in the central section of the study area (Figure 6-166). The crest and mid slope contain an outcropping of sandstone rocks. Approximately five metres downhill from the outcropping a sandstone fragment with a partial grinding groove was observed (Figure 6-154). The term 'Grinding Groove' has been used as it reflects discussions with the Ngemba, Ngiyampaa, Wangaaypuwan and Wayilwan Registered Native Title Claimants during the fieldwork. This artefact could also be called a 'Whetstone' where some have a grinding groove on both sides while others just on one surface. The principle use for Whetstones was for grinding and resharpening the blades of axes, chisels and knives. The groove covers the top of the fragment and measures 20 cm long by 20 cm wide (Figure 6-155). GSV within the site was 90% but decreased further uphill and downhill. Vegetation is comprised of native grasses, small shrubs, Wilga and Grey Box.

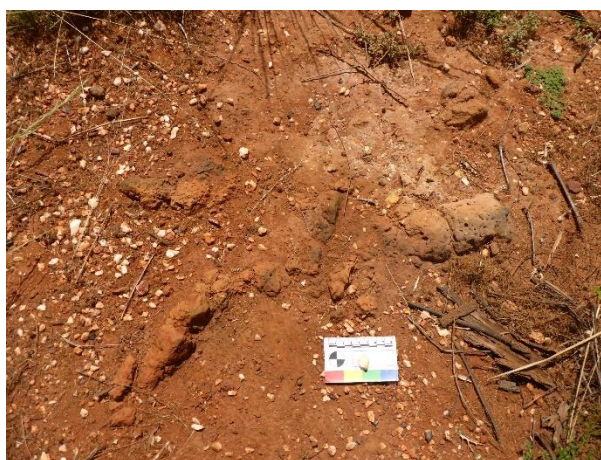
Figure 6-157: Close up of the hearth

Mallee Bull Hearth 01 is located on the mid-slope on the western side of the ridgeline and contains a hearth of burnt clay and charcoal (Figure 6-166, Figure 6-157). The hearth is eroding out of the surface soil and is surrounded by quartz fragments of possible cultural origin (Figure 6-158). Given the location of the hearth near historic mining activity in the 1800s, it cannot be determined if the fireplace was historic or prehistoric. In this instance the precautionary principle has been applied where it is assumed as Aboriginal in origin. The hearth covers approximately one metre square. GSV within the site was high (80%) but decreased immediately outside the site due to the dense grass.

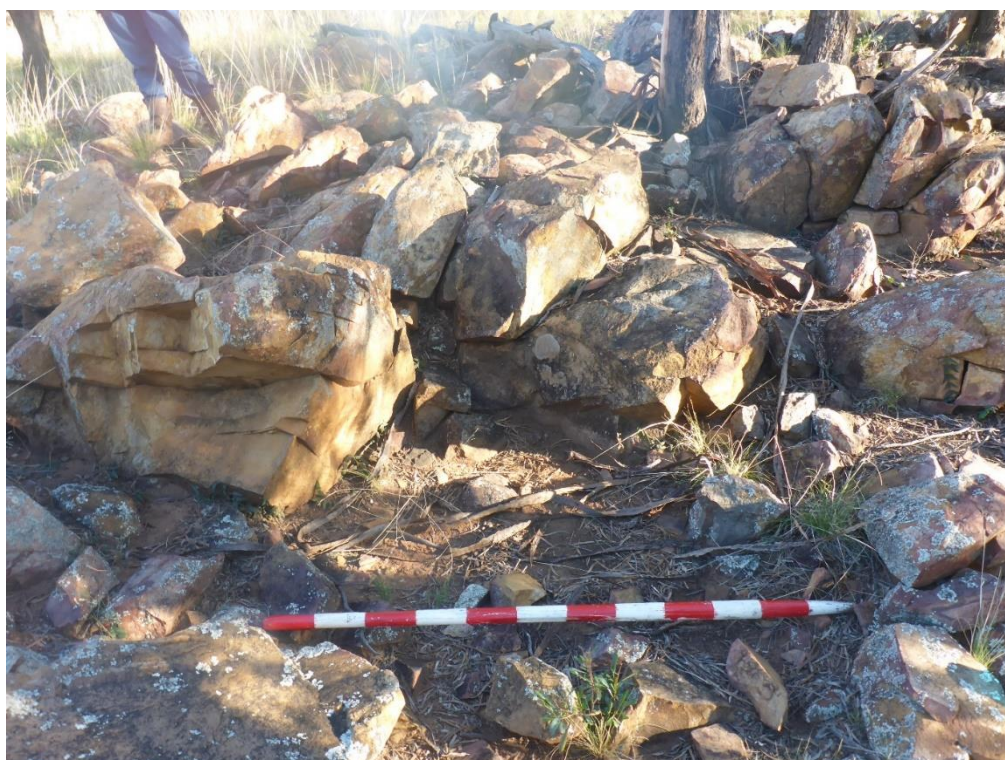
The ridgeline in the central portion of the study area is not only the highest landform in the area but also contains several outcroppings of sandstone rocks and boulders. These outcroppings of sandstone were used by the Ngiyampaa people to store water. After times of rainfall the water would pool at the base of the rocks and not evaporate due to the underlying sandstone. The Ngiyampaa people would scoop out the sand and debris to make the holes bigger and sometimes cover the top with bark to stop evaporation.

Figure 6-160: Example of rock formations utilised to water storage

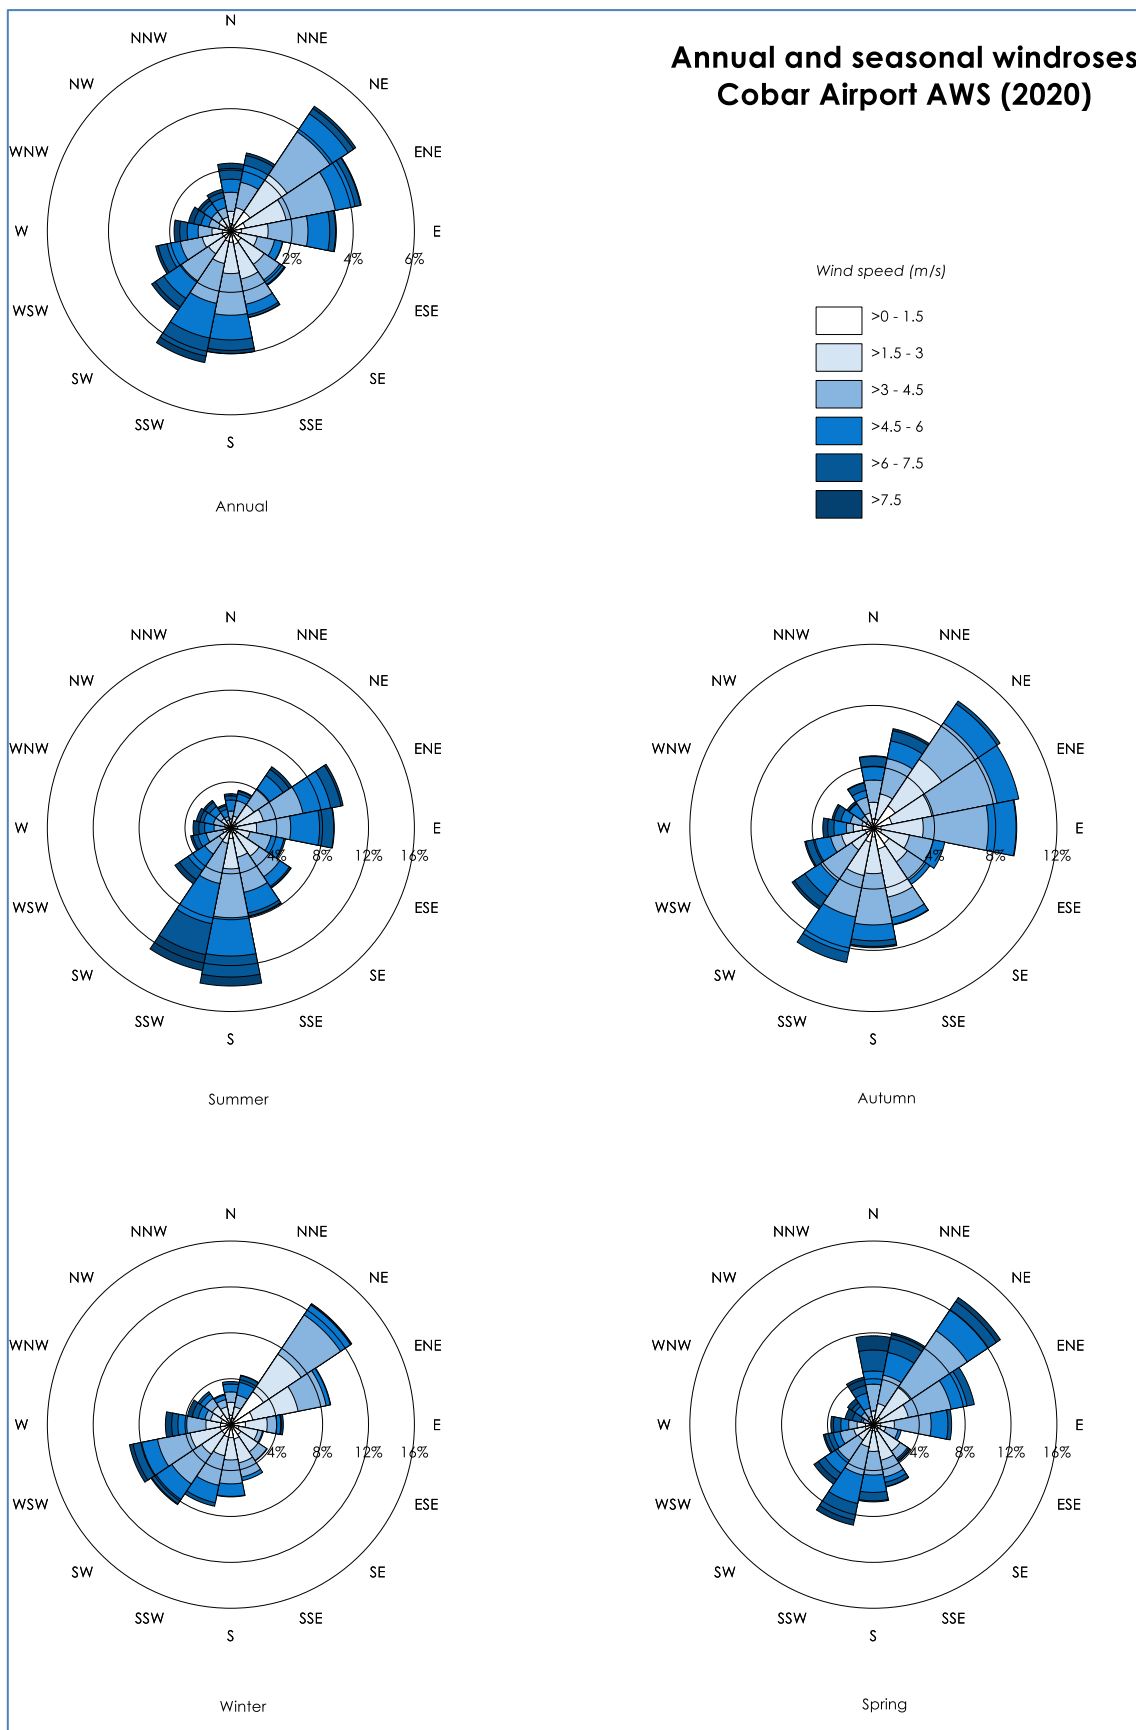
On an annual basis, winds predominately follow a northeast to southwest axis with varied winds from other directions. In summer, winds occur predominately from the south and south-southwest. During winter, winds primarily occur from the northeast and southwest quadrants. The autumn and spring windroses have a similar distribution to the annual distribution with winds flowing on a northeast to southwest axis with varied winds from other directions.

Figure 4-2 : Annual and seasonal windroses – Cobar Airport AWS (2020)

Annual and seasonal windroses for the Cobar Airport AWS during the 2020 calendar period are presented in **Figure 4-2**.

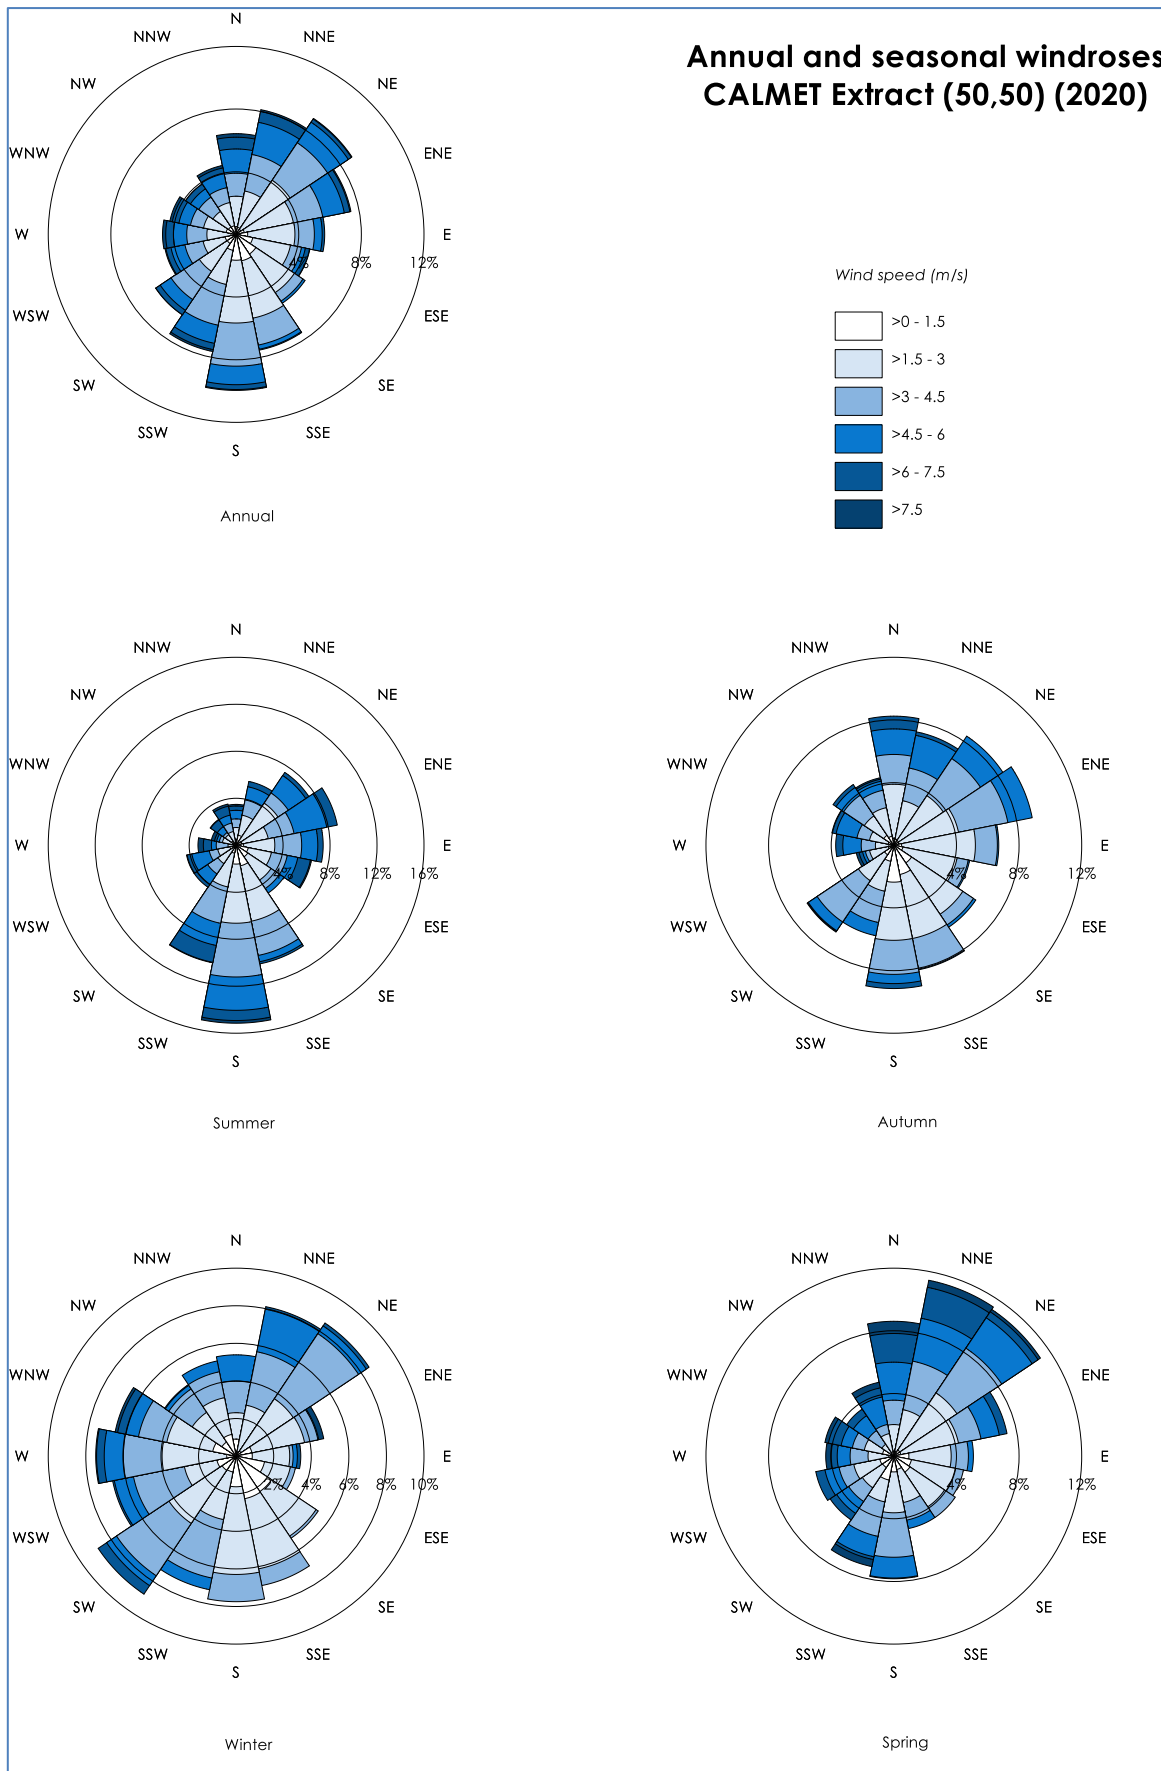
Figure 5-2 presents the annual and seasonal windroses from the CALMET data. Overall, the windroses generated in the CALMET modelling reflect the expected wind distribution patterns of the area as determined based on the available measured data and the expected terrain effects on the prevailing winds. **Figure 5-3** includes graphs of the temperature, wind speed, mixing height and stability classification over the modelling period and shows sensible trends considered to be representative of the area.

Figure 5-2: Annual and seasonal windroses from CALMET

CALMET generated meteorological data were extracted from a point within the CALMET domain and are graphically represented in **Figure 5-2** and **Figure 5-3**.
