Review of Environmental Factors

Mallee Bull Exploration Project

RWCorkery&co

February 2023

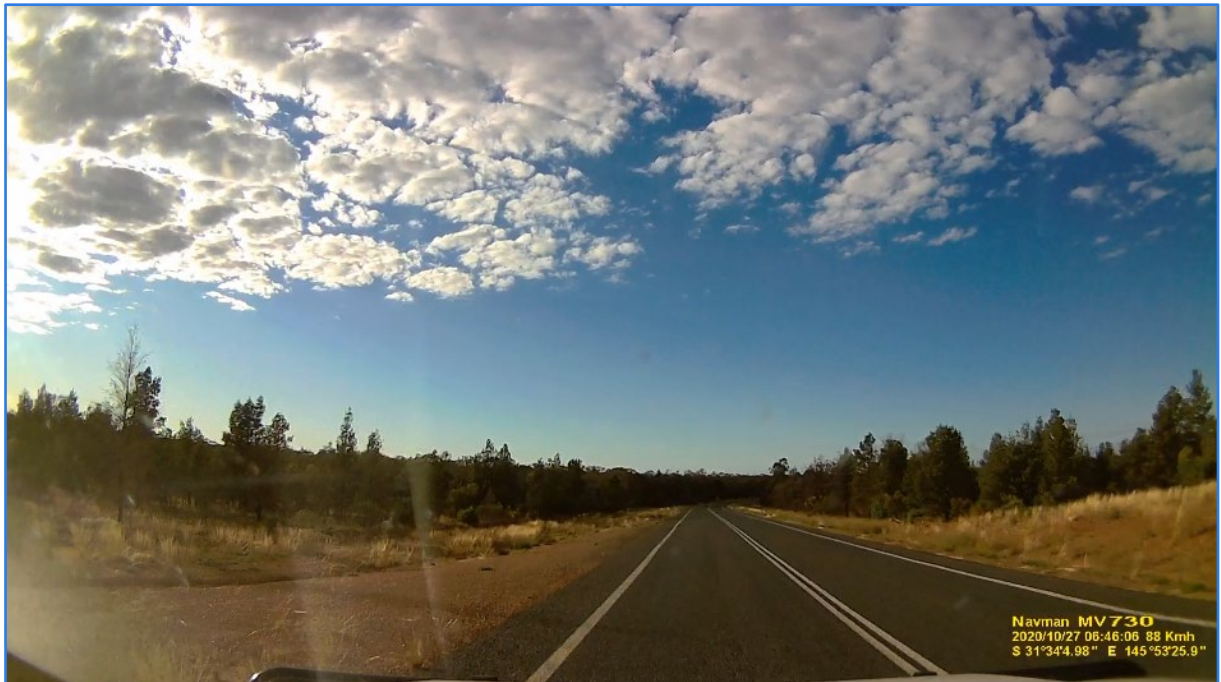
Figure 3.2: Typical Section of Kidman Way

Kidman Way (MR410) is a State road which forms part of a regional link through western NSW between Mitchell Highway at Bourke and Newell Highway near Jerilderie, via Cobar, Hillston, and Griffith. Between Cobar and Hillston, Kidman Way typically has a single travel lane in each direction, with either solid double centrelines or a single broken centreline, with sealed shoulders. Kidman Way has a posted speed limit of 100 km/h that reduces to 90 km/h over approximately 3 km near Cobar, commencing 300 m south of the intersection with Barrier Highway. There are several school bus stops along Kidman Way. Figure 3.2 indicates the typical conditions along Kidman Way.

Looking south approximately 9km from Barrier Highway.

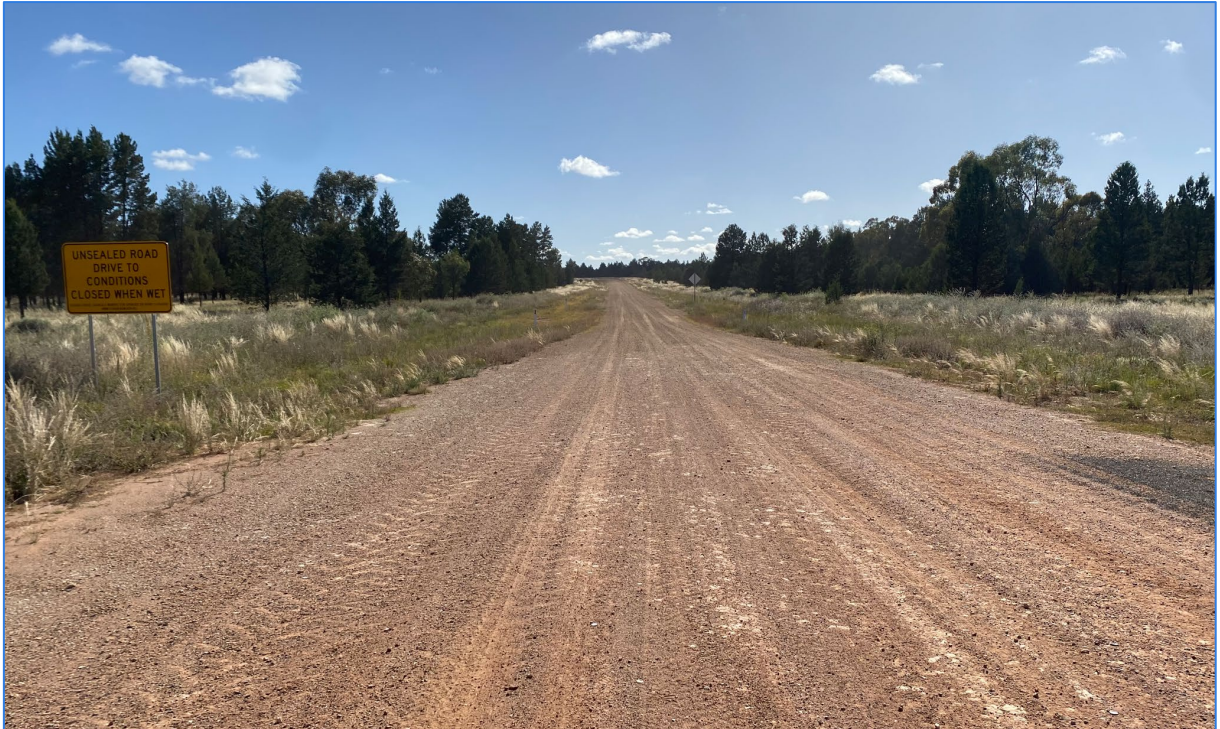
The carriageway of Glenwood Road typically approximately 9 to 11 m wide, and it follows a level alignment with large radius curves. There is a single lane stock grid across Glenwood Road approximately 550 m east of Kidman Way.

Figure 3.3: Typical Section of Glenwood Road

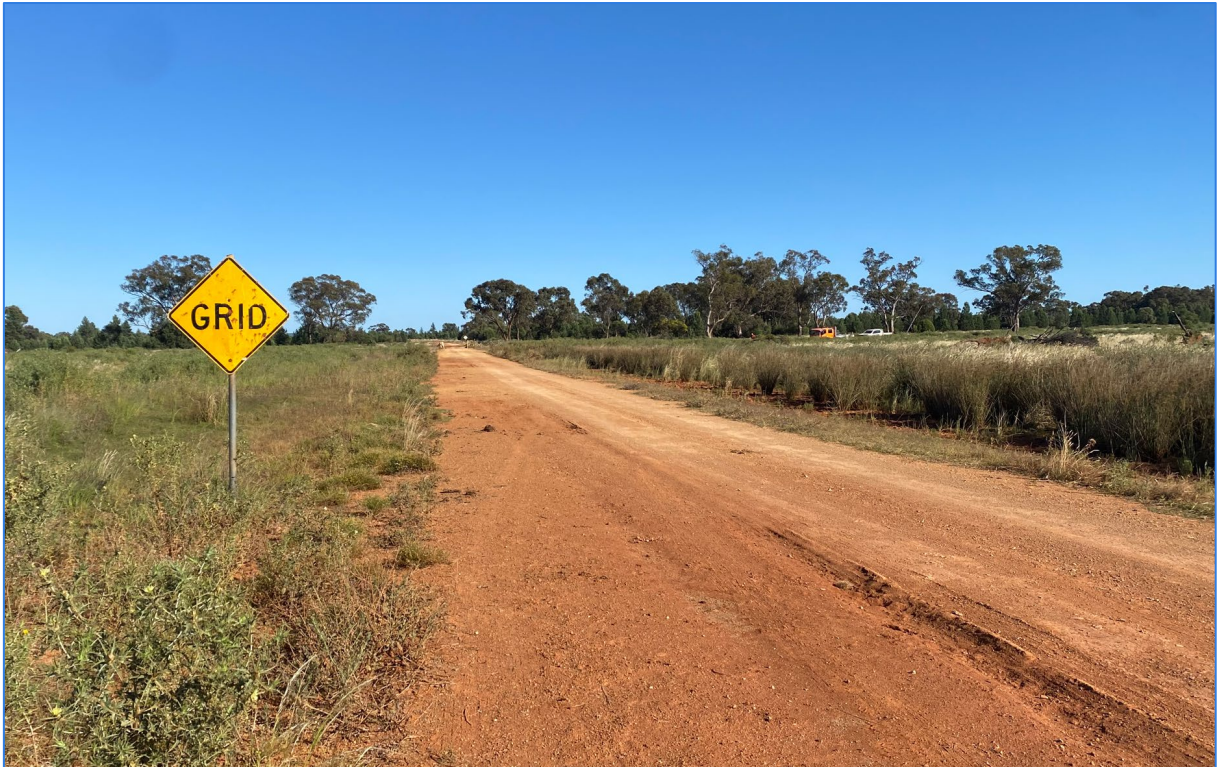
Figure 3.4: Typical Section of Grain Road

Grain Road (SR20) is a local road that provides a link between Kidman Way at Gilgunnia and Kiacatoo Road at Euabalong. It is an unsealed road for most of its 90 km length, with a sealed surface for approximately 20 km near Euabalong. Grain Road has a sealed surface over approximately 180 m near Kidman Way. It is signposted near Kidman Way as "UNSEALED ROAD DRIVE TO CONDITIONS CLOSED WHEN WET".

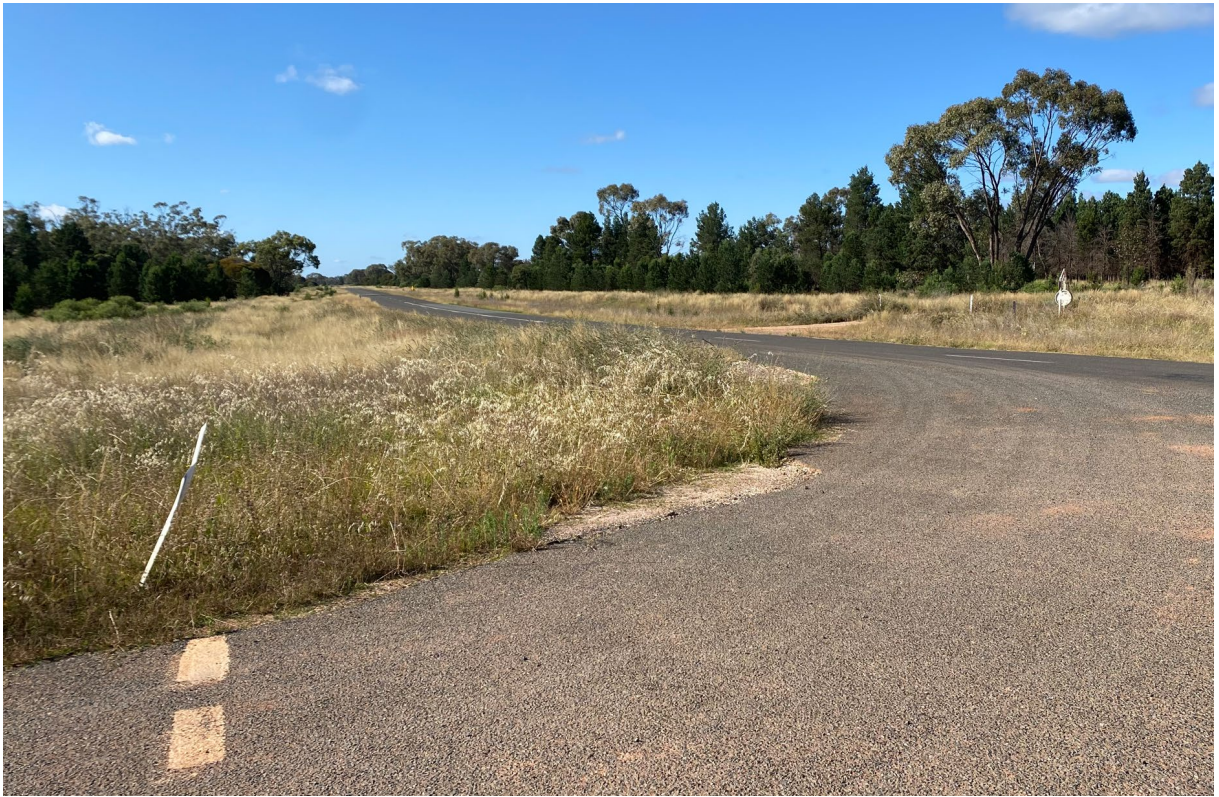
Sightline to North from Glenwood Road

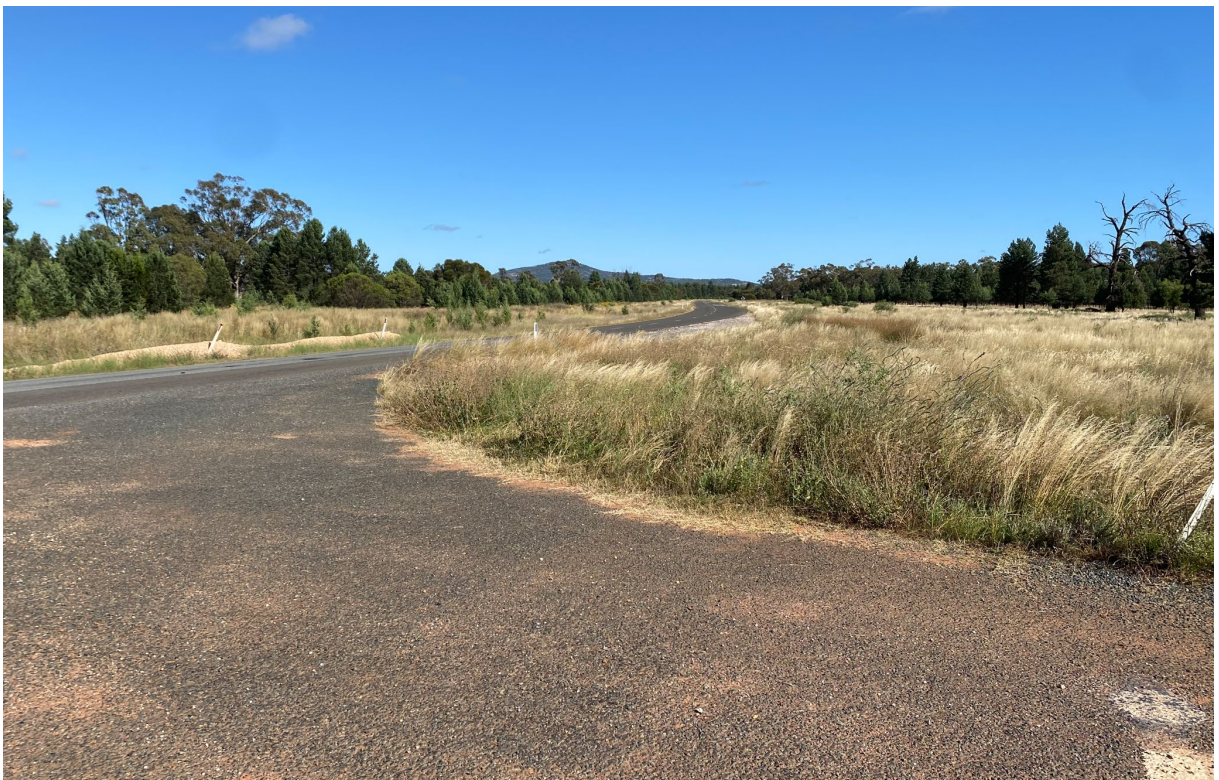
Sightline to South from Glenwood Road

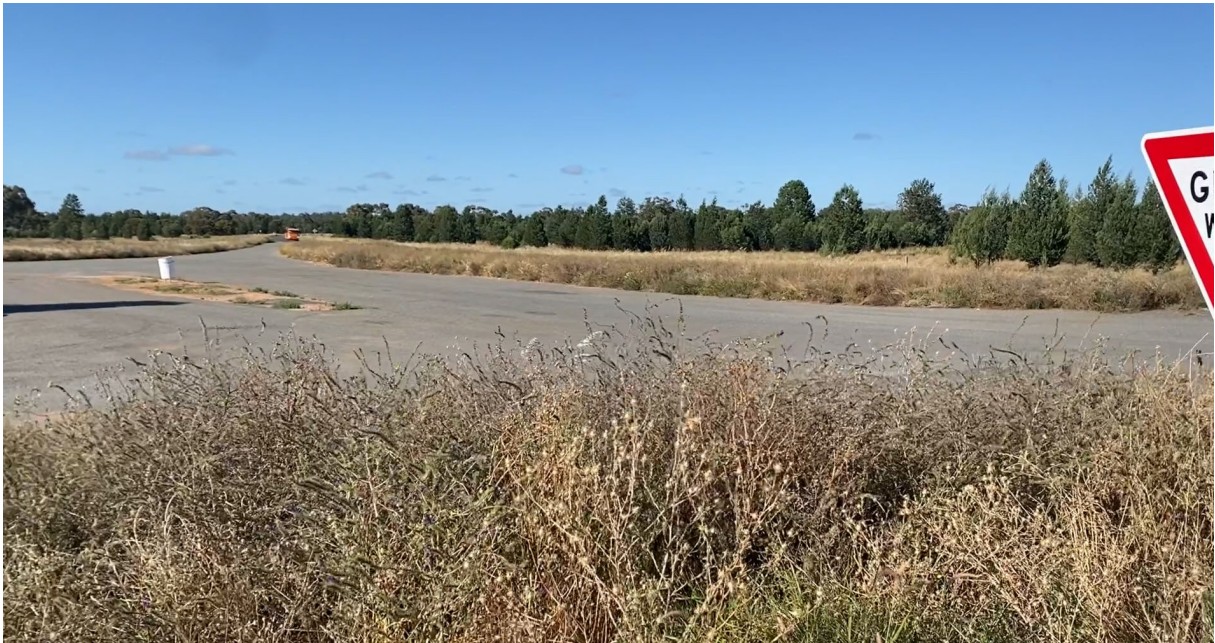
Sightline to South from Grain Road

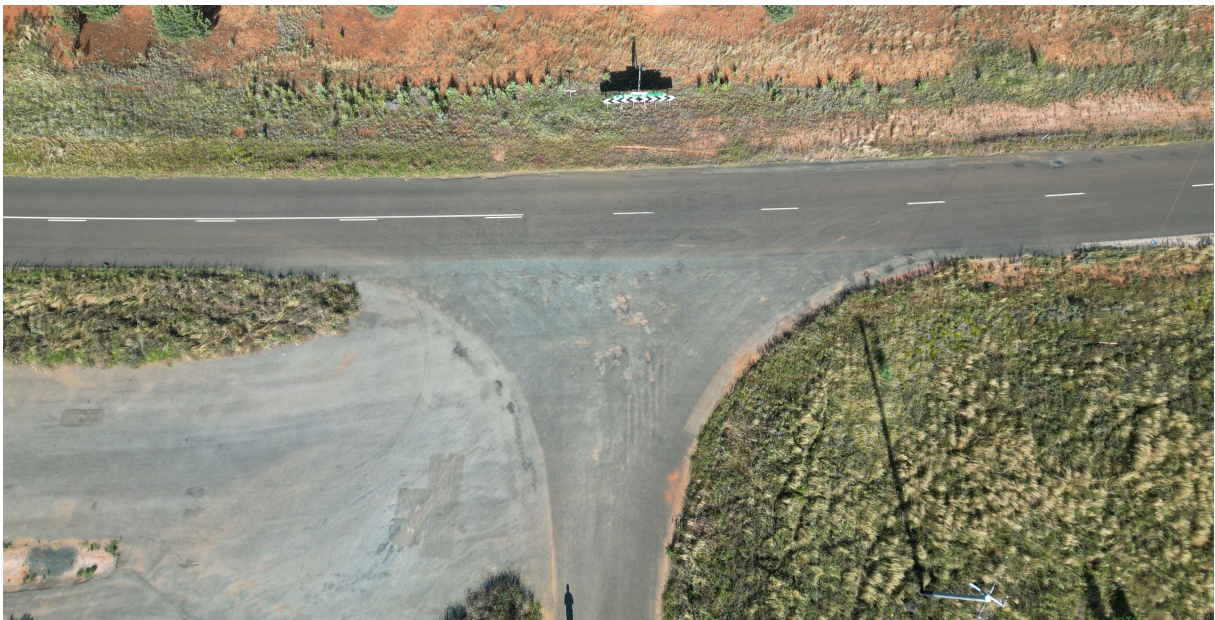
Aerial View of Grain Road, Kidman Way and Rest Area Access

Sightline from the Give Way sign east of the rest area access from Kidman Way, looking across the rest area, truck is approaching on Kidman Way, which lies behind the mid-photo vegetation, refer to following photo.

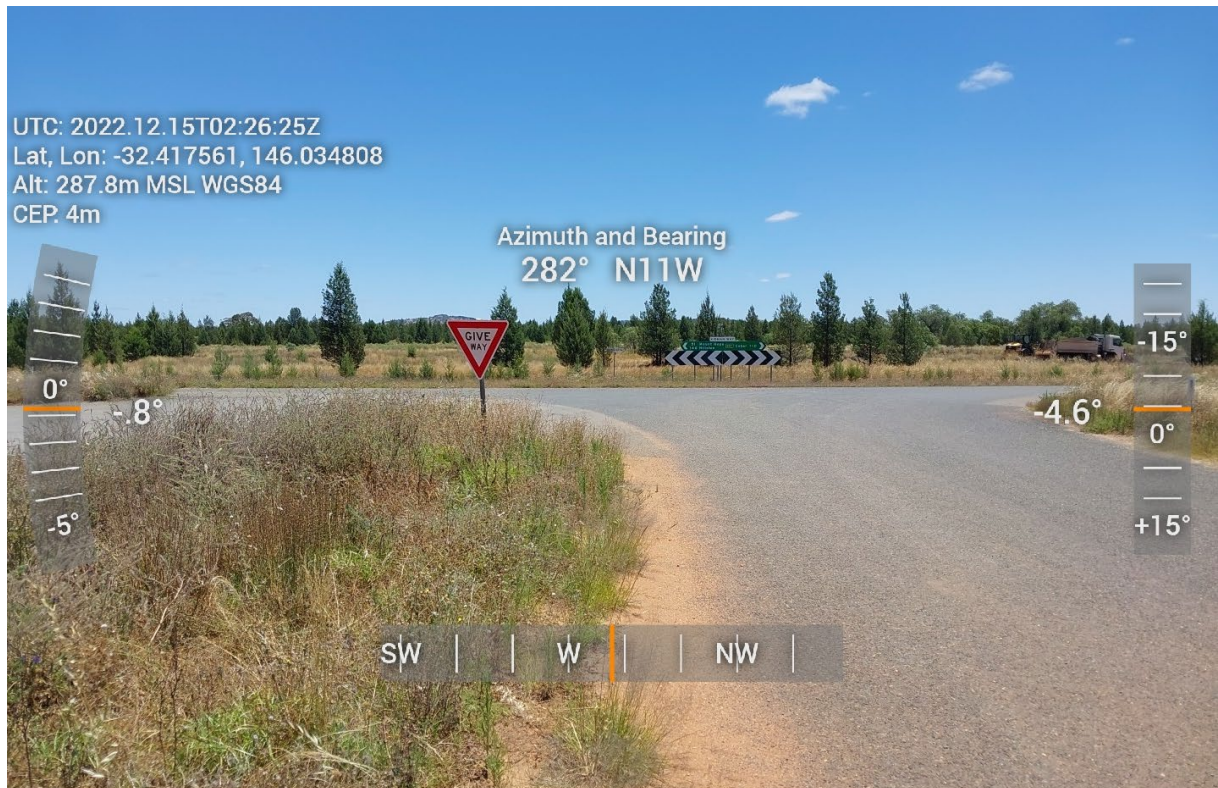
Grain Road approaching Kidman Way

The rest area access from Kidman Way is located east of the Give Way sign, which is approximately 20 m from Kidman Way.

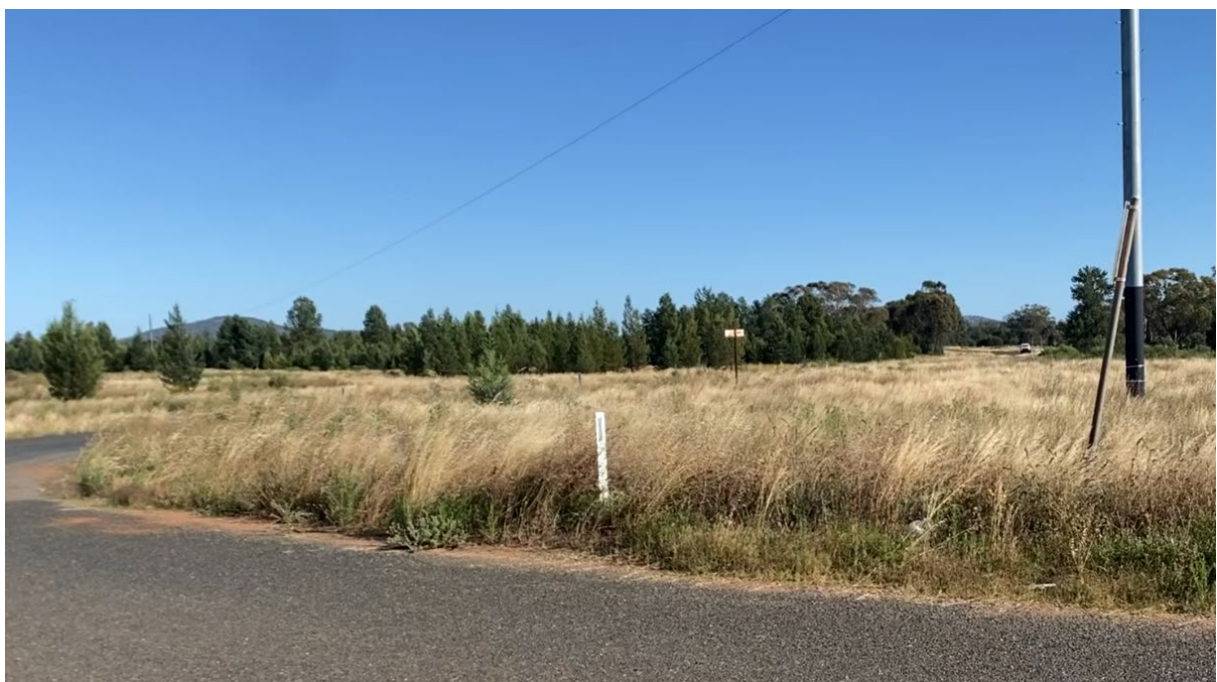
Sightline to North from Grain Road

Sightline from the Give Way sign east of the rest area access from Kidman Way.

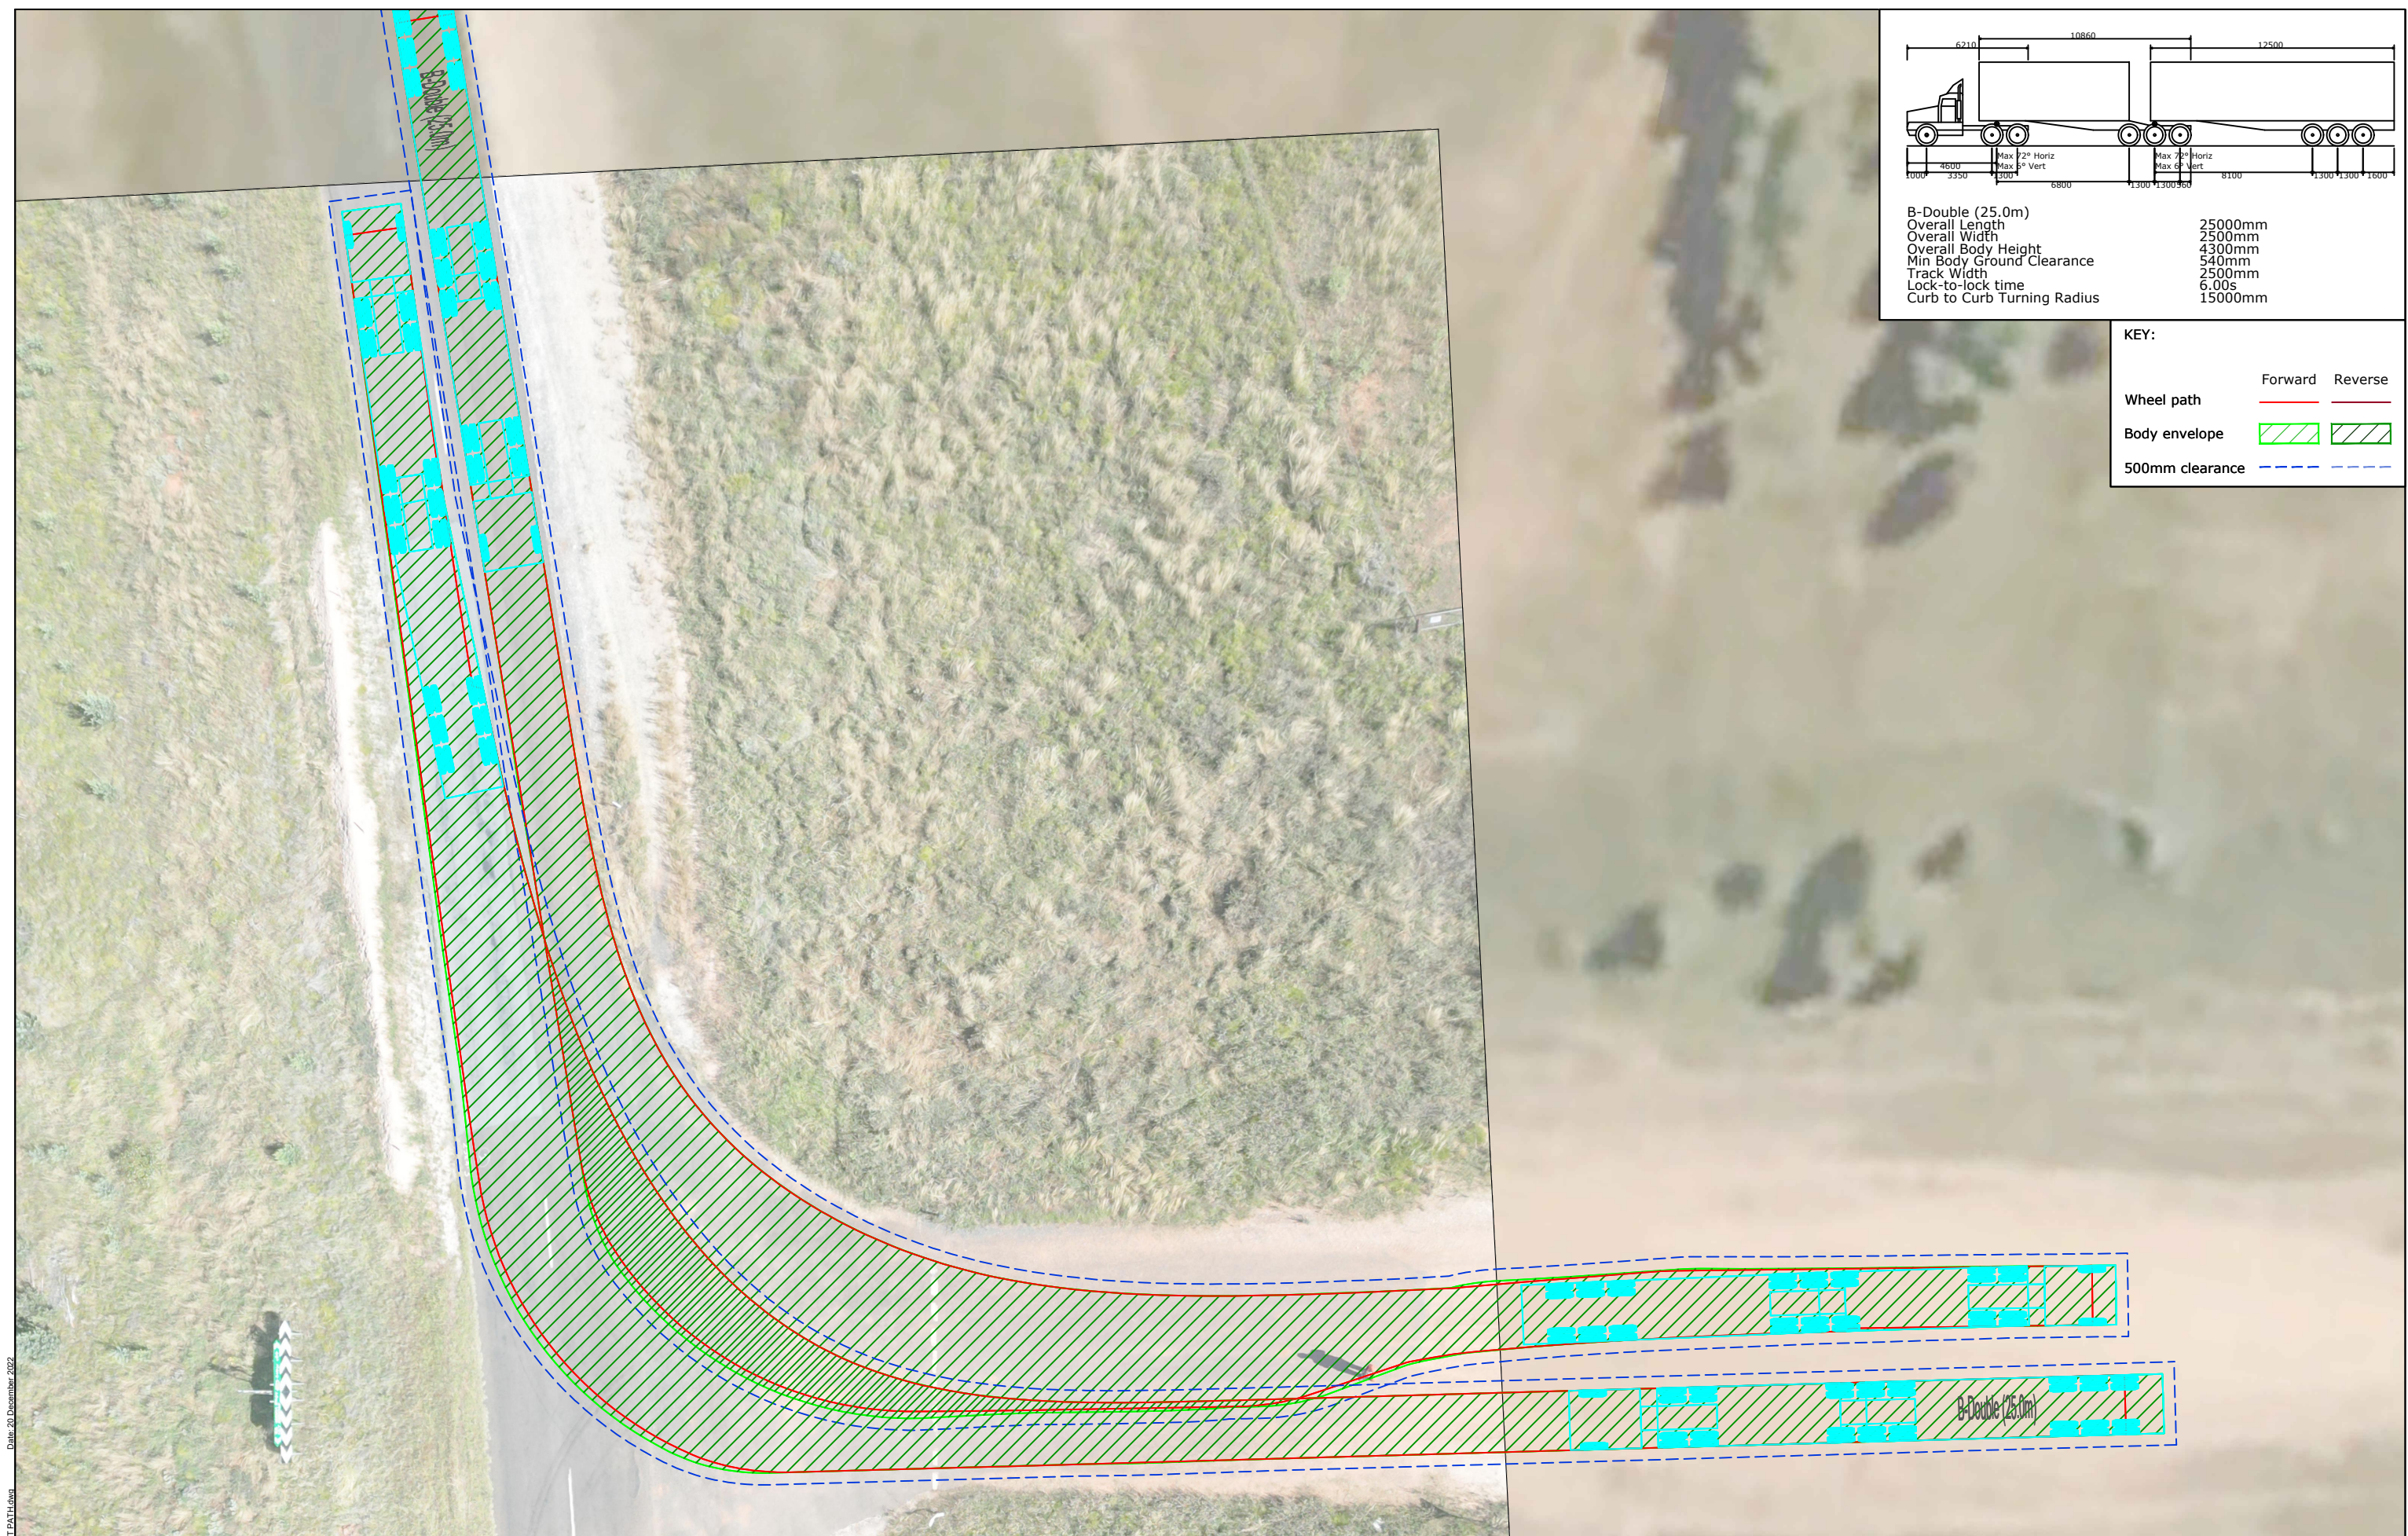
Forward	Reverse
Wheel path		
Body envelope		
500mm clearance

It is further recommended that the existing dip at the edge of the Glenwood Road carriageway at the Site Access Road be flattened to provide adequate ground clearance for the oversize vehicles expected to use it, and to ensure the angle of articulation of articulated vehicles remains satisfactory. The swept paths of semitrailers turning into and out of the Site Access Road are presented in Appendix C (Figure C8), showing the wheel paths of

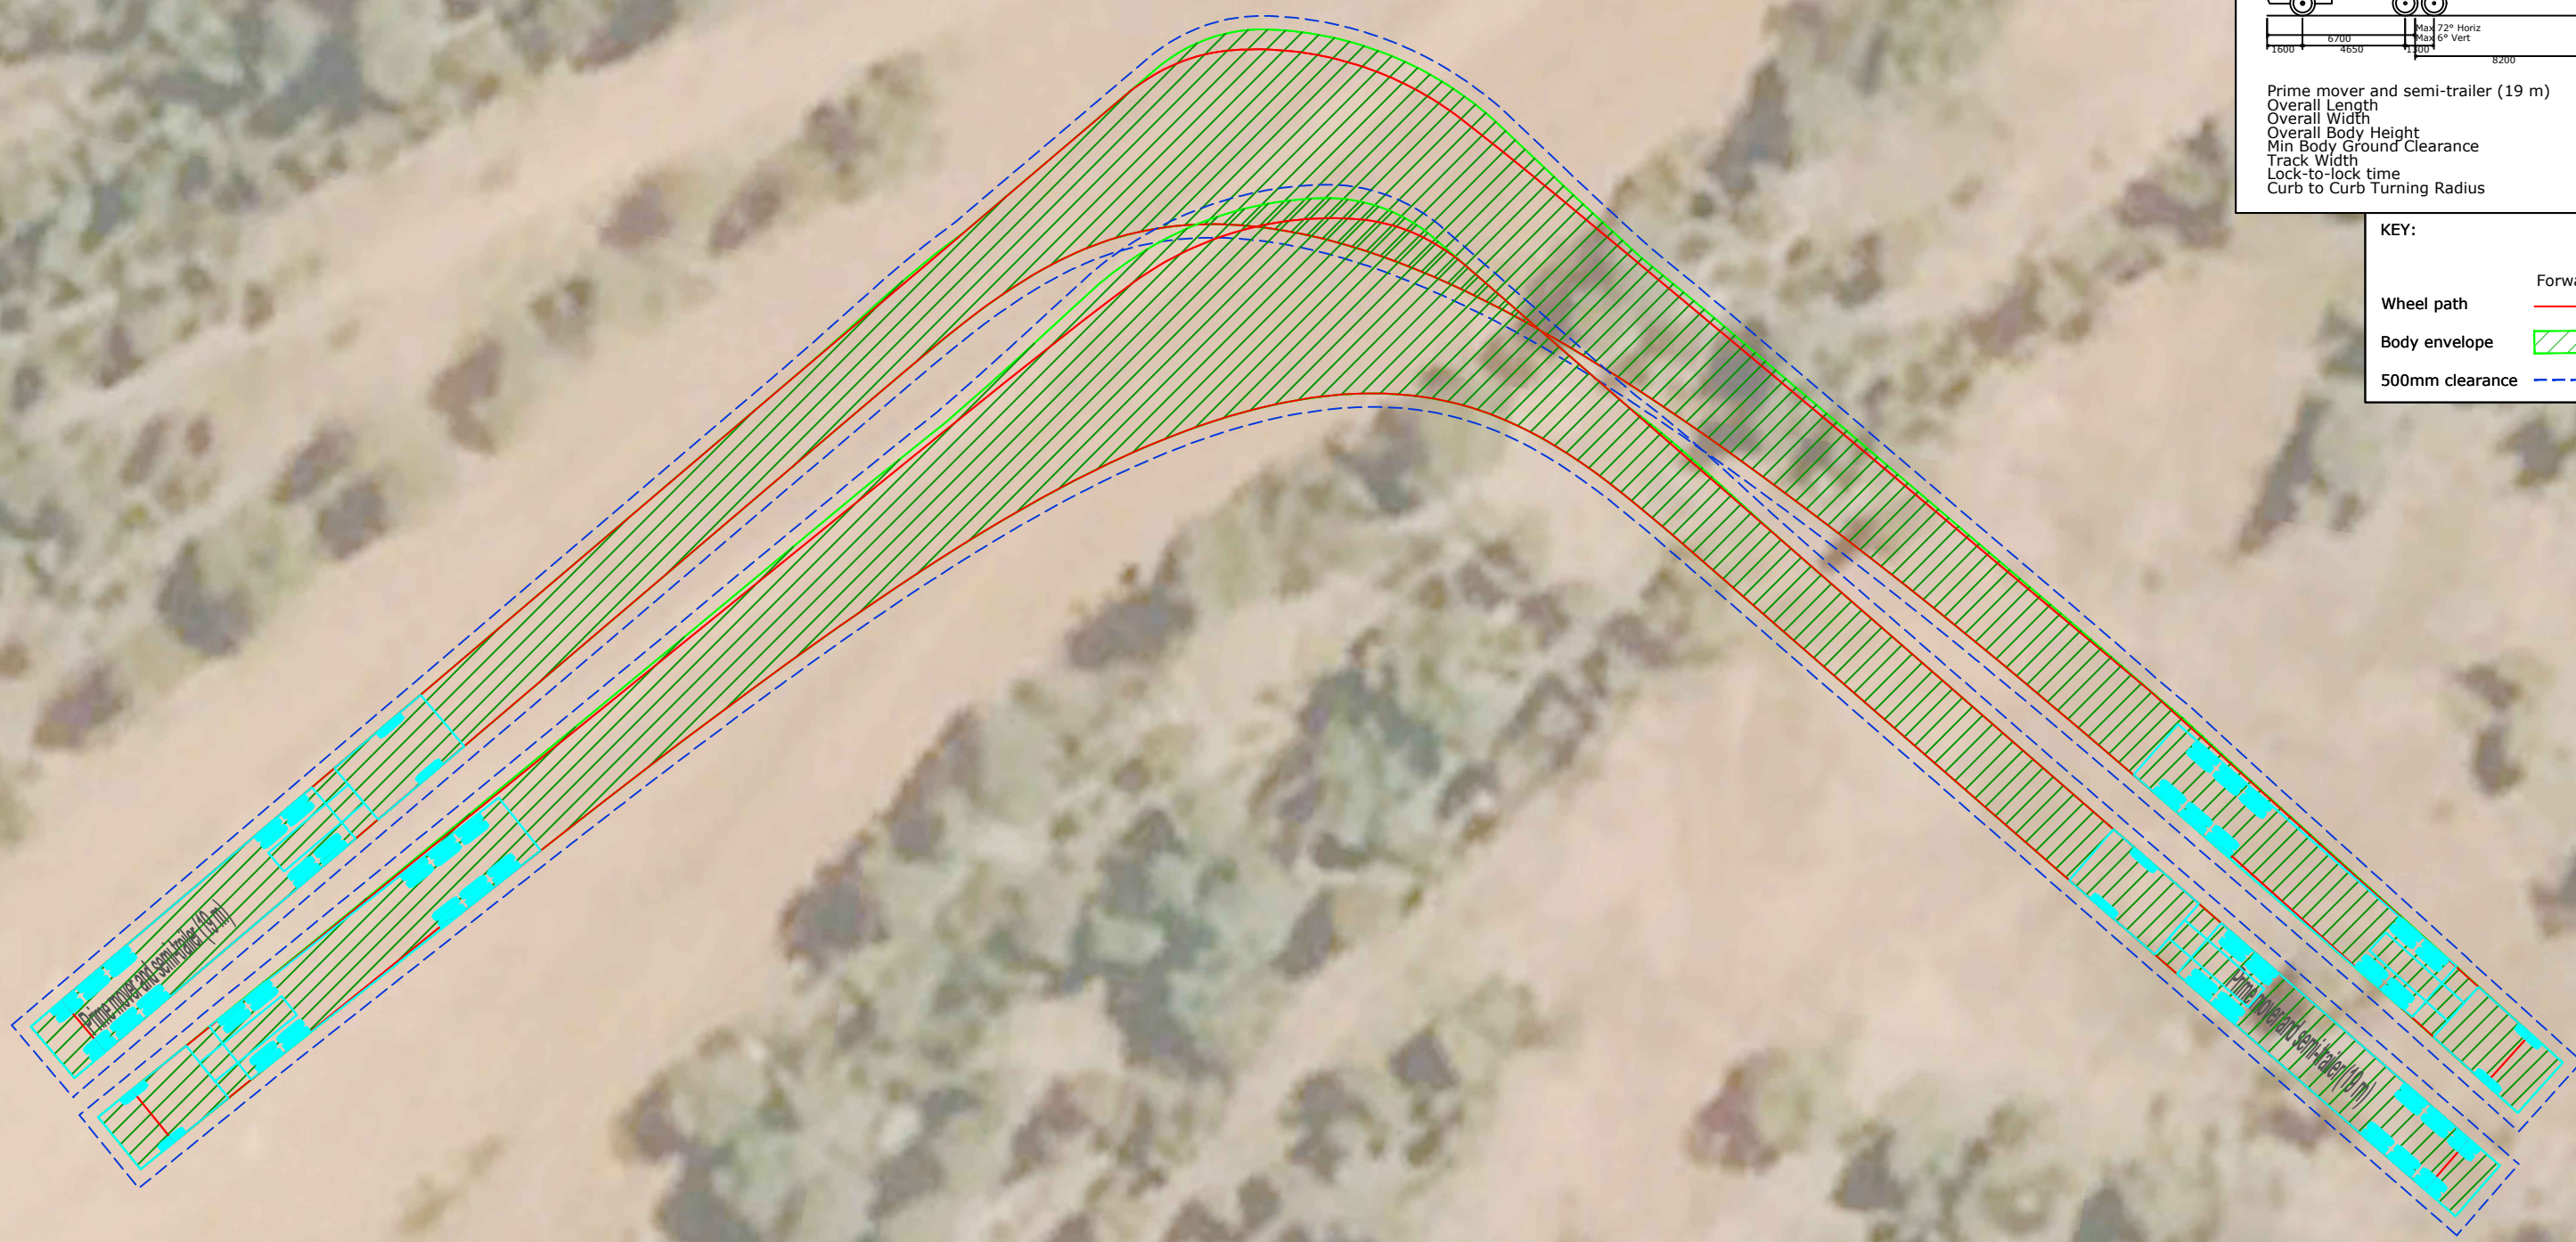
Filename: 22510CAD001-221220-SWEPT PATH.dwg Date: 20 December 2022

Forward	Reverse
Wheel path		
Body envelope		
500mm clearance

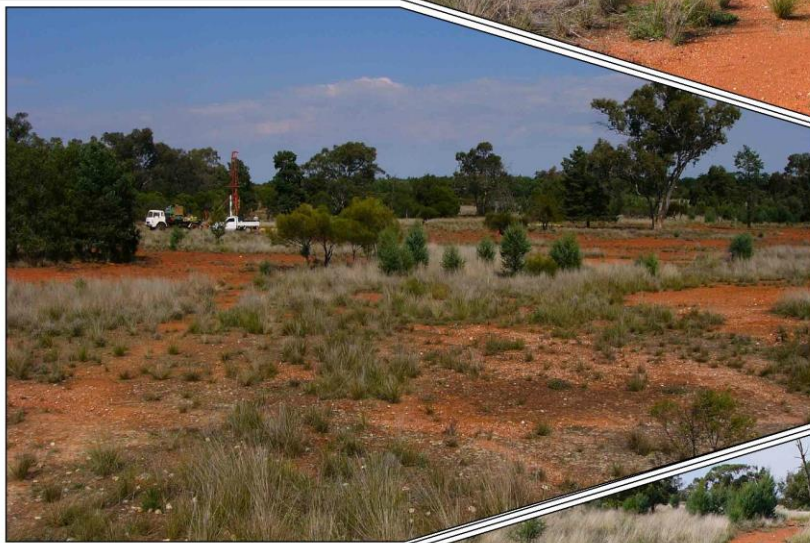
Plate A4-Existing Station Tracks within the Exploration Area
(Source Peel Mining Limited)
