Weekly incident summary

Week ending 3 November 2023

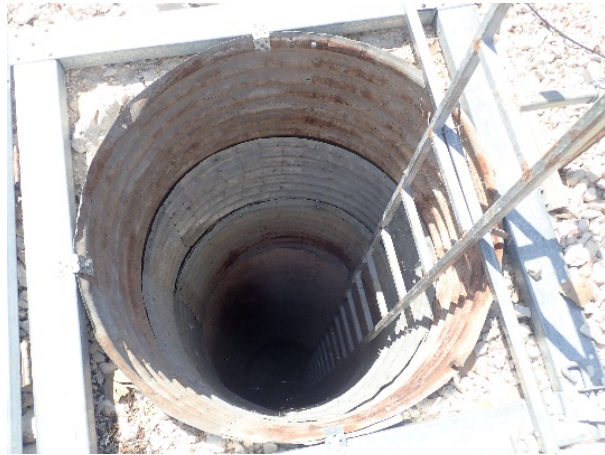
| Incident type | Summary | Comments to industry |
|---|---|--|
| <p>Dangerous incident IncNot0045710 Opal mining</p> | <p>An opal claim worker fell 7 metres while inside a 14 metre mine shaft entry after the shaft hoist failed.</p> <p>He suffered 2 broken ankles.</p> | <p>Opal claim holders must ensure that routine maintenance inspections are carried out on critical plant such as hoists, and that repairs are carried out as required.</p> <p>After maintaining and repairing plant, the plant should be inspected, tested and verified as fit-for-purpose before being returned to service.</p> |

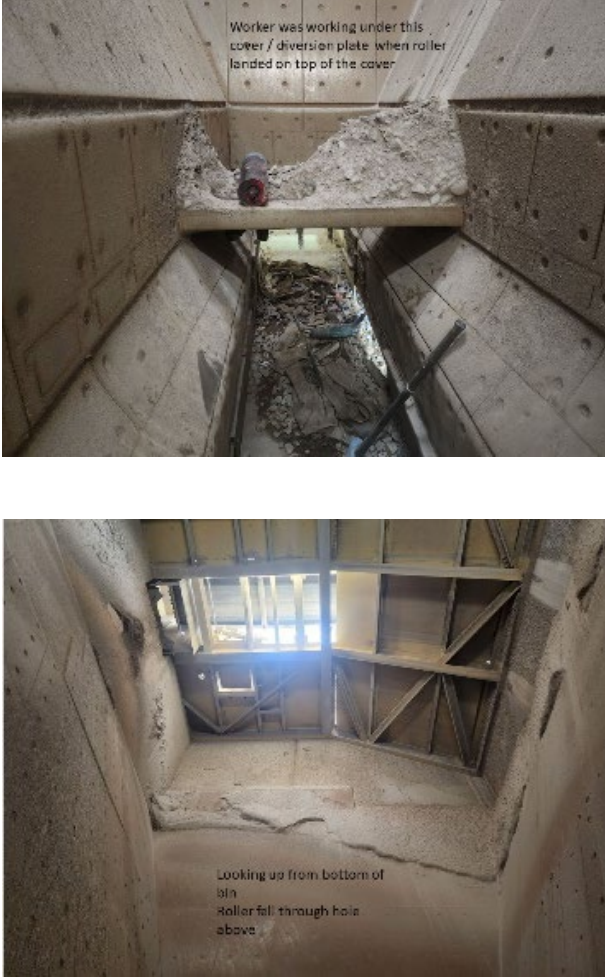
| Incident type | Summary | Comments to industry |
|---|---|--|
| <p>Dangerous incident IncNot0045716 Underground metals mine</p> | <p>A worker was inside a bin replacing skirt liners under a diversion plate. Another worker was replacing rollers on a conveyor above the bin.</p> <p>A conveyor roller fell into the bin and landed on the diversion plate. The roller fell about 11 metres.</p> | <p>The risk of falling objects hitting a person is an easily identifiable risk for which controls need to be put in place before work begins.</p> <p>Work groups must communicate with other work groups in the area</p> |

| Incident type | Summary | Comments to industry |
|---|---|---|
| | <p>Worker was working under this cover / diversion plate when roller landed on top of the cover</p> <p>Looking up from bottom of bin Roller fell through hole above</p> | <p>to determine if there are interactions or risks between work groups.</p> <p>Documented risk assessments and/or procedures for such tasks should be available and supervisors should ensure that controls are in place and communicated to all workers involved in the tasks.</p> |
