# Weekly incident summary

## Week ending 23 August 2024

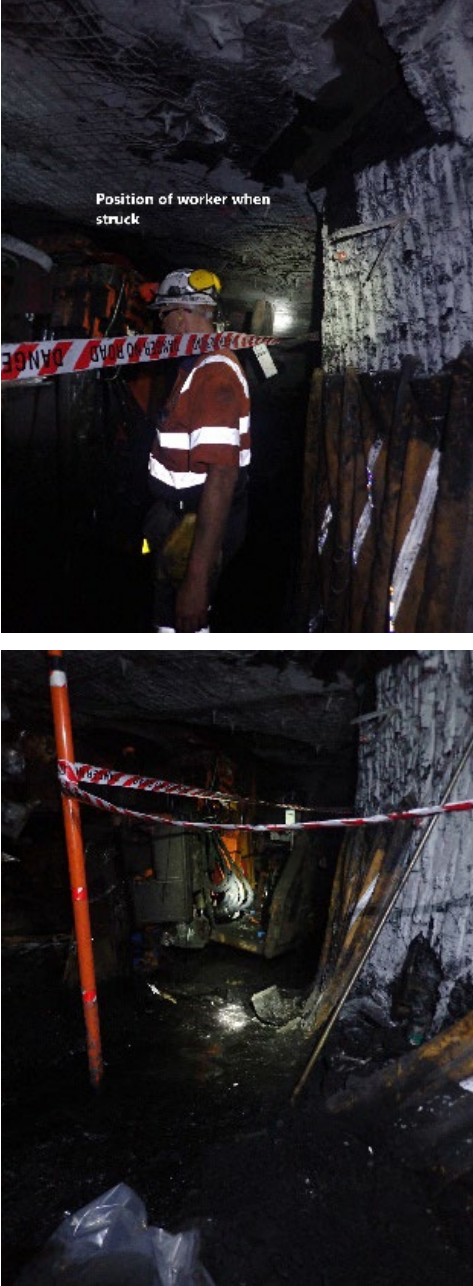
<p>Serious injury IncNot0047508 Underground coal mine</p>	<p>Contract mine workers were reclaiming a 300 x 30 cm pipe using a workbasket attached to a load haul dump machine (LHD). Two workers were in the basket and one was in the LHD.</p> <p>The recovered pipe was lying horizontally across the basket, unsecured. When the LHD moved forward the pipe hit a gate valve from a dropper and rotated in the basket hitting one worker in the back and knocking him forward. The worker's face hit the basket railing resulting in a laceration from his nose to his chin and the loss of 2 teeth.</p>	<p>This incident highlights the consequences of not using fit-for-purpose equipment for tasks and not having procedures that identify the risks in undertaking such tasks and how they are to be avoided.</p> <p>The risk of unsecured objects hitting a person is an easily identifiable risk for which controls need to be put in place before work begins.</p>

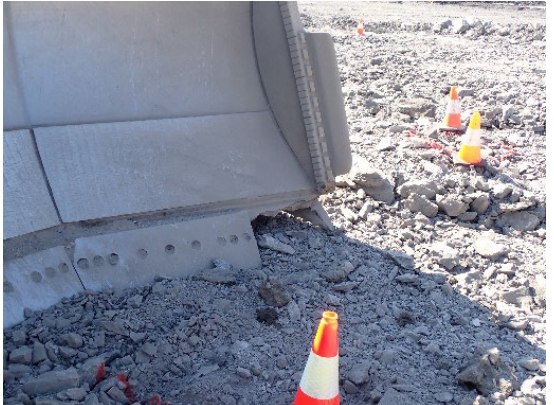
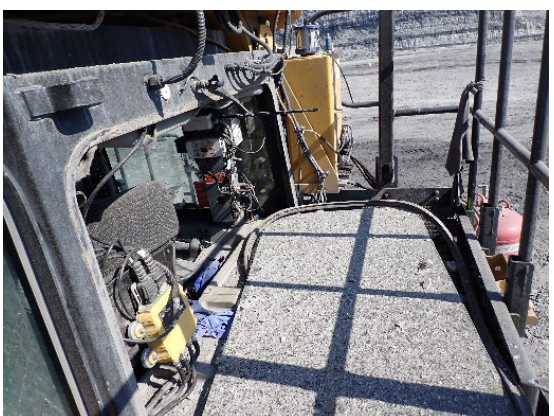
<p data-bbox="113 618 411 808">           Dangerous incident            IncNot0047505            Open cut coal mine            Fire or explosion         </p>

<p data-bbox="419 618 975 741">           An uncontrolled explosion occurred due to a misfire adjacent to an excavator and a dozer.         </p> <p data-bbox="419 752 975 875">           Material from the dozer blade was blown off the blade and the windows on the dozer were damaged in the incident.         </p>

<p data-bbox="983 618 1477 741">           This incident is under investigation and further information may be published later.         </p>
