September 2024

## Rehabilitation information release

# Rhondda Colliery rehabilitation and development of the Black Rock Motor Sport Park

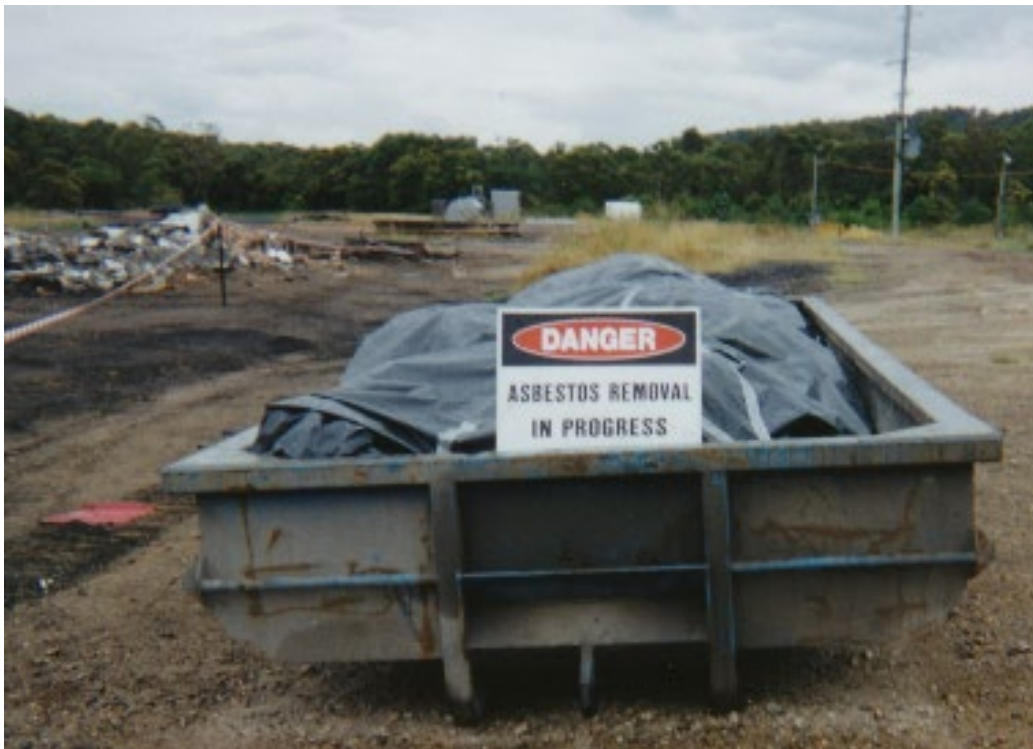
Figure 3: Removing asbestos contaminated demolition materials (circa 1999)

- Decommissioning and removal of buildings, services, structures and hazardous materials, with the exception of the horse stables and explosives magazine, which were recognised for their heritage value.
- Remediation of contaminated soil.

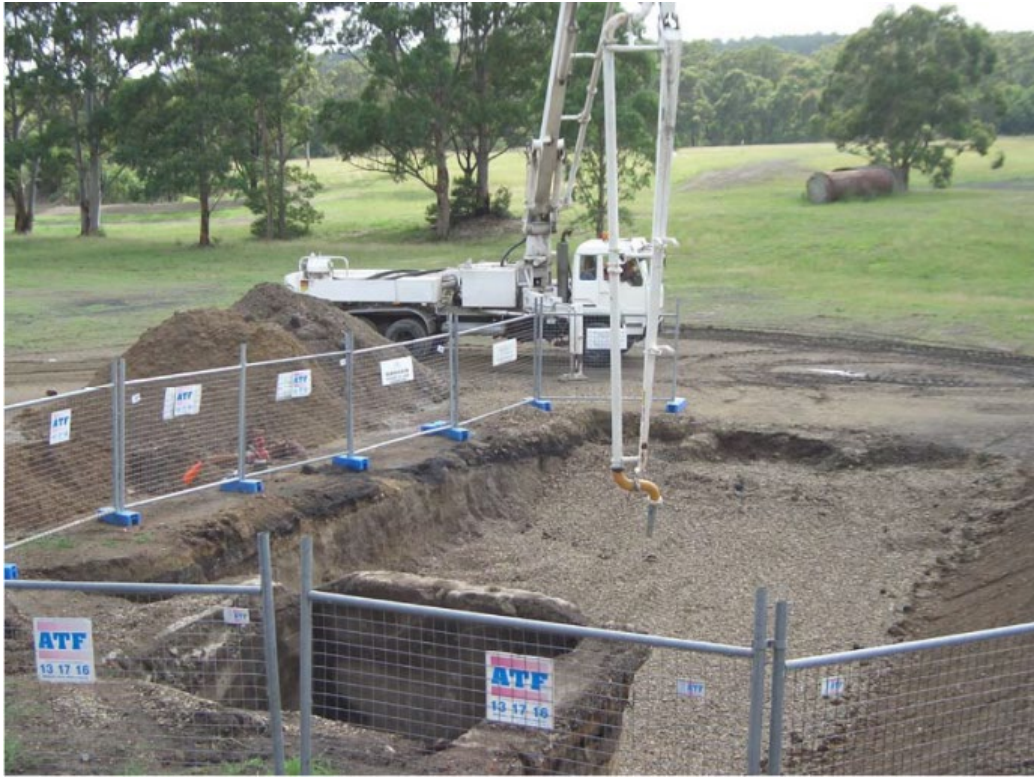
Figure 4: Remedial mine entry sealing works (circa 2007)

- Sealing all mine entries and boreholes.
- Backfilling of open cut pits including contouring of high walls to ensure acceptable slopes, including fencing/safety barriers in some steep locations.
- Subsidence cracking repairs, including filling and/or grouting work.
- Reworking and contouring of surface emplacements and capping of tailings emplacement areas to minimise the potential for future spontaneous combustion of coal material.
- Growth medium development including spreading the prepared landform with topsoil and other nutrients.
- Planting vegetation.
- Retaining clean water dams and associated water testing and monitoring.
- Long term monitoring and maintenance activities including geotechnical assessments, subsidence inspections, water monitoring, ecological monitoring, pest and weed control.

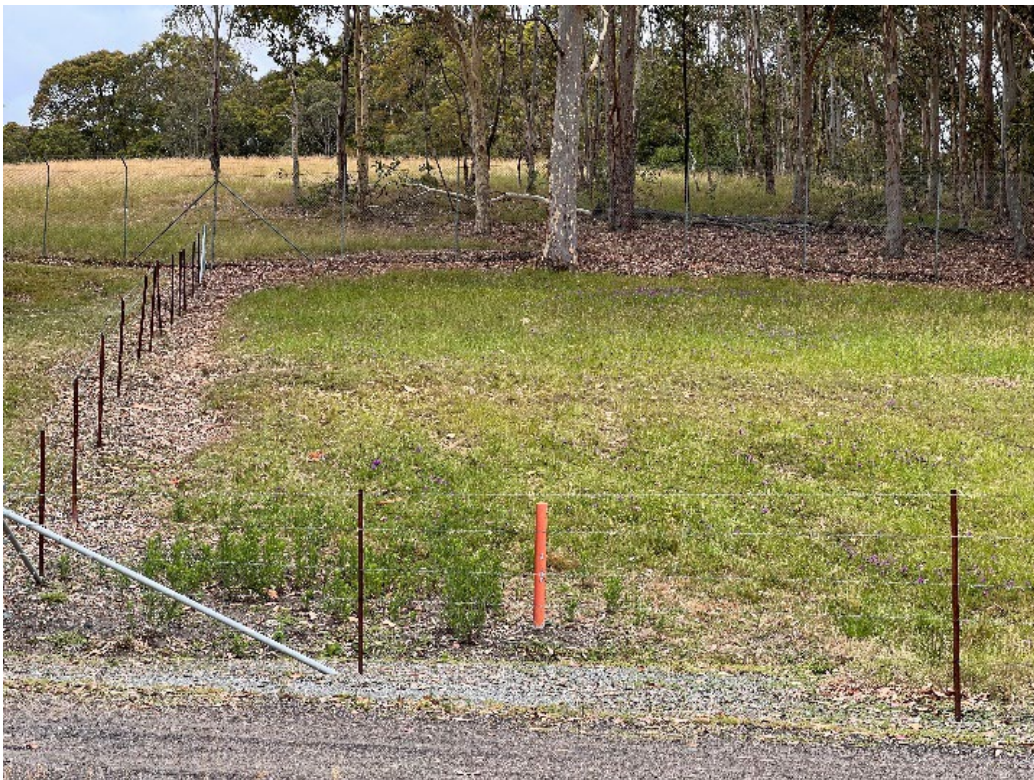
Figure 5: Completed mine entry rehabilitation (circa 2022)

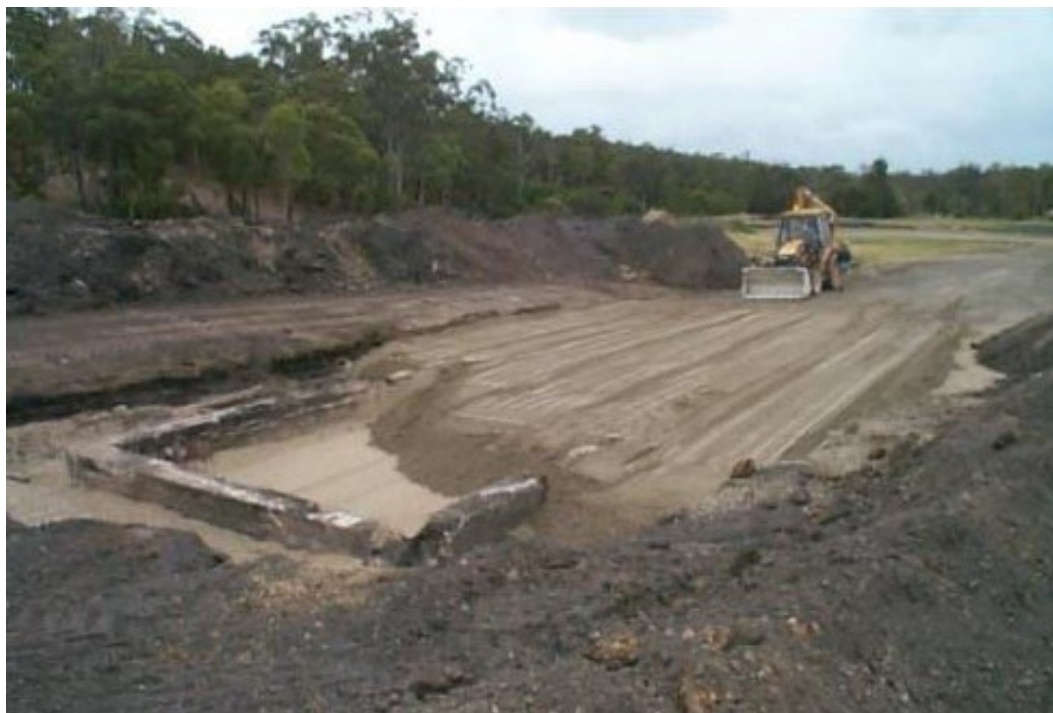
Figure 6: Respreading excavated natural material following removal of potentially contaminated soils (circa 1999)

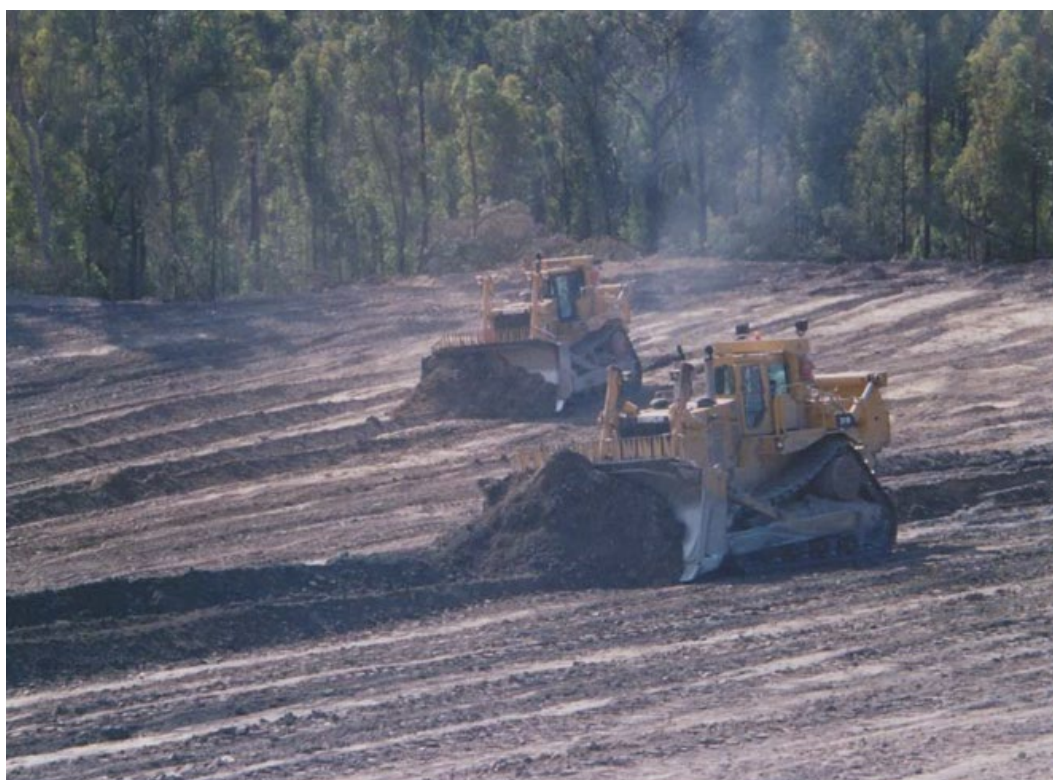
Figure 7: Reshaping of main open cut area (2004)

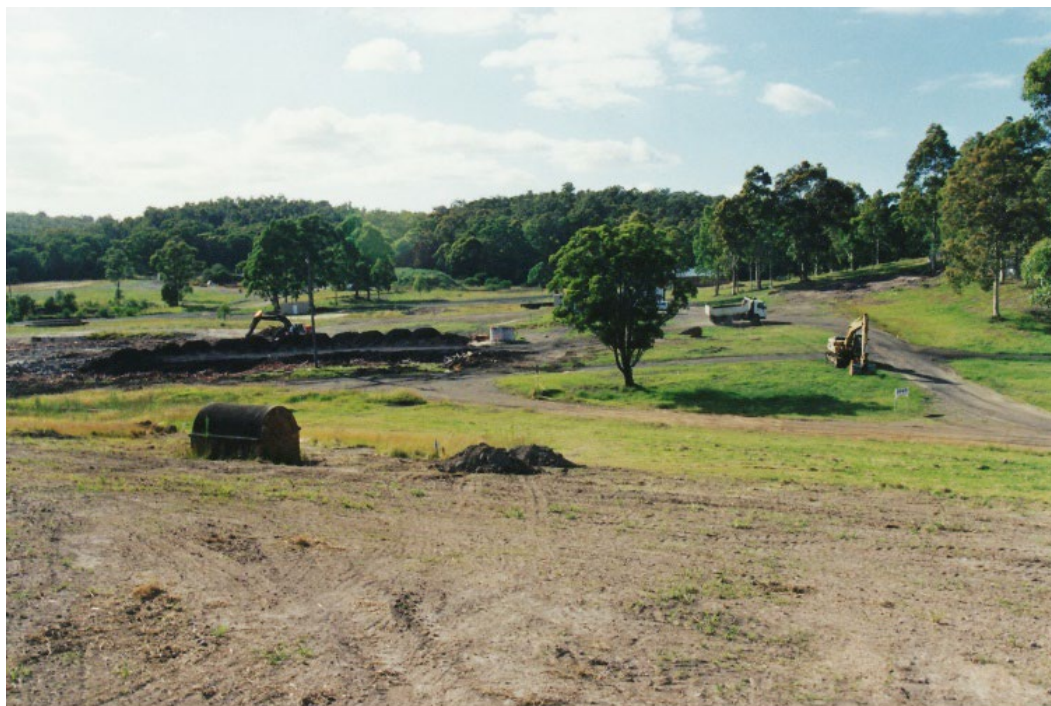
Figure 8: Coarse rejects spread following demolition (circa 1999)

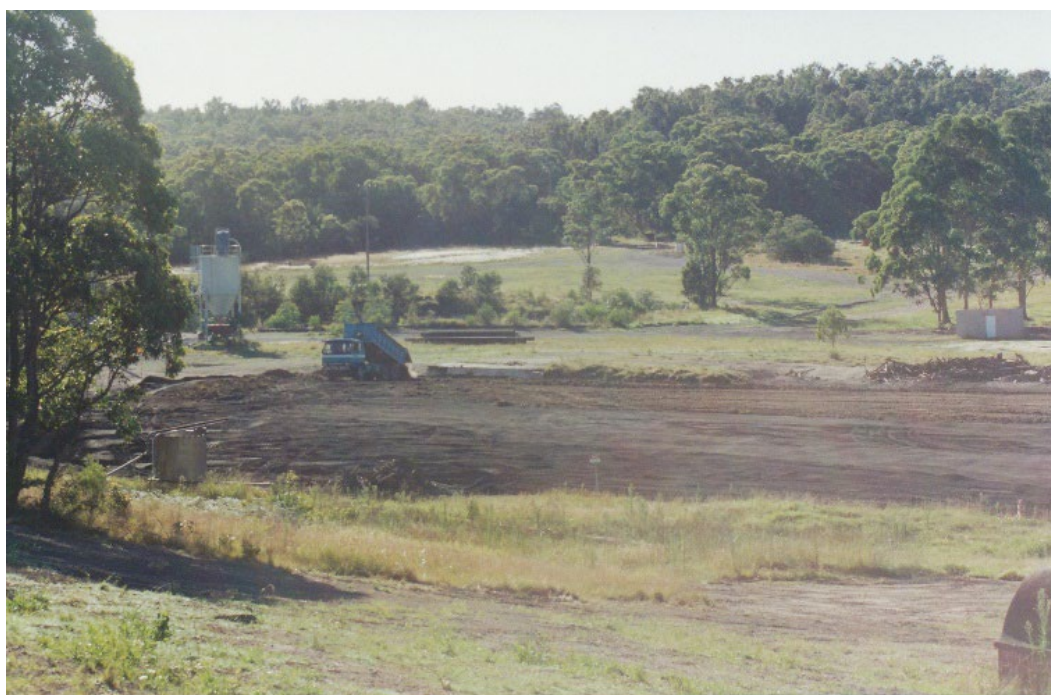
Figure 9: Topsoil spreading over coarse rejects for final planting (circa 2000)

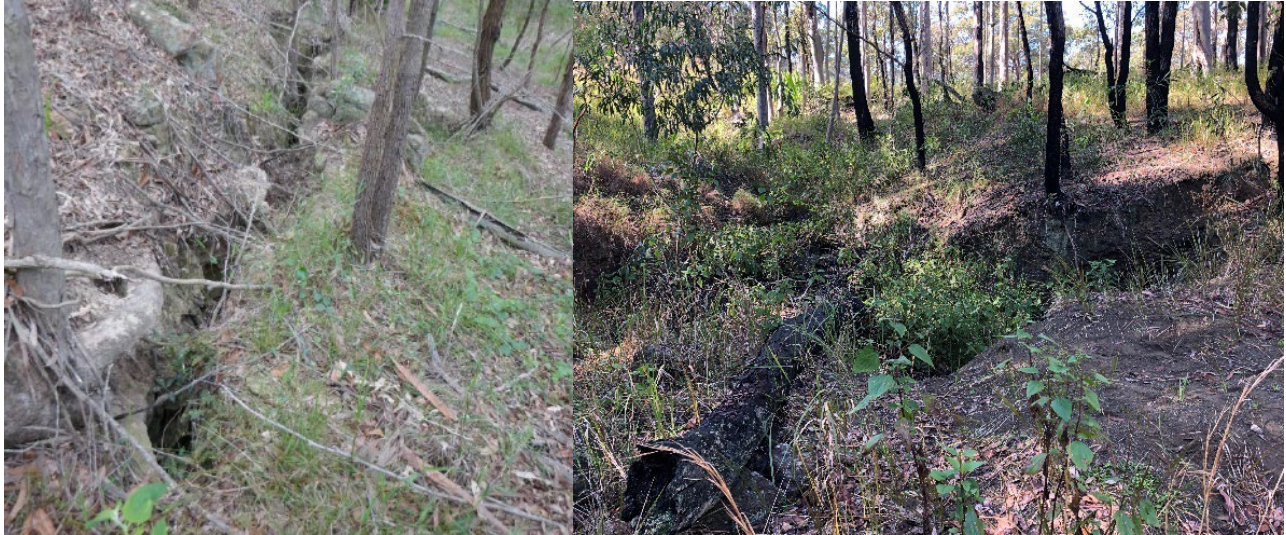
Figure 10: Subsidence cracks (circa September 2022)

Figure 11: Remediation of subsidence cracks following grouting (circa October 2022)

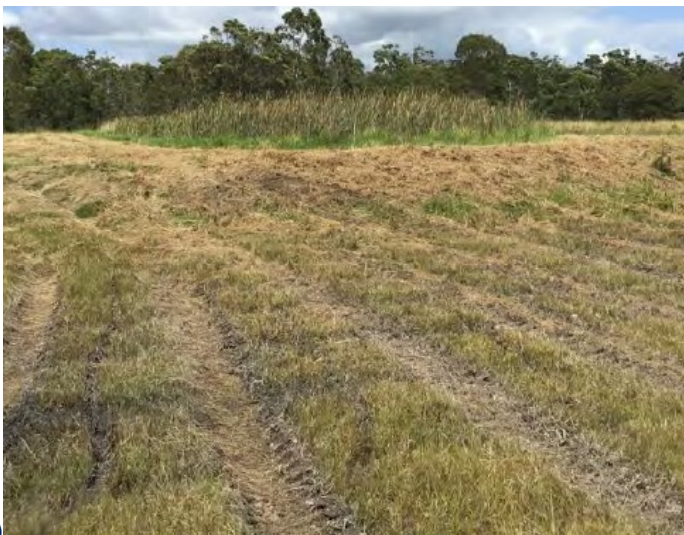
Figure 12: Vegetated tailings dam cap and 'turkeys nest' central dam (2022)

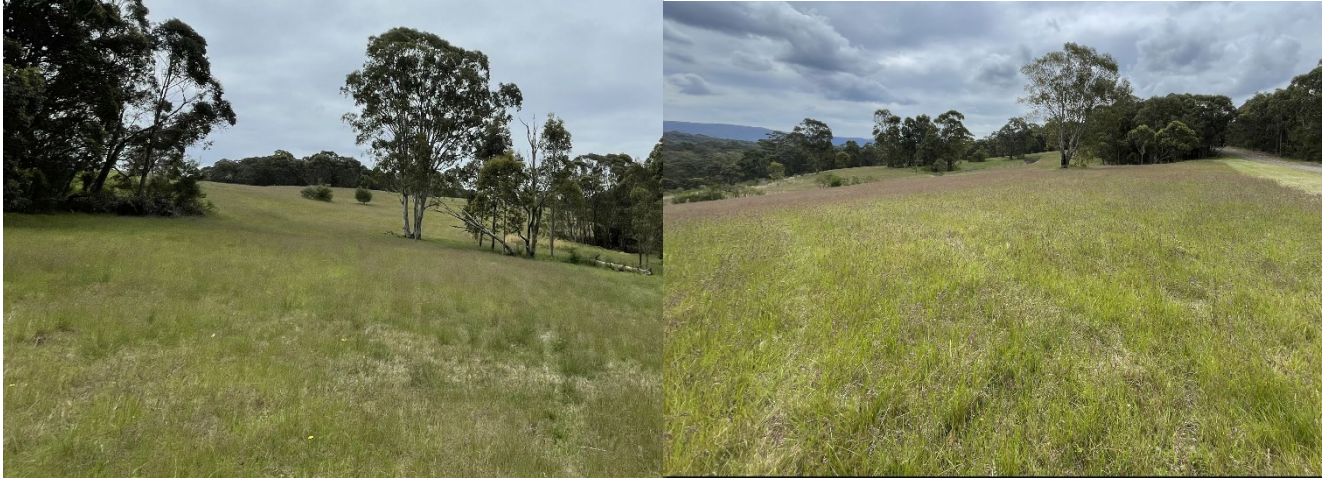
Figure 13: Vegetated reject emplacement areas (2022)

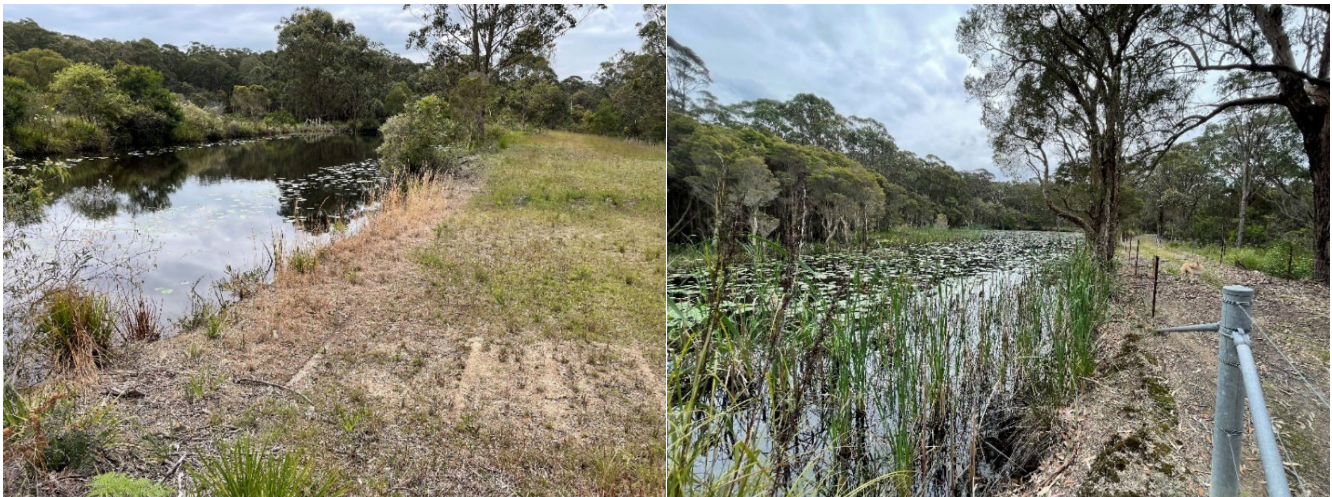
Figure 14: Retained dams (2022)
