Weekly incident summary

Week ending 7 February 2025

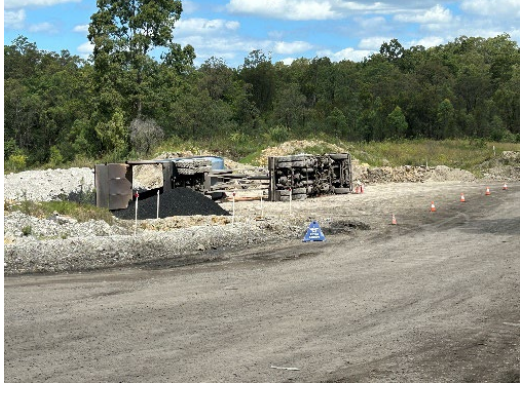
Incident type	Summary	Comments to industry
Dangerous incident IncNot0048482 Open cut coal mine Roads or other vehicle operating areas	<p>A prime mover with a single trailer was moving coal between a washery and a train-loading facility when an issue occurred with the reverse gear. The trailer was being tipped when the coal hung-up in the top part of the trailer and caused it to tip over on its side. In the process, the prime mover also rolled onto its side.</p> <p>The location selected to tip the load had a 5% cross slope. The cross slope was enough to cause instability in the truck as the load was being tipped, resulting in the truck tipping onto its side.</p>	<p>Pre-task inspections of work areas should be undertaken to identify and manage any hazards that are present. Where the work area conditions change, workers should stop and reassess the area.</p> <p>This is particularly important when a task is being conducted in unusual circumstances such as tipping a load away from a designated dump area.</p>

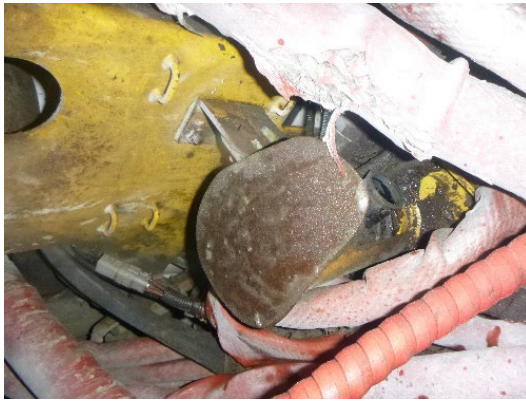
<p>Dangerous incident IncNot0048480</p> <p>Underground metals mine</p> <p>Fire or explosion</p>

<p>A fire occurred on an underground haul truck as it was being refuelled.</p> <p>A breather hose came loose from a pipe, resulting in atomised diesel interacting with a hot surface.</p>

<p>Mine operators should ensure that risk control measures to prevent underground fires are implemented and remain effective.</p> <p>Inspection regimes and housekeeping standards should be routinely examined to ensure minimum standards are met or exceeded.</p> <p>Mine operators should also ensure stringent monitoring and quality control of maintenance and repair activities.</p>
<p>Dangerous incident IncNot0048512</p> <p>Underground metals mine</p>	<p>A worker using an angle grinder to cut grid mesh repositioned the mesh on its edge to cut off some remaining tags.</p> <p>As the worker was placing the angle grinder on the ground, the grid mesh shifted, striking his right arm, which pushed the hand holding the angle grinder into the back of his lower right leg. This resulted in 2 lacerations and impacted underlying tissue. The worker had surgery to repair his Achilles tendon.</p>	<p>Angle grinders can be a dangerous power tool. When carrying our grinding activities, mine operators should have safe work practices in place and workers trained in those practices. During grinding activities, the work piece should be held firmly.</p>
