INVESTIGATION INFORMATION RELEASE

Continuous miner slides into worker

Incident date: 30 May 2019

Location: Ashton Coal Mine, Camberwell NSW

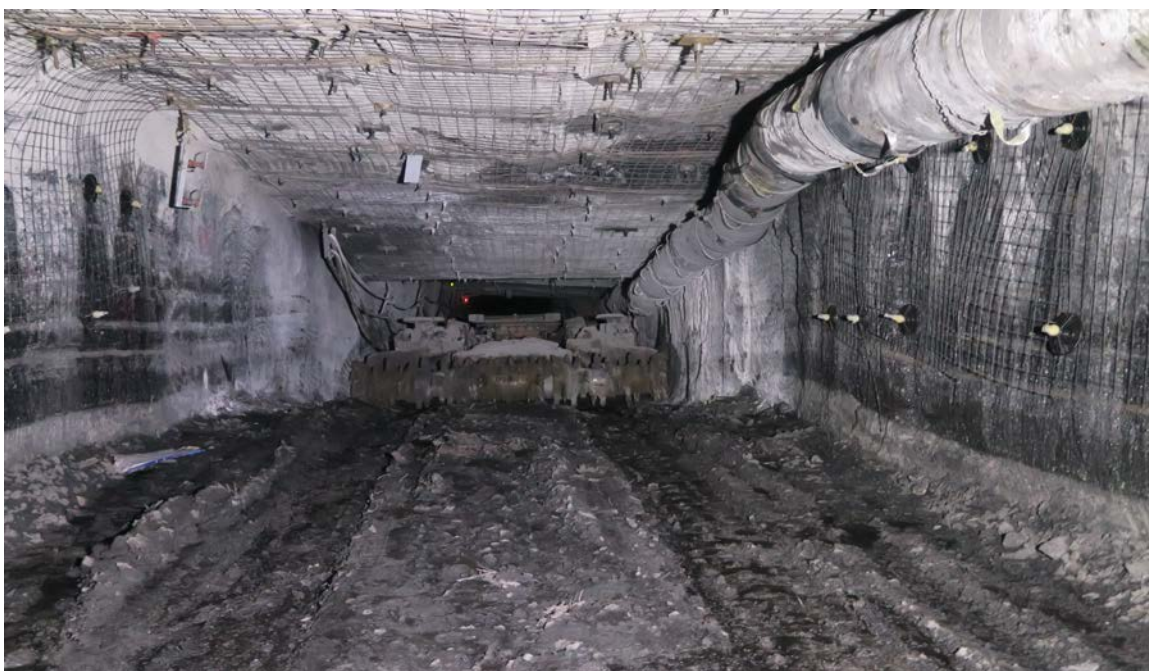
Figure 1 Position of continuous miner after uncontrolled movement

While attempting to tram forward, the continuous miner lost traction, sliding backwards down the sloped roadway impacting with the worker.

Consideration must be given to identifying, implementing and maintaining appropriate no-go zones and separation distances between workers and mobile plant.

Mine roadways should not exceed plant operating parameters.
