INVESTIGATION INFORMATION RELEASE

Worker seriously injured from fall

Event: Worker sustains serious arm and leg injuries after handrail on haul truck access ladder fails

Location: Wilpinjong Coal Mine

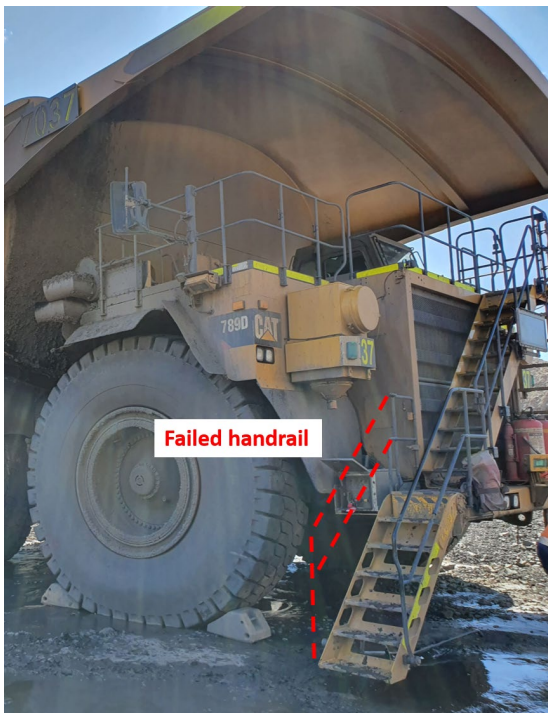
A hand rail on the access ladder of a Caterpillar 789D failed, causing a worker to fall about 1 to 1.5 metres to the ground. The worker sustained serious arm and leg injuries which required surgery.

Figure 1 Failed handrail on haul truck

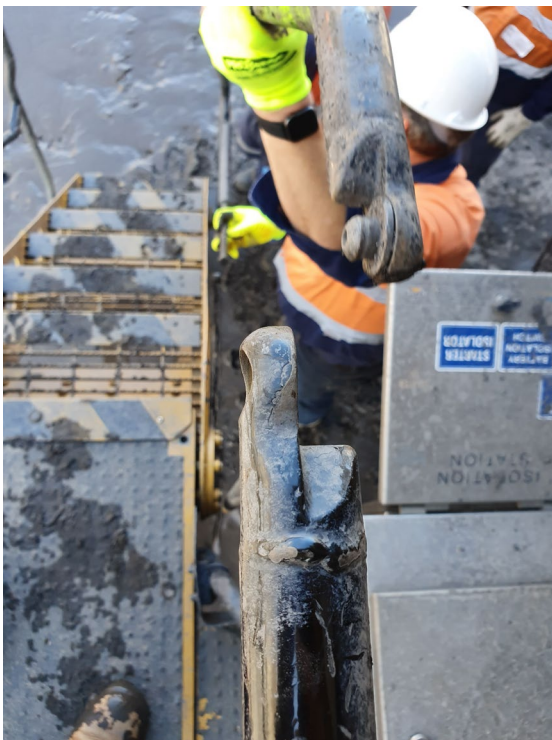
Initial indications are that the handrail failed as a result of wear on the pivot points connecting the lower fixed and moving handrail sections. Following an inspection of the mine's haul truck fleet, similar defects were identified on six other haul trucks at the mine. Several days later, a further defect was identified on the access ladder of a different haul truck during a routine inspection by an operator. This also resulted in a failed handrail, however did not cause injury.

Figure 2 Failed handrail from initial incident

A person falling from height from mobile plant is a foreseeable risk and adequate measures should be put in place to control the risk. The provision of safe access equipment on mobile plant is a critical control measure to reduce the risk of falling from mobile plant.

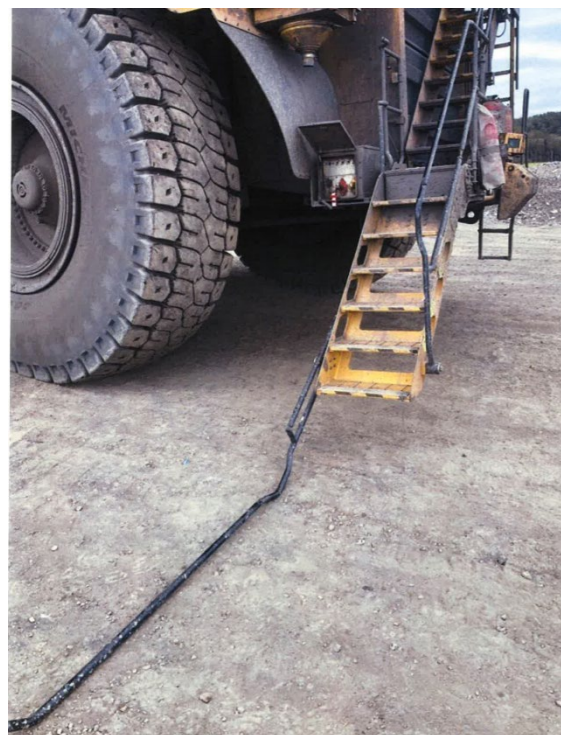
Figure 3 Failed handrail from second incident
