SAFETY ALERT

Falling rock strikes loader operator

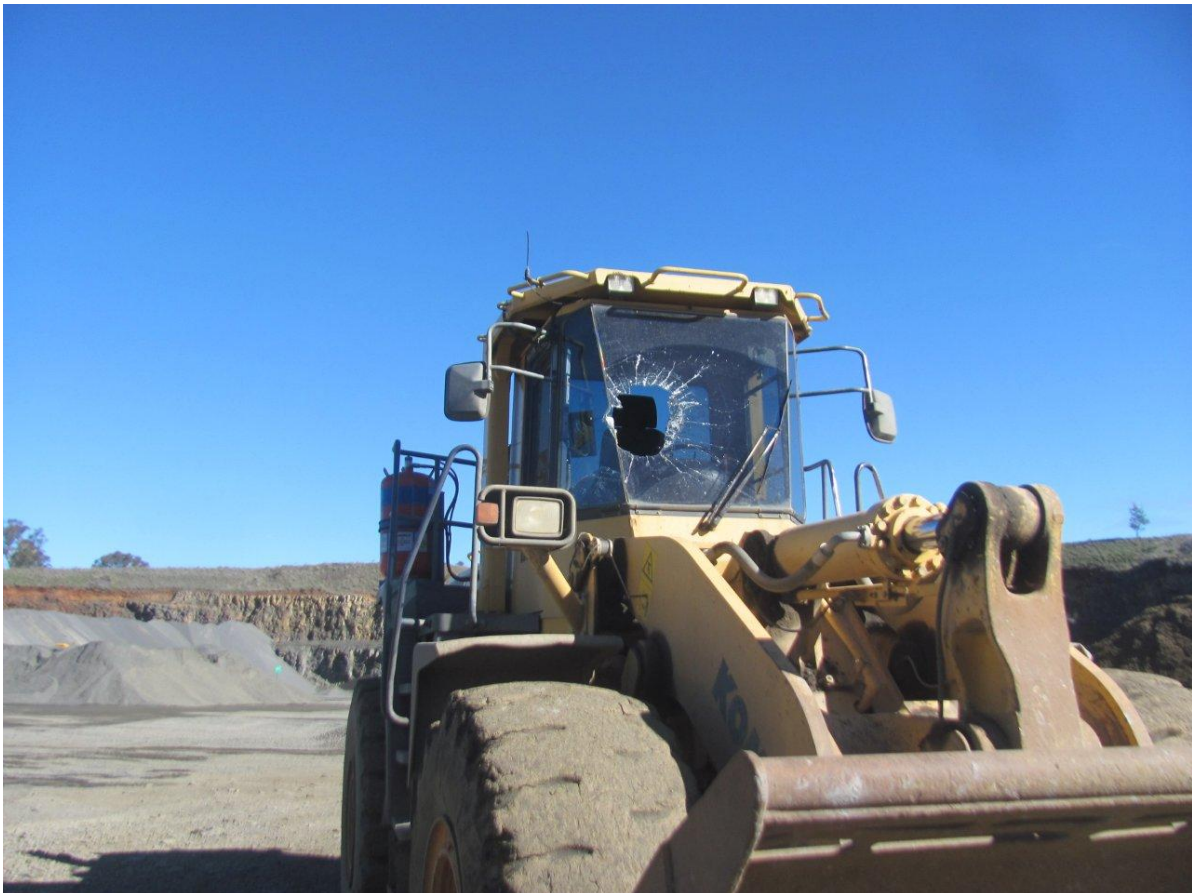
The rock struck the loader bucket arm, which was in the raised position, and bounced through the windscreen of the operator's cab.

Figure 1: Damage to the loader windscreen. Photo by Mine Safety

1. Mobile mining equipment should be fit for purpose and matched to the work activity undertaken.
2. Risk assessments and SWMS for loading from blasted stockpiles should assess the risk of rocks/material falling from height.
3. Supervisors and workers should be competent to identify and act on identified hazards in the workplace.
4. Supervisors and workers should inspect the workplace at regular intervals to ensure the workplace is safe and without risk. If risks are identified, appropriate actions must be taken.
5. A change management process should be conducted when changes to the workplace system or activities are planned.

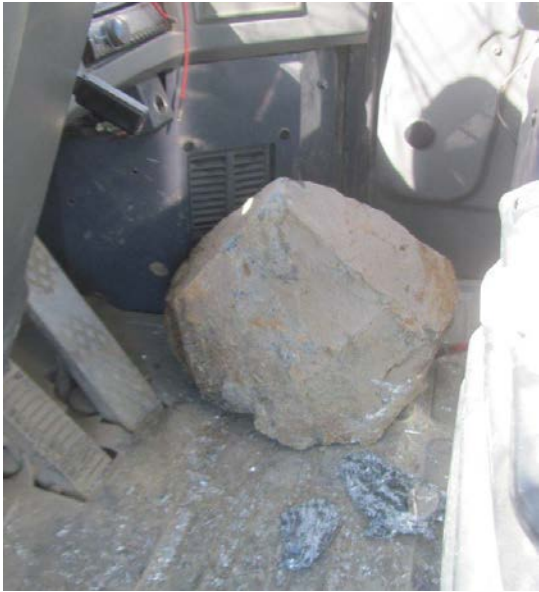
The operator was struck in the upper chest and suffered minor lacerations.

Figure 2: Rock inside the operator's cab. Photo by Mine Safety Figure 3: Area where loader was operating. Photo by Mine Safety

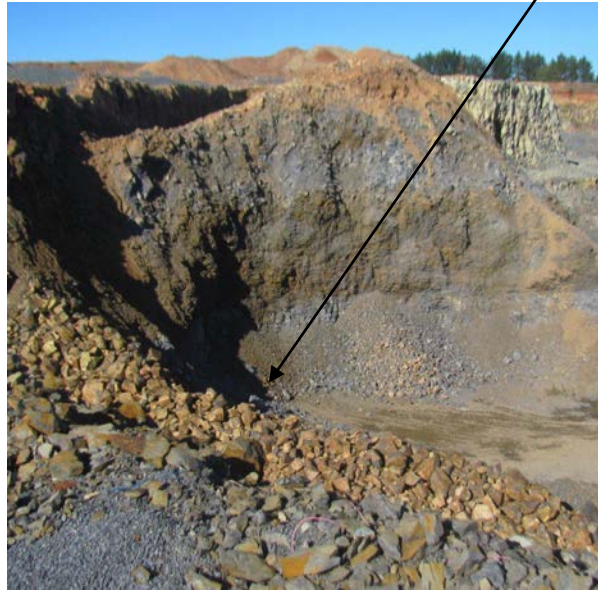
The working face where loading was taking place was approximately 18 m in height.

The area had recently been blasted and material had held up in the face with only a small amount riling away from the face for free loading.
