SAFETY ALERT

Severe Electric Shock from Power Tool

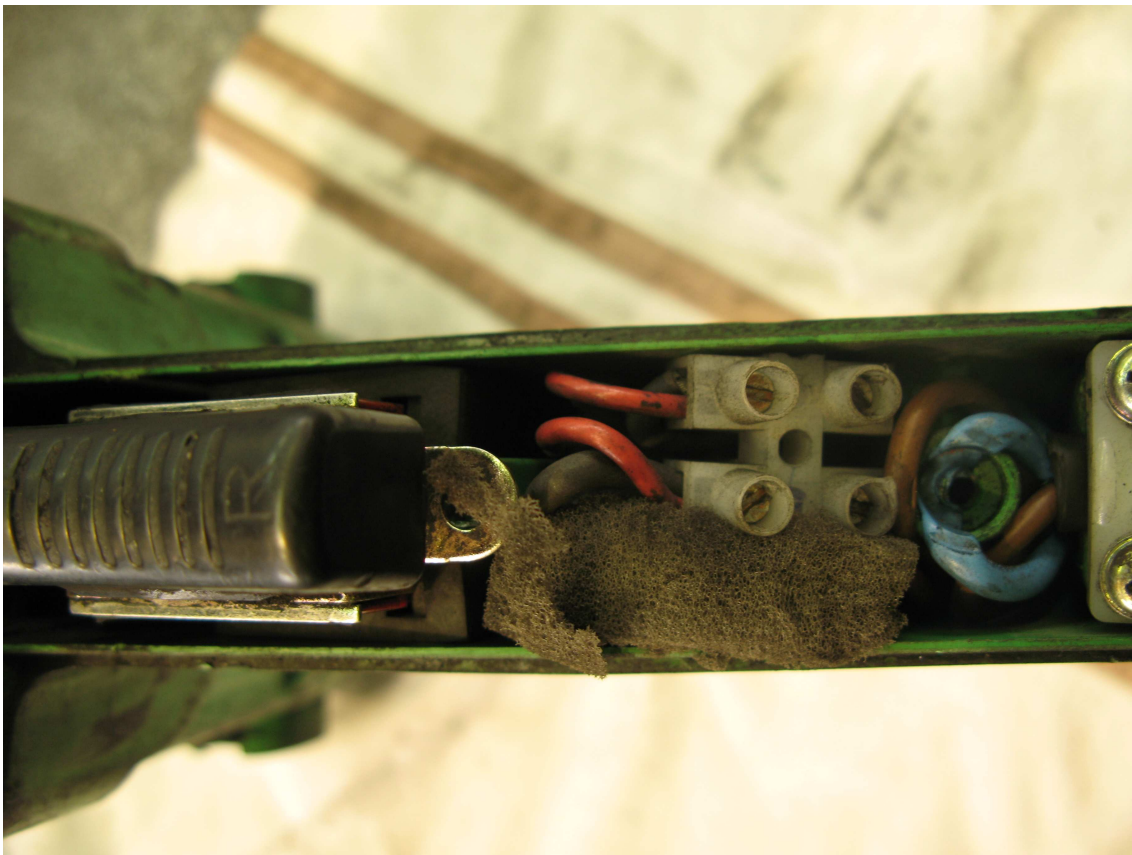
Figure 1

1. The power tool chuck insulation failed due to an extremely dirty tool (internally) with fine dust/grime evident. The dirt entered the tool through ventilation slots at the chuck/gear box and commutator. An Electro Magnetic Interference (EMI) filter system was connected across mains conductors and the internal metalwork (Figures 2, 3 and 4).
2. An external metallic screw in the power tool pistol grip handle cover penetrated one of the insulated supply conductors (Figure 1).

Mines apply the hierarchy of risk controls. Where the use of electric power tools can not be eliminated, there should be tools that substitute the hazard of portable 240V tools with a portable tool that gives rise to as low as reasonably practical risk.

Any tool used must be fit for purpose, and maintaining tools in a satisfactory condition for use is a key activity that is part of the work cycle.
