SAFETY ALERT

Structural bin failure

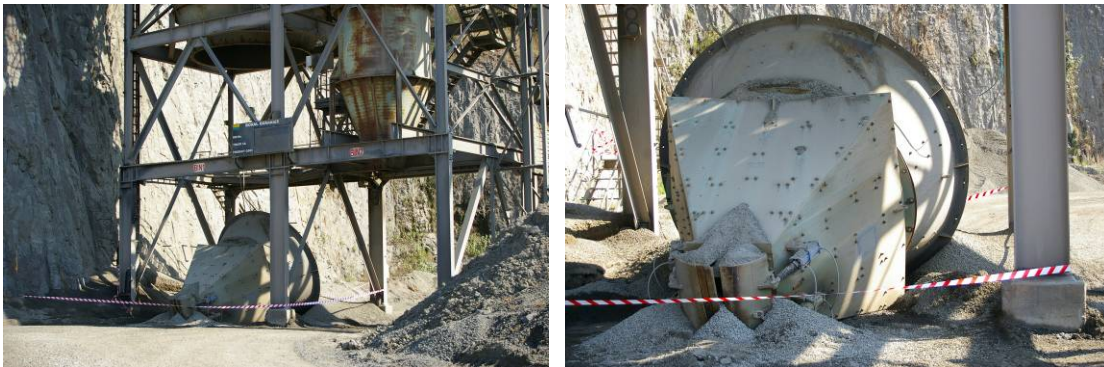
A cone-shaped 100-tonne truck loading bin failed suddenly and fell to the ground.

Preliminary investigations have indicated the two lower sections of the bin had been previously removed for liner replacement. It was noted that bolt holes on the support flanges had been elongated which had allowed some bolts, complete with washers, to pull through the greater than 20mm holes in the support flange.

As part of the investigation a design review of the bin has been requested and a review on the practice of elongating bolt holes.

5. All structural equipment/plant must be periodically inspected by a competent person (eg structural engineer) to ensure it is safe to use.
6. Steel structures should be designed, manufactured, erected and modified in accordance with Australian Standard *AS 4100 Steel Structures* or *AS 3990 Mechanical equipment – Steelwork*.
