SAFETY ALERT

Polyurethane workshop floor pad becomes a projectile

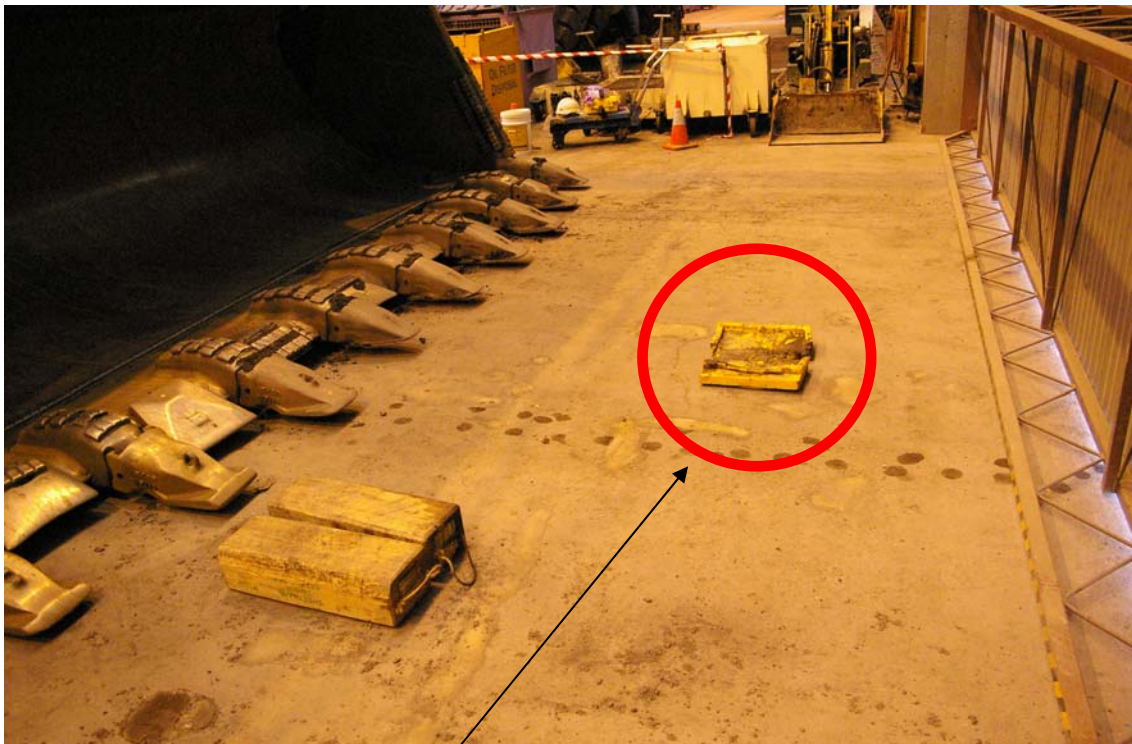
A contractor received extensive head injuries when a workshop floor pad was forcefully ejected from beneath a front end loader bucket.

A polyurethane pad (400mm x 470mm x 40mm weighing 9.6kg) was placed under a centre bucket tooth to prevent concrete spalling. The loader bucket was then tilted slightly forward which caused the pad to be expelled out and upwards, striking the contractor forcefully in the forehead.

The polyurethane workshop floor pad (circled) that was ejected from beneath the front end loader bucket.

1. Systems of work are safe and without risk to the health of people.
2. Workers are provided with information, instruction, training and supervision as may be necessary to ensure their health and safety.
3. Tools are fit for purpose.
4. Additional items introduced for tasks have been risk assessed and are fit for purpose when properly used.
5. The use of plant energy sources must be identified and taken into account when risk assessing tasks and materials.
6. Repetitive work is standardised to minimise unsafe variations of activities and should include the use of tools and materials, eg safe work procedures are developed.
