SAFETY ALERT

Seatbelt saves forklift driver

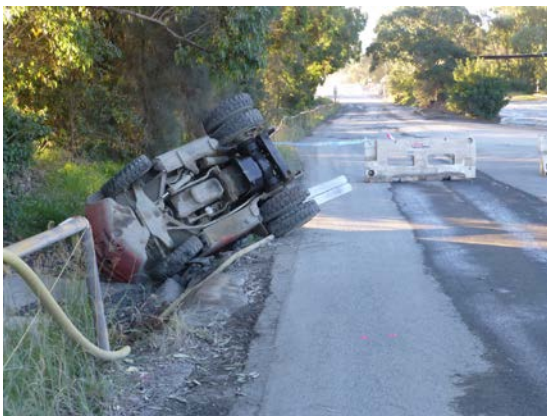
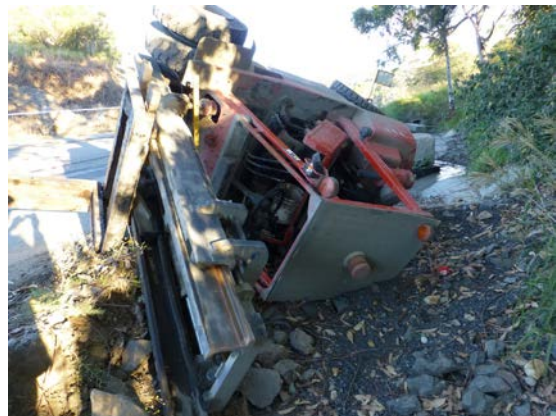
After delivering spare parts to the processing plant the driver was returning to the workshop unladen when he lost control of the forklift and rolled over in an adjacent drain.

The investigation highlighted speed and uneven road surface as contributing factors. The speed limit for all vehicles on this road was 30 kph. The forklift did not have a speedometer so the driver did not know the speed at the time of the incident. Forklifts commonly have a top speed of around 25-30 kph. The road prior to where the forklift came to rest had a downward grade and slight undulation which were also contributing factors.

The driver reported the forklift started to wobble from side to side which resulted in him losing control.

- Consider lower speed limits for forklifts in comparison to other vehicles.
- Forklift operators must know the limitations of the machines they drive including appropriate speeds for all kinds of road surfaces.
- Consider fitting speed limiting devices to forklifts. This is a reasonable control when considering the hierarchy of controls according to legislation.
- Ensure roads travelled by forklifts are well formed and clearly marked.
- Ensure all quarry roads accessed by mobile plant have a windrow at least $\frac{3}{4}$ of the height of the largest wheel that accesses the road.
- Ensure seatbelts are correctly fitted and worn. Consider installing intelligent systems so the forklift can only be started if the seatbelt is fastened.
