DATE: DECEMBER 2018

Potential fall of excavator over highwall

This safety alert provides safety advice for the NSW mining industry.

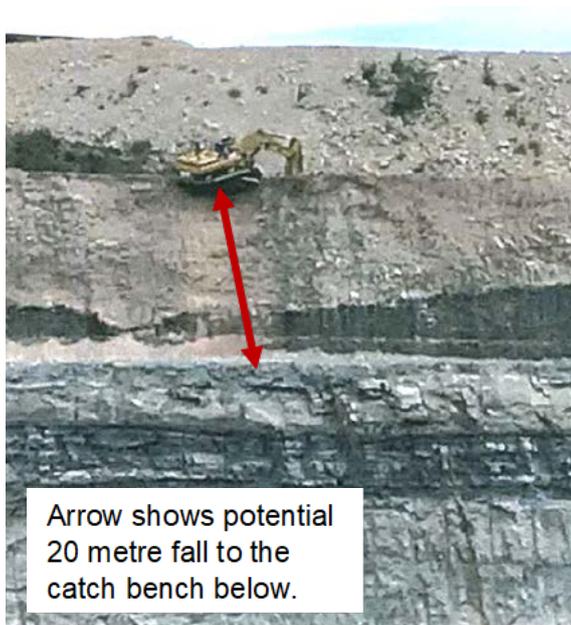
The activity was an alteration to a planned task and mine supervisors had not authorised the altered work method. The excavator reversed into an area where there was no highwall edge bunding. The excavator slumped over the edge when the edge collapsed. The operator got out of the cabin.

Photograph 1: View of the excavator sitting on the edge of the highwall. (Photograph supplied by the mine)

- documented tasks that are reviewed by supervisors should ensure that principal hazard risks are identified and adequately controlled (such as working near a highwall edge)
- adequate communication arrangements should be made with workers in service and maintenance crews so that when tasks are altered, and unplanned events occur, adequate notification for approval is made to a supervisor
- workers in service and maintenance crews should be considered in the supervisory arrangements for the relevant statutory supervisor
- review highwall edge bunding to design specifications in work areas to prevent mining equipment going over highwall edges and have adequate demarcation in areas where appropriate bunding is not installed
- review that the equipment used for handling poly pipe is fit-for-purpose.

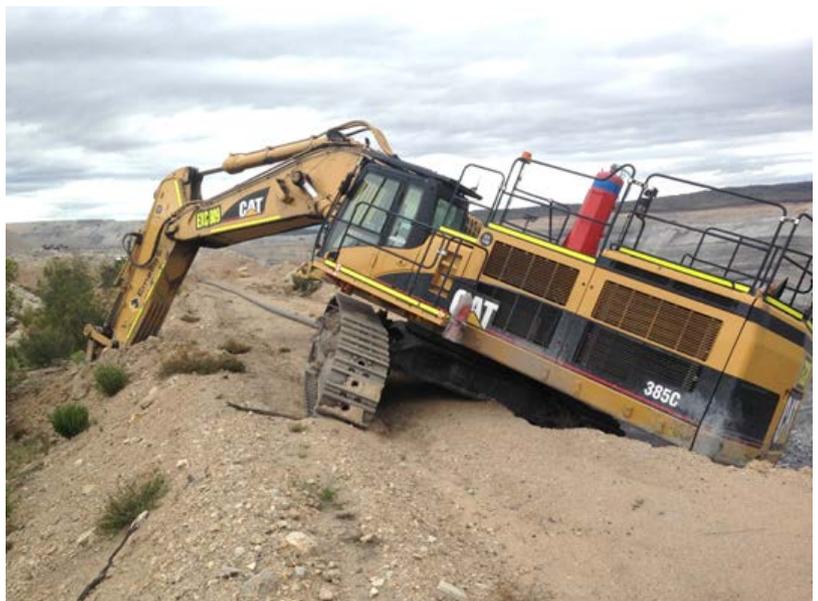
The services crew leading hand then disconnected the poly pipe from the excavator, got into the cabin, and rotated the excavator to secure the bucket into the ground. Rotating the excavator significantly increased the potential risk of the machine falling over the highwall.

Photograph 2: View from the bench of the excavator rotated over the edge of the highwall. (Photograph by Resources Regulator)
