# SAFETY ALERT

## Drill rig contacts 22kV power line

This safety alert provides safety advice for the NSW mining industry.

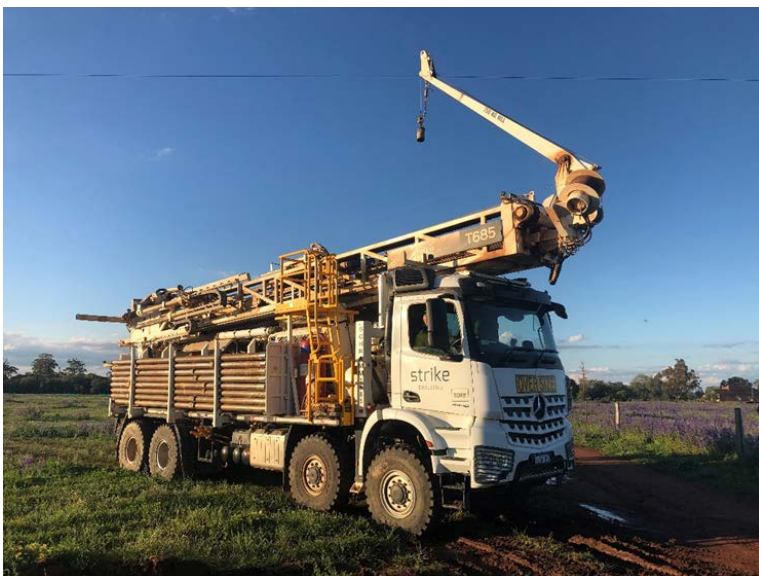
An exploration drill rig contacted energised 22kV overhead power lines while travelling across a paddock. One of the three overhead lines was broken and dropped to the ground. The operator dismantled the rig without suffering any injuries or electric shocks.

*Figure 1. Raised jib contacts 22kV overhead power line*

The drill, a Shramm 685 rubber tyre truck mounted rig, had just completed drilling an exploration hole and was being moved to set up on the next hole. The operator lowered the mast, however the rod handling jib remained raised.

As the drill rig passed under the 22kV overhead powerline the raised jib contacted the energised conductors.

Initial investigations indicate that a failure to follow procedure and lower the raised jib allowed the rig to contact the 22kV power lines, dragging the first line into contact with second line causing a high voltage fault which subsequently tripped the power and caused the power line to fall to the ground.

- Risk assessments should consider the risks associated with all activities that may occur near overhead power lines, irrespective of the frequency or complexity of the activity.
- Risk assessments should identify all controls to prevent equipment encroaching on safe approach distances for high voltage overhead power lines, including:
  - alternate travel routes or work sites
  - limits on maximum height for any equipment that may travel, or be transported below, or work near overhead power lines
  - warning signage or barriers (temporary or permanent) for overhead power lines (include safe height limits).
- The use of procedures, check lists and permits should also be supported by planned tasks to verify their implementation and effectiveness in managing the risk.

- Emergency procedures should be established and include contact details of the electricity supply controller.
