MINE SAFETY

INVESTIGATION UNIT

**Serious head Injury – chains and slings
28 May 2004**

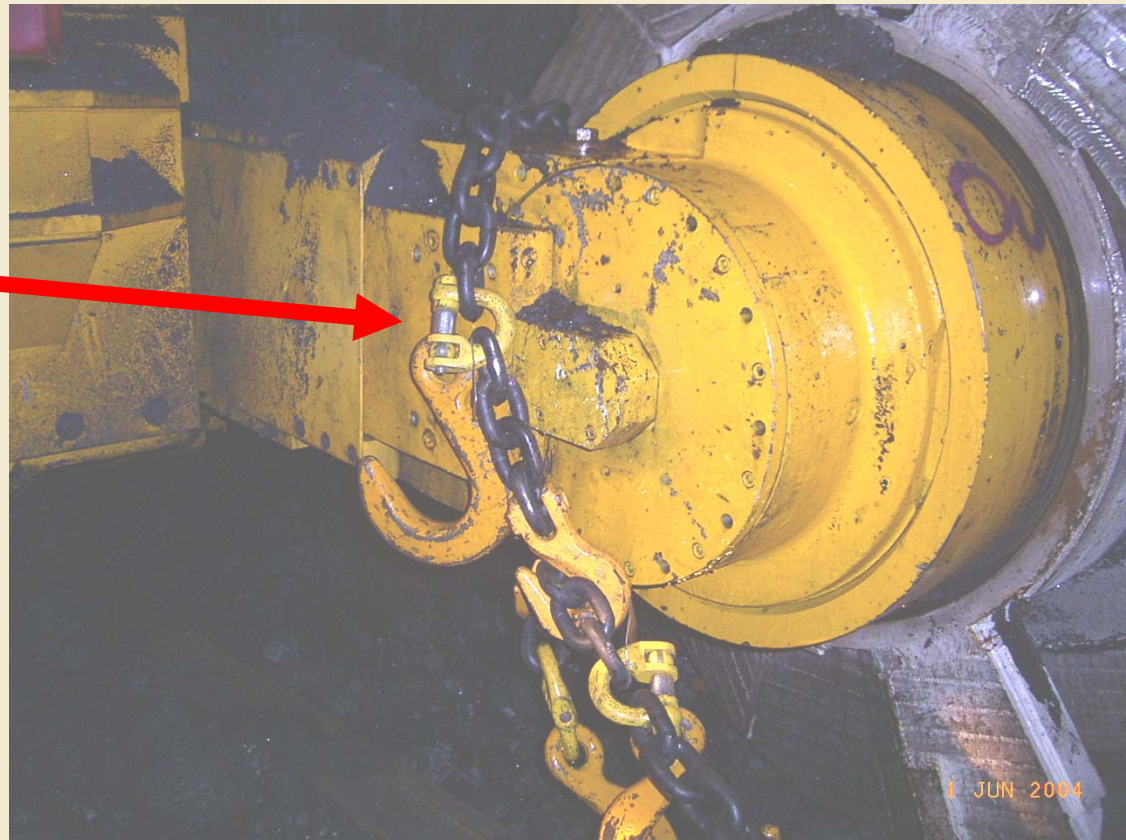
- Underground Coal Mine near Wollongong NSW
- Using the shearer to pull the AFC chain
- A chain joiner with two links on one side
- Chain joiner put in side load
- Worker seriously injured by flying chain parts

Chain Connector
shown in side pull

- Pulling and lifting tasks must be designed by a competent person
- Pulling and lifting tasks require competent supervision
- The max. forces and loads must be considered
- Only use correctly rated pulling and lifting gear.
- Damaged lifting and pulling equipment should be reported and not re-used
- Never place a chain connector in side load

- Mechanical Engineering Safety Management Plans – Lifting and pulling
- Supervision and training
- Suppliers of Lifting and Pulling Equipment to provide correct equipment and information

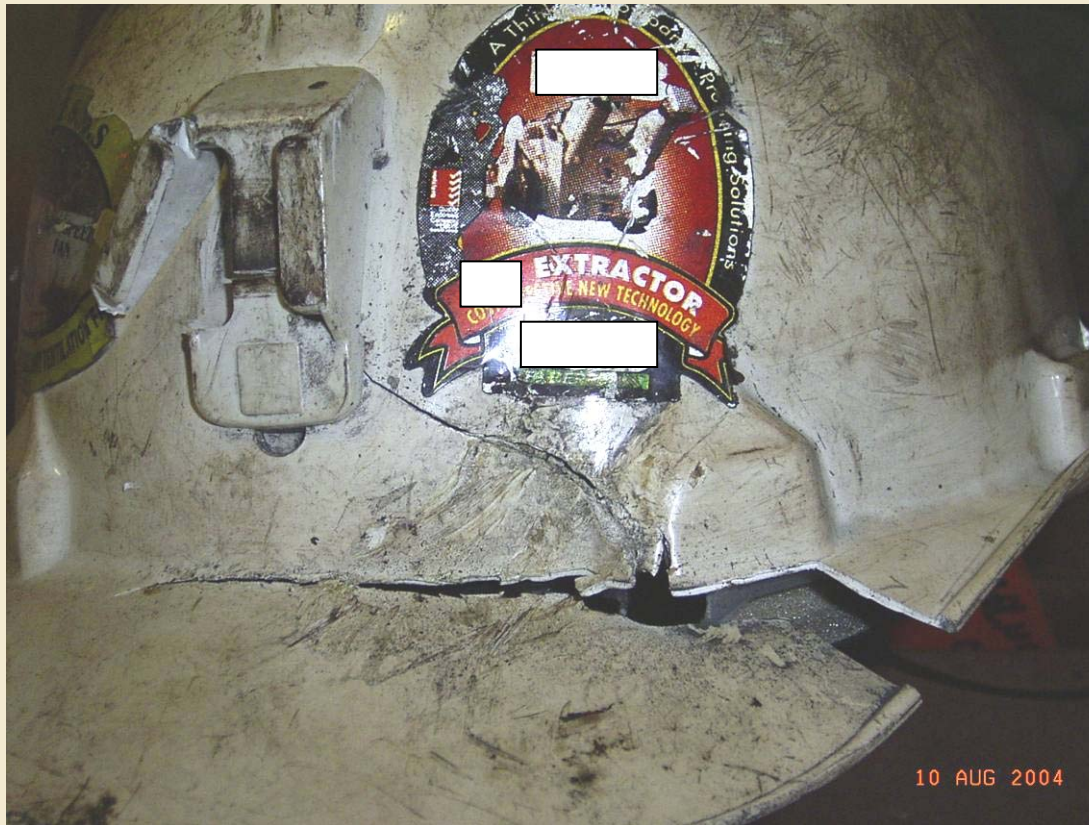
Damage sustained by helmet worn by injured person
