WEEKLY INCIDENT SUMMARY

Week ending Friday 23 July 2021

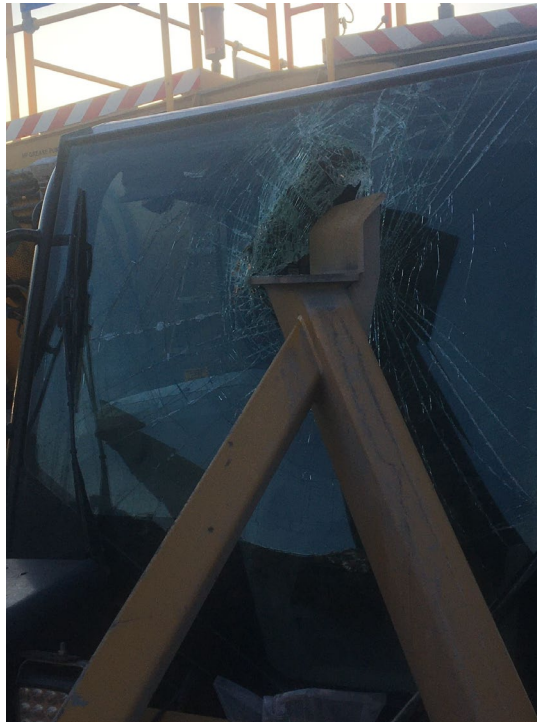
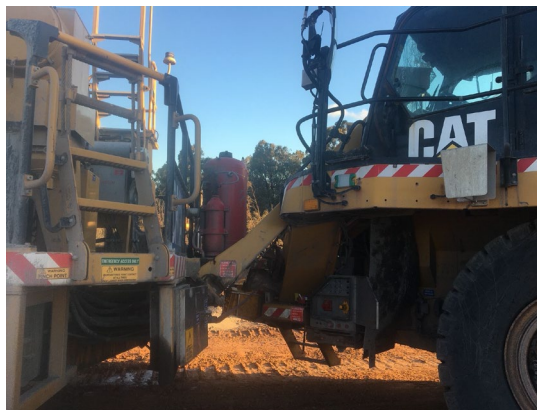
INCIDENT TYPE	SUMMARY	COMMENTS TO INDUSTRY
Dangerous incident IncNot0040317 Open cut coal mine

Roads or other vehicle operating areas	A service cart entered an operational drill area and parked facing the front of a drill rig. The drill rig trammed forward and one of the drill support cradle arms made contact with the hand rail and windscreen of the service cart. Visibility from the drill cabin was poor due to dust on the windows and glare from the sun. The service cart operator did not establish positive communications with the drill rig operator. There were no injuries.	Operators of plant must establish positive communications before entering the work area of other mobile plant. All mine operators must have well established procedures for such communications and workers have a legal obligation to follow those procedures. Our recent campaign focused on the risk of collisions involving heavy mining equipment. Refer to: Vehicle incidents - heading in the wrong direction

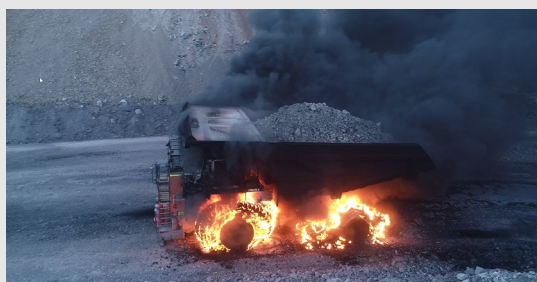
Dangerous incident
IncNot0040327
Open cut coal mine

Fire or explosion

A haul truck caught fire while driving on a haul road. Another truck operator noticed that the fire suppression system had activated and alerted the operator. The operator was able to exit the truck before it became engulfed in flames.

The cause of the fire is being investigated. Further information may be published later.

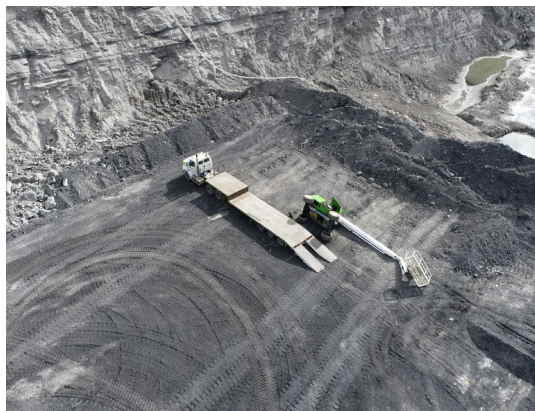
Dangerous incident
IncNot0040361
Open cut coal mine

An elevated work platform (EWP) was being driven toward the ramps of a low loader when it slipped off the edge of the deck. The operator was in the basket of the EWP at the time. A spotter was helping to guide the operator during the unloading process. The operator was thrown from the basket and sustained a fractured vertebra.

Mine operators must have controls in place to manage the risk of EWP's overturning during loading and unloading activities. EWP's should be matched appropriately to the size of the transport vehicle (length and width) and be centrally positioned on the deck or tray. Operators should plan loading and unloading tasks and final machine position before commencing the task.
