Week ending 22 August 2018

This incident summary provides information on reportable incidents and safety advice for the NSW mining industry. To report an incident to the NSW Resources Regulator: phone 1300 814 609 24 hours a day, 7 days a week.

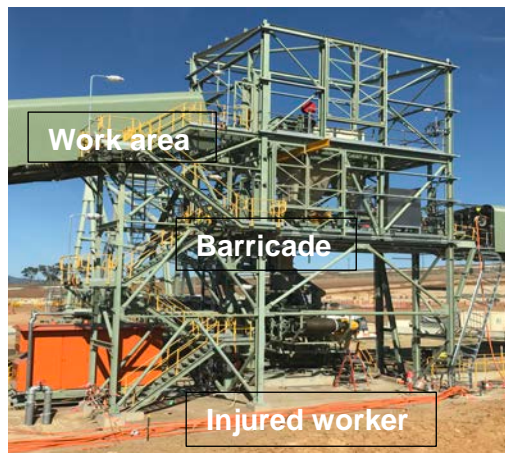
Incident type	Summary	Recommendations to industry
Dangerous incident SinNot-2018/01345	<p>A worker was installing scaffold about 11 m above the ground when a 1.5 m piece of scaffold was dropped. As it fell, it ricocheted down a staircase hitting a worker below on the ear. The worker was taken to hospital and received eight stitches to the wound.</p> <p>While barricading was in place, it was only to protect the level immediately below the work area, not other levels below this.</p>	<p>Before starting a task, when establishing drop zones the following should be considered:</p> <ul style="list-style-type: none"> → fall distance → potential for ricochet → method of barricading → consultation with other work groups → communication to other workers in the area → assessment of timing of work to minimise exposure to the workers.
