Week ending 29 August 2018

This incident summary provides information on reportable incidents and safety advice for the NSW mining industry. To report an incident to the NSW Resources Regulator: phone 1300 814 609 24 hours a day, 7 days a week.

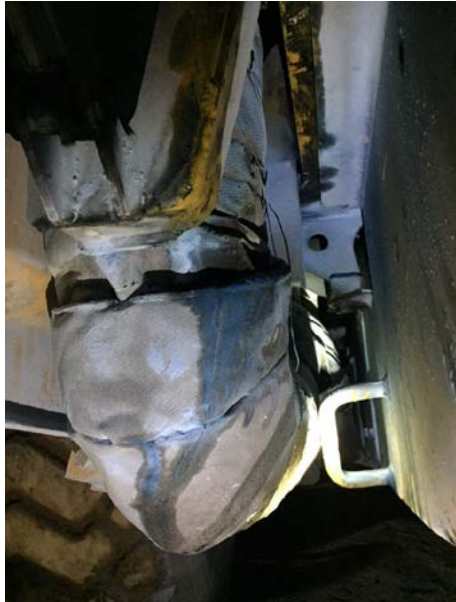
Incident type	Summary	Recommendations to industry
Dangerous incident SinNot-2018/01391	<p>A fire occurred on an agitator truck in the decline of a metalliferous underground mine. The operator saw a glow on the decline wall and stopped to investigate. There was a small flame around the exhaust lagging, which was extinguished with a hand-held extinguisher.</p>

<p>Lagging can become a fuel source when hydrocarbons accumulate in it. This risk should be addressed in the fire risk assessment for the item of plant.</p> <p>SA18-08 Underground mine fire initiates emergency response details a recent serious incident in similar circumstances.</p> <p>In-service fires on mobile plant - September 2017 should also be reviewed.</p>

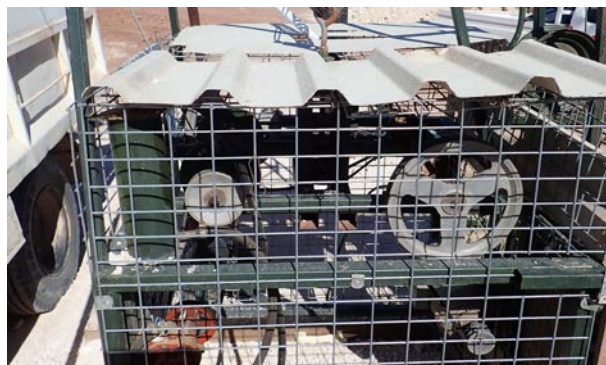
An opal miner severed three fingers at the first knuckle on his hand. The miner was adjusting a belt drive while it was operating, when his fingers were drawn into the pulley.

All mines must have a system where workers isolate equipment before working near rotating parts.

SafeWork NSW has issued [Managing the risks of plant in the workplace code of practice](#), which is applicable to all mines.

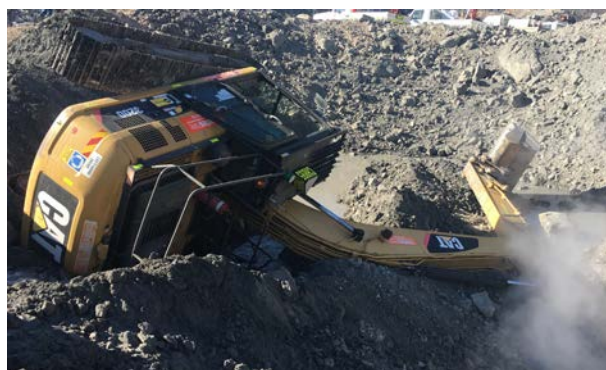
An excavator rolled onto its side when the ground gave way under the right-hand track. At the time, the excavator was digging a sump for water due to a 'hot shot'. The cab door was open at the time.

When working near heat-affected ground, the ground stability needs to be considered when preparing a safe work procedure.

When a risk of roll over exists, additional controls must be implemented to minimise the risk including set back distances, further pad construction and use of alternative machines.
